BY JIM BRADLEY AND CHRIS WEST

A Troubled Tiny House

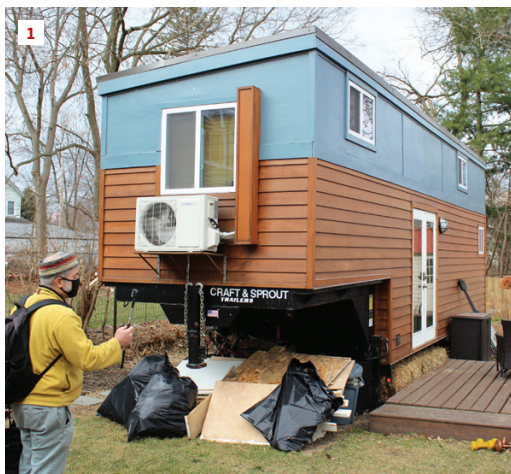
The cozy structure (1) was part of an HGTV program presenting an idyllic look at the tiny house movement—reality proved otherwise for the first-time homeowners. Here are two inside views: looking toward a raised dining room in the front of the home (2), and in the kitchen looking toward the bathroom beyond (3). Sleep quarters were in a loft above the kitchen.

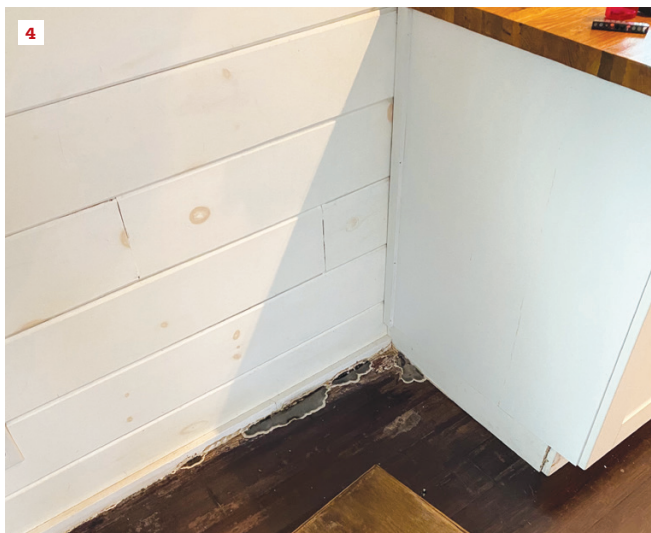
Mushroom blooms thrive at the base of an interior wall (4). The manufacturer did not consider basic building science or changes in climate zone when building the home; it was built in Connecticut (zone 5) and trucked to Vermont (zone 6).

To prevent condensation on the first cold, solid surface of an assembly (walls, floors, and ceilings), one needs to use either all rigid insulation or a mixture of rigid and fluffy insulation that keeps the first solid surface in the assembly warm—above the dew point. The floor was insulated with Rockwool batts, which qualifies as a fluffy insulation. It is vapor open, meaning that water vapor can move through it. The first cold surface in the floor is the metal floor of the trailer and the sides of the studs. The water vapor in the air of the tiny house condensed on these surfaces and became liquid water. Then it couldn't evaporate; instead, it wicked up into the floor and walls, leading to the extreme level of rot evidenced by the mushroom blooms.

Possible solution. Included in our forensic report were plans to remediate the damage and shut down the conditions that allowed rot and mushroom blooms to occur (see illustration, left). We recommended first removing the interior finishes and the bottom 18 inches of the home, followed by decoupling the wood-framed structure from the metal trailer and isolating the metal from the living space with structurally rated low-permeable EPS rigid insulation. To repair the lower portion of the tiny house, we suggested removing the rotted bottom sills and any compromised wall studs and applying a mold and mildew stain remover to affected areas as needed. The final step would be to lower the structure back onto the trailer and reattach it, using the existing anchors if possible or, the more likely scenario, securing it with non-corrosive threaded rods (welded to the trailer's chassis), nuts, and washers.

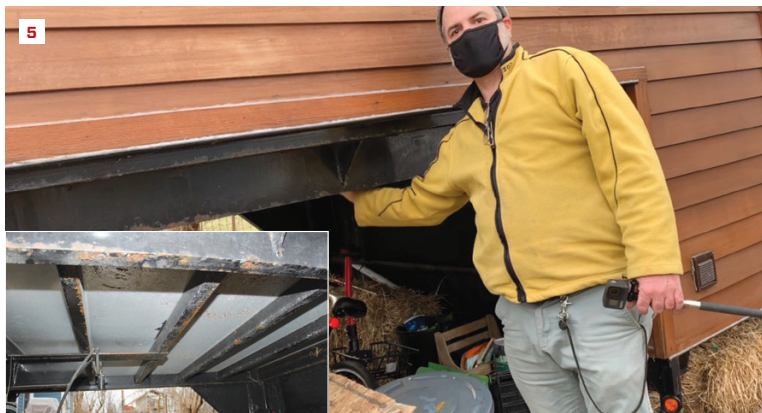
Seams in the sheet-metal bed had not been air-sealed, providing cold, moist air access into the framed floor (**5, inset**). More critically, warm, moist air from the interior condensed on the metal bed, saturating vapor-open batts; water accumulated in the batts over time, resulting in rotted OSB subfloor and framing (**6**). The problem was more acute along raised, uninsulated edges (**7**).

The main culprits leading to the floor damage were cold, moist air infiltrating the framed floor through seams in the sheet-metal bed that had not been air-sealed and, more critically, warm, moist air from the interior condensing on the inside surface of the trailer's sheet-metal bed and saturating the vapor-open Rockwool batt insulation on top of the metal between sleepers. With a lack of drying potential, water accumulated in the batts over three years of use, resulting in a rotted OSB deck, waterlogged 2-by sleepers, and a rusty sheet-metal bed. The problem was more acute around the plate-metal wheel wells and along the raised, uninsulated edges of the trailer where OSB subflooring was laid over the steel bed.

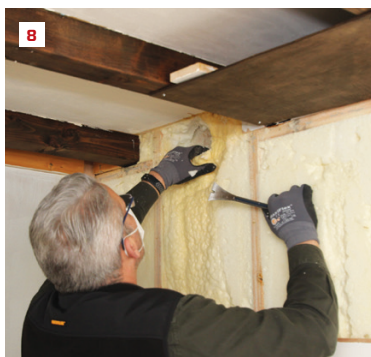
Test holes at walls and ceilings proved dry; moisture hadn't penetrated the open-cell spray foam and condensed on the OSB sheathing as feared (**8**). A questionable HRV (**9**) and inadequate heat pump were installed.

On our second visit, we determined that the rot found in the floor had migrated 8 to 12 inches up the sides of the walls. We cut test holes higher up in the walls and in ceilings and found them to be mostly dry. Moisture hadn't penetrated the open-cell spray foam and condensed on the interior side of the OSB wall and roof sheathing as feared, though it was probably just a matter of time before this happened due to the absence of an interior vapor-control membrane.
