BY DOUG HORGAN

## Troubleshooting a Failed TPO Roof

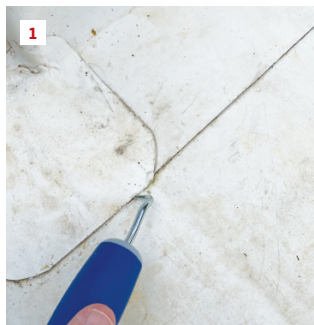
Using a seam probe on a recently installed roof, the author found multiple voids along welded seams and patches (1). In addition, required sealant along cut edges of TPO had been omitted. Dirt and moss built up at drip-edge seams, indicating water intrusion (2).

**Signs of poor construction.** Evaluating the 16-by-29-foot roof, we first checked the TPO seams using a seam probe. Running the awl-like tool along the edge of the seams, we quickly found multiple voids. In addition, heat-welded patches were missing at numerous seam intersections, so it didn't take us long to determine that the roof's seam and patch work would have to be carefully checked and heat welded as needed. We also noticed that seam sealant hadn't been applied to the field-cut edges of the TPO membrane and patches. Some brands have factory edges on all sides, but once cut, the membrane's fabric reinforcing layer becomes exposed and vulnerable to weather damage.

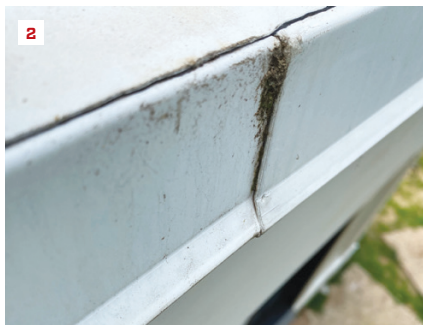
roof, the membrane was glued to the edge metal—and poorly at that. There were lots of voids in the adhesive, and dirt from rain had collected between the metal and the roofing within a short period of time.

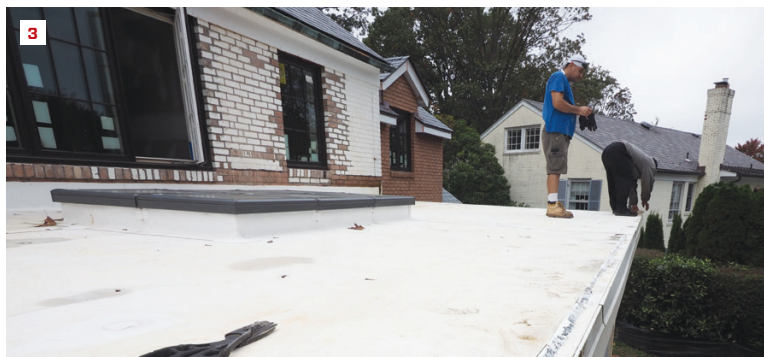
When the TPO was cut back from the edges (3), it was discovered that the drip edge and gravel stop edge metal had been installed on top of the protection board. The manufacturer's rigorous flashing detailing had not been followed, resulting in leaks where metal flashing overlapped (4). A "leak path" had occurred from the outside corner back to the substrate; water had bypassed sealant at overlapped pieces of drip edge (5).

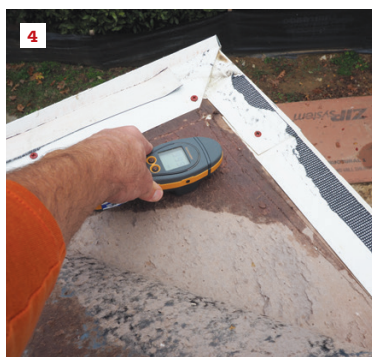
When we cut back the membrane along the edges, we found that five of the six edge-metal joints had leaked. The leaks were mainly from water getting between the two overlapped pieces of metal; the manufacturer calls for the edge metal flashing to be “butted” end to end with a 1/4-inch gap to account for expansion and contraction. It also calls for multiple layers of heat-welded TPO flashing to seal the joint, but these were not installed. Instead, copious amounts of sealant were “smooshed” between the overlapped metal pieces in hopes of keeping water out.

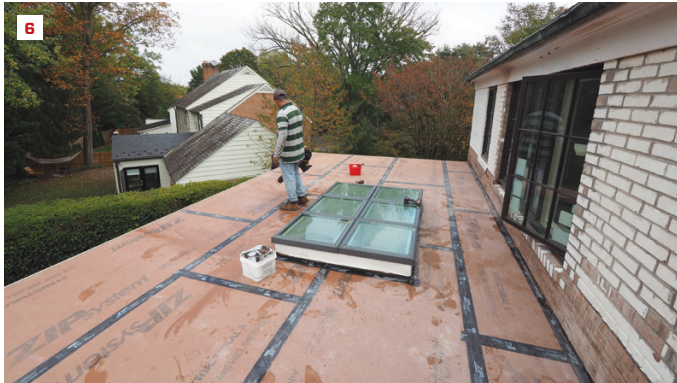
In addition to the leaky edges, application of the roof-to-wall and skylight curb flashing had been subpar. It was deemed preferable to remove the roof down to the decking rather than repair its many deficiencies (6).

Other trouble spots included unfinished roof-to-wall flashing (the termination bar and counterflashing hadn’t been installed) and the skylight TPO flashing (the curbs had been flashed and heat welded in a hodgepodge manner). Because the edges needed to be redone and the difference in cost for a total reroof was not huge, the clients decided to replace the months-old TPO roof completely.
