### A Two-Phase Seismic Retrofit Prepping a 1930s-era building for the next 'big one'

BY GERRET WIKOFF

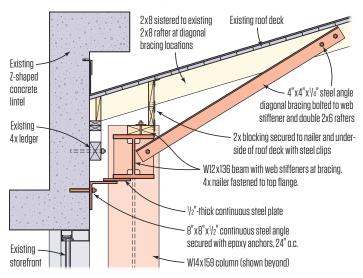
#### Section A-A

A new 46-foot-6-inch-long moment frame was needed at the angled wall-to-wall storefront opening (plan, top). Rafter ends would be connected to the moment frame via 2-by blocking and metal clips (detail, above).

In the showroom wing, the rafter ends were connected to the moment frame via 2-by blocking and steel connectors, bonding the roof diaphragm to the moment frame. See the section detail, at left.

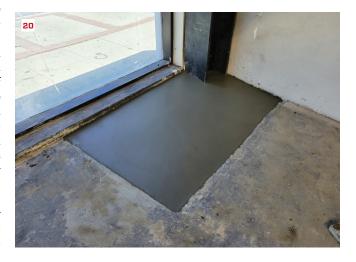
**Moment frame.** A second concrete pour buries the column base plates and is troweled smooth (20).
