Repairing a Buckled Ceiling

How poor framing and a meager insulation job led to failure

BY JAKE LEWANDOWSKI

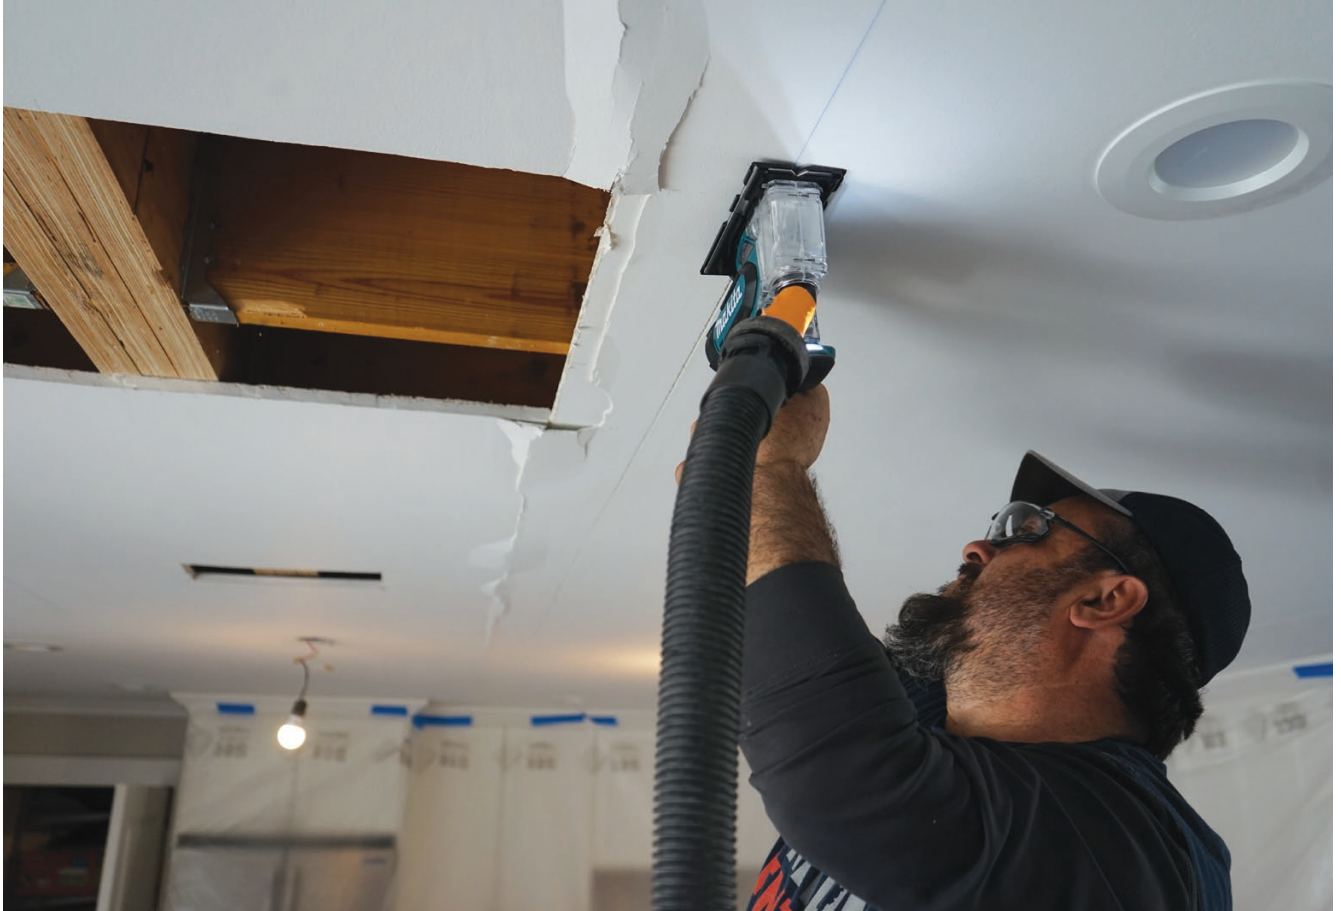
On a recent job completed by my family's company, Great Lakes Builders, we were called out to look at an unusual condition: The ceiling drywall had buckled along random panel seams near the middle of an open living area (see photo, above). Similar failures were found in other areas on the first floor, which we also corrected, but in this article I will focus on the repairs in the main living room.

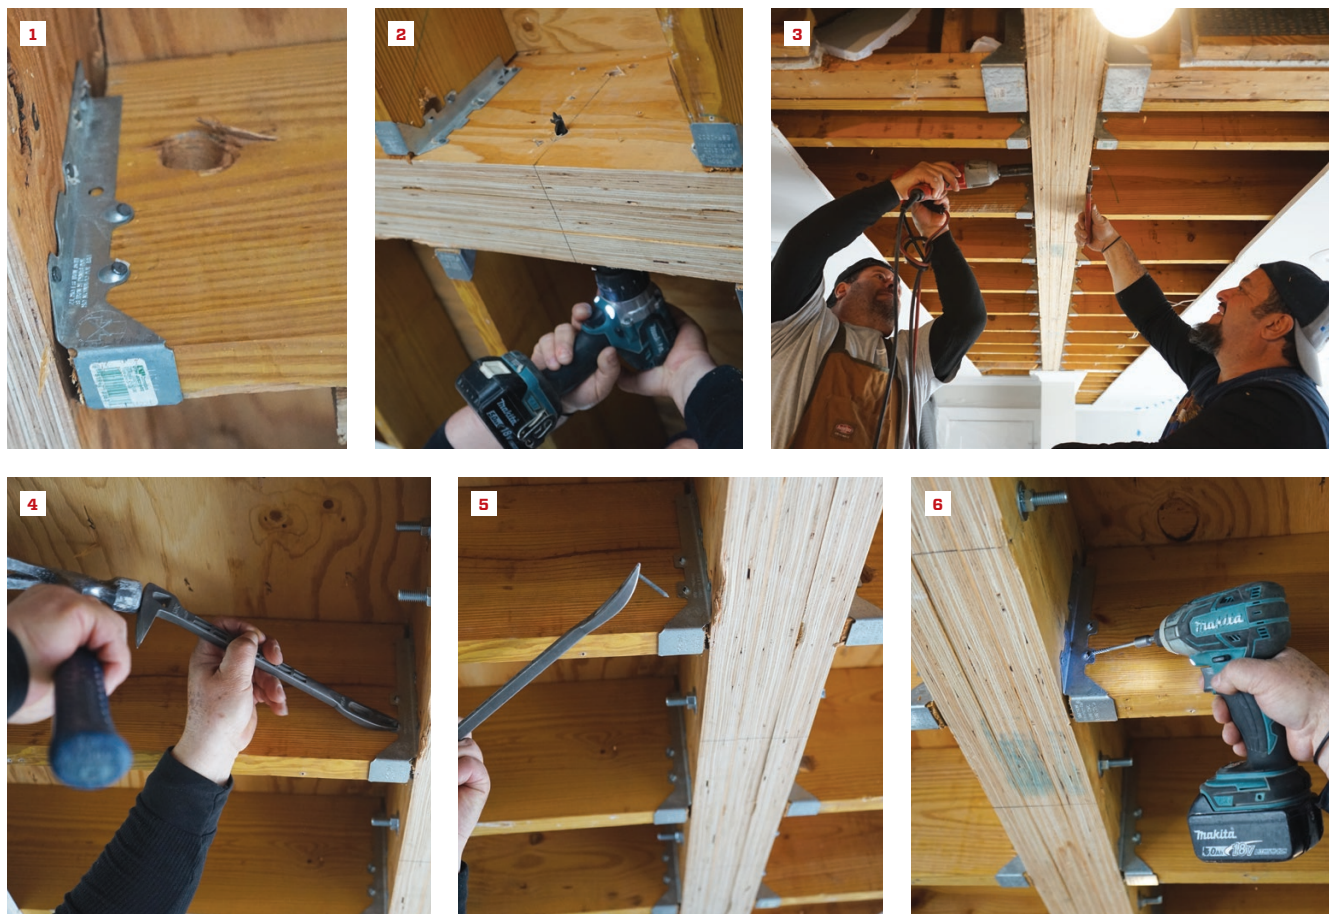
Overcut joists. Gaps at joists ranged from $\frac{1}{4}$ to $\frac{1}{2}$ inch wide (1). **Repair work** began with drilling for $\frac{1}{2}$ -inch threaded rod on 16-inch centers (2). Ernesto and Toby Bonilla of Great Lake Builders worked together to tighten the nuts, drawing the beam plies together (3). All the undersized nails had to be pulled from the joist hangers (4, 5) and replaced with structural screws (6).

While the framing checked out, we did notice some irregularities: Nails were missing from the face-mounted joist hangers, and many of the nails that were there had backed out. These proved to be only $1\frac{1}{2}$ inches long, not the 3-inch joist-hanger nails that we would have expected. On closer inspection, we noticed large gaps—from $\frac{1}{4}$ to $\frac{1}{2}$ inch wide—between the ends of the joists and the LVL beam (see photo 1, above). This is much wider than the $\frac{1}{8}$ -inch maximum allowed for code-accepted standards on face-mounted joist hangers. We speculated that the framers might have originally built the new floor expecting an undermount beam, and then switched direction when they noticed it was a flush beam. There were clear signs on the underside of the floor sheathing that the joists had been cut off with a recip saw—not what you'd expect for installing new joists.

We also noticed that one side of the LVL beam was plumb while the other side was out of plumb, suggesting to the engineer that the LVL plies had separated. And as it turned out, the LVL plies had been secured on each face only with two rows of small ($\frac{3}{16}$ -inch-diameter instead of $\frac{5}{16}$ -inch) structural screws on 32-inch centers, with the rows staggered at 16 inches. That was not nearly enough fasteners for this beam, in the engineer's estimation, accounting for one of the plies rotating out of plumb.

Lateral loads from the winds coming off the lake pushed and pulled at the floor framing, and the gaps between the joist ends and the LVL beam, along with inadequate nailing of the joist hangers, allowed the joists to move.

Through-bolts. With the beam and joist ends fully exposed, we set to work first on installing 1/2-inch-diameter threaded rod with nuts and bolts on each side to draw the beam laminations back to plumb. Working to the engineer's spec, we placed these 16 inches on-center. When drawing the LVL plies together, we expected a lot

Secure hangers. Next, we backed out all the 1½-inch joist-hanger nails and replaced these with 2½-inch-long connector screws made by Simpson Strong-Tie. As required for all metal framing hardware, we filled every hole in the hangers.

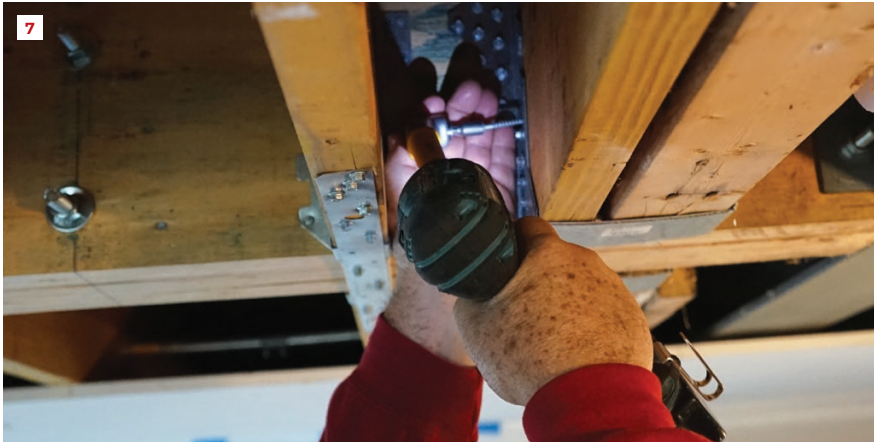
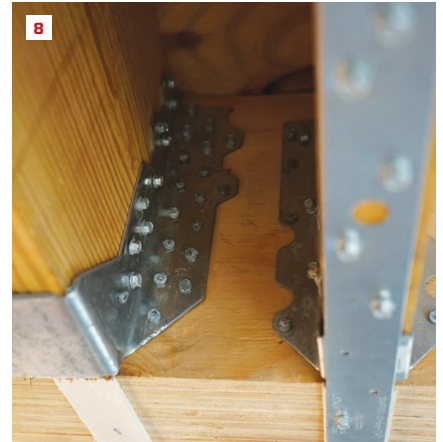
Tight quarters. Every hole had to be filled with a fastener—a feat that can be challenging in narrow bays. Here Toby used an angle drive (7) to get the job done (8). **Tension ties.** Ernesto screwed off 20-gauge steel straps to the bottom edge of the joists (9). Each pair of joists abutting the LVL beam was tied together with these straps (10).

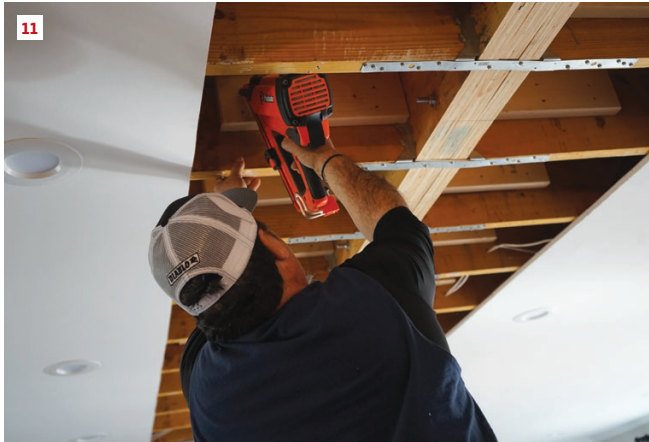
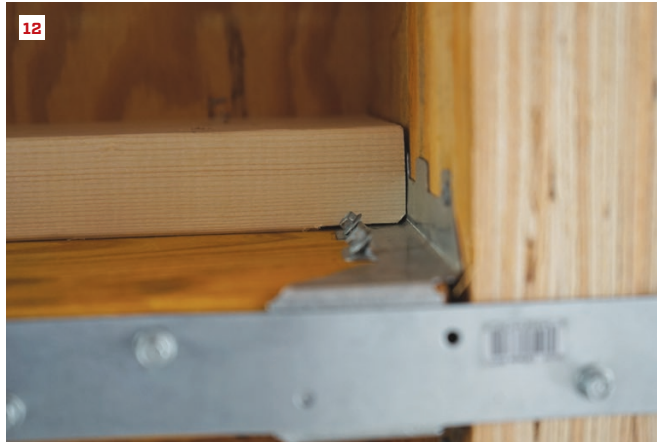
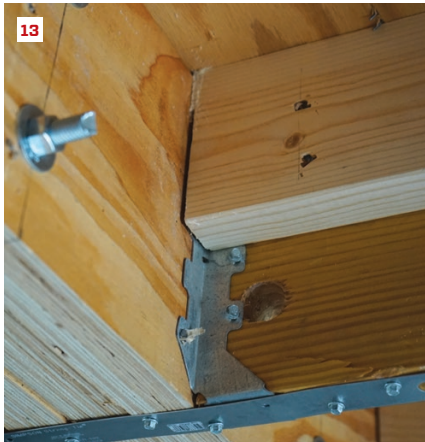
Compression blocks. Toby nailed off 18-inch-long 2x6 blocks at the top edge of the joists (11). These blocks hit the joist hangers and screws, so the crew eased the corners (12) and in places used shims (13) to get a tight wood-to-wood connection. The result of all the repairs (14) is a single assembly rather than a collection of disconnected parts.

Compression blocks. To prevent the movement of the 2x10 joists, the engineer called for 18-inch-long 2x6 blocks nailed off with 16d nails at the top of the joists butting the beam. These blocks ran into the joist hangers and screw heads, so we had to work at getting a tight connection between the end of the block and the beam.
