# HISTORIC PRESERVATION

## Preserving an 1870 Tiny Home

A temporary roof bought time to save the building from collapse

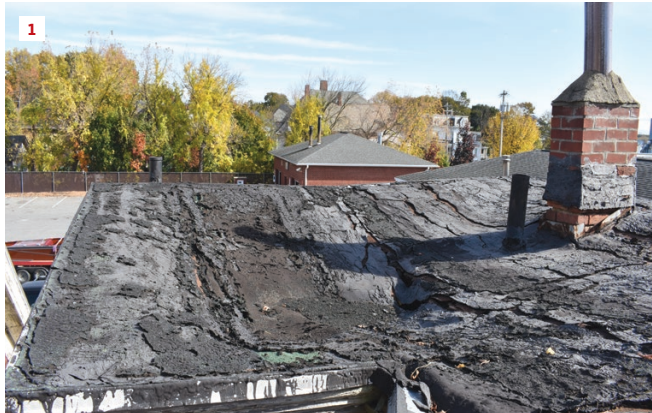
The existing roof was funneling water into the building (1), so the author covered it with a temporary roof framed with 2x10s, sheathed, and topped with a heavy tarp (2). Temporary 2-by bracing around the perimeter helped the roof support snow loads over the winter months (3).

With winter fast approaching, the first order of business was to tackle the mansard roof to prevent it from collapsing and blowing out the walls. The original flat-seam metal roofing had failed, along with the built-up roofing over that, so the roof deck boards had rotted and created a funnel diverting water inside.

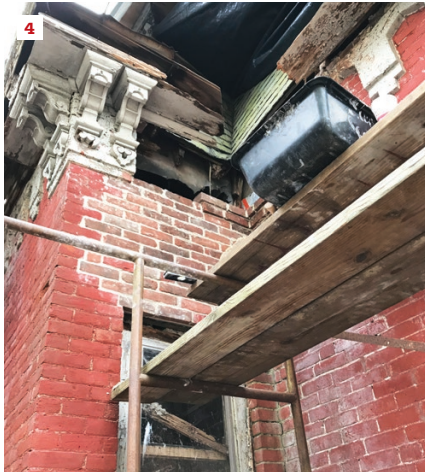
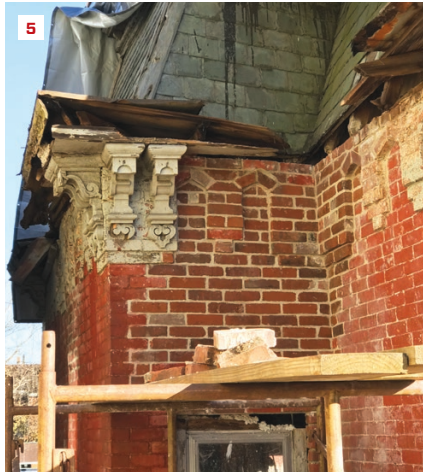
A combination of salvaged and new modular brick was used to rebuild the portions of the walls that had collapsed (4, 5). In places, the tops of the walls supporting the roof were single wythe (6), while the remainder of the walls were double wythe (7).

**Brick masonry repairs.** Then we rebuilt the exterior brick masonry walls that had caved in, salvaging and reusing existing brick as much as possible. This work needed to be completed before the roof work the following spring because the roof framing rested on the brick masonry.

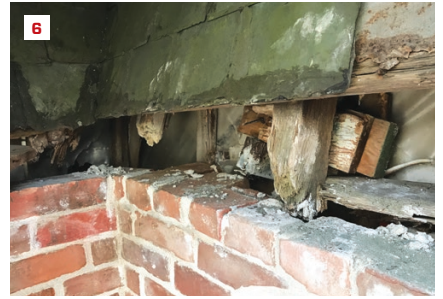
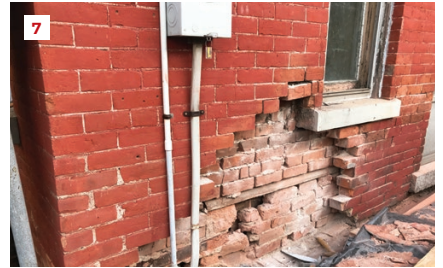
Original construction was wood lathe and plaster over brick. Interestingly, some walls were double wythe and some were single wythe, with wood framing backup. Nails driven into the exterior of the studs and left proud served as brick ties, but these ties had corroded and weren't effective—in some cases, they had completely disintegrated. Some wood framing was rotted and had become compost. As a result, the masonry walls were bowing and looked like they were ready to come down with a strong wind gust.

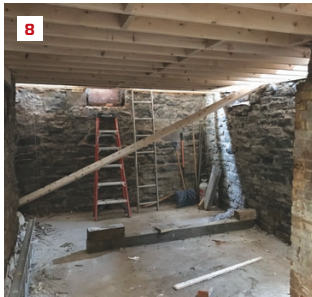
The stone foundation walls were in good shape and a full 8 feet high, but the basement's poured concrete floor needed to be replaced (8). Virtually none of the existing framing could be salvaged, so most of it was rebuilt from the first floor up (9). Tension ties screwed to the second-floor joists (10) and through-bolted to the masonry walls (11) help reinforce the brickwork.

We decided to demo the existing concrete floor because it wasn’t level and was in poor condition. By doing so, we were able to add a 6-mil vapor barrier underneath the new slab, a critically important measure for controlling moisture in the building. Once we had the building envelope restored and weathertight, finishing up the project proceeded more or less conventionally.

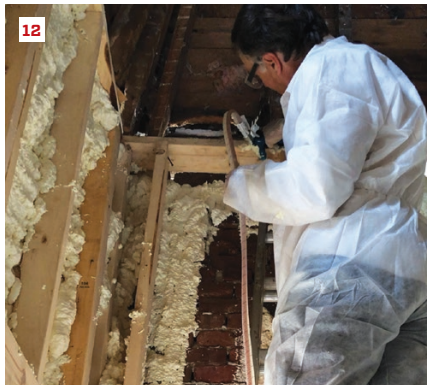
The author used spray foam to insulate and reinforce the single-wythe brick walls (12), and rigid foam to insulate the double-wythe walls. Studs were glued to the brickwork to reinforce the walls, while an air space between the rigid foam and the brick allows for ventilation (13). Joints between the foam sheets and framing were sealed with spray foam (14).

We left an air space between the brick and the new rigid insulation, in part because the brick wall bowed out but also to create a ventilation channel between the brick and the foam. We sprayed foam insulation directly on the single-wythe wall, a unique detail that worked well to stabilize the wall.

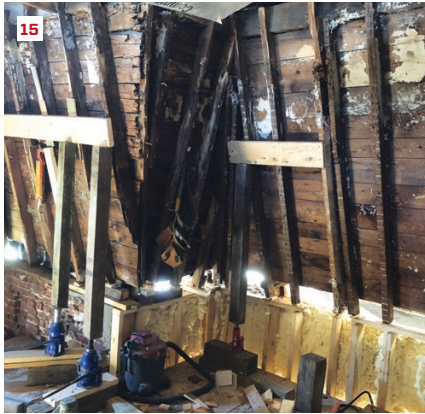
**Framing fix.** We shot reference elevations with a laser level and determined that portions of the roof had dropped as much as 7 inches. To correct this problem, we completely cut free the mansard roof framing from the wall top plate and jacked up the roof. We've jacked several structures over the years, including a boathouse that

The author detached the rafters from the plates, then jacked the existing roof framing back close to level (15). After repairing the mansard roof framing, stripping the old roofing (16), and rebuilding the roof deck, the author installed a new EPDM roof membrane on the flat roof (17) and intersection at the eaves (18). Here it was necessary to remove and replace the lowest course of slate (19, 20).

An old structure moans when it is jacked. With every sound, our heads turned and eyes darted, looking for problems. Eventually, we made most of the roof structure level and settled on gaining back 5½ inches out of the 7 inches in the worst area, deciding that jacking that area any more might be pushing our luck. (It's wise to know when to stop, no matter what task.) This strategy saved us money and preserved functional historic materials.

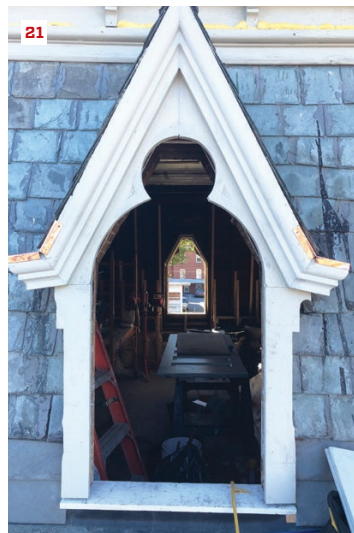
Select cedar prefinished with an oil-based primer and two coats of latex paint was used to replace rotted exterior trim (21). The repaired brick walls were coated with Silacote mineral paint (22). Now restored from its former dire condition (23), Dr. Ferguson’s Office has been transformed into an attractive rental property (24).

We used select cedar for all of the exterior replacement trim. Before installation, we primed all six sides with a coat of oil-based primer, followed by two finish coats of 100% acrylic latex paint. We treated end cuts on the fly with a brush.

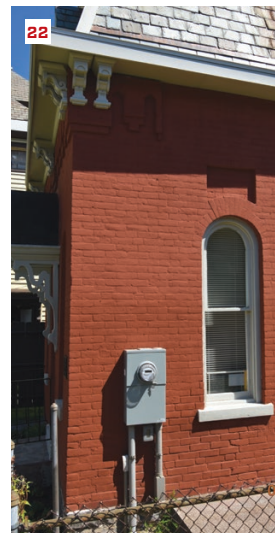
**Exterior brick coating.** The brick exterior needed attention because the existing coating was failing, mortar joints were soft, and the brick repairs were aesthetically unpleasing. After much research, I decided to use a silicate mineral paint—called Silacote—to coat the brick and the mortar joints. The previous coating appeared to be mineral paint, so incompatibility was not an issue; we simply pressure washed and applied.
