Replacing a 'Deck House' Deck

Engineered wood beams were used to help restore a
Midcentury Modern-style deck to its former sleek aesthetic

by Kyle Diamond

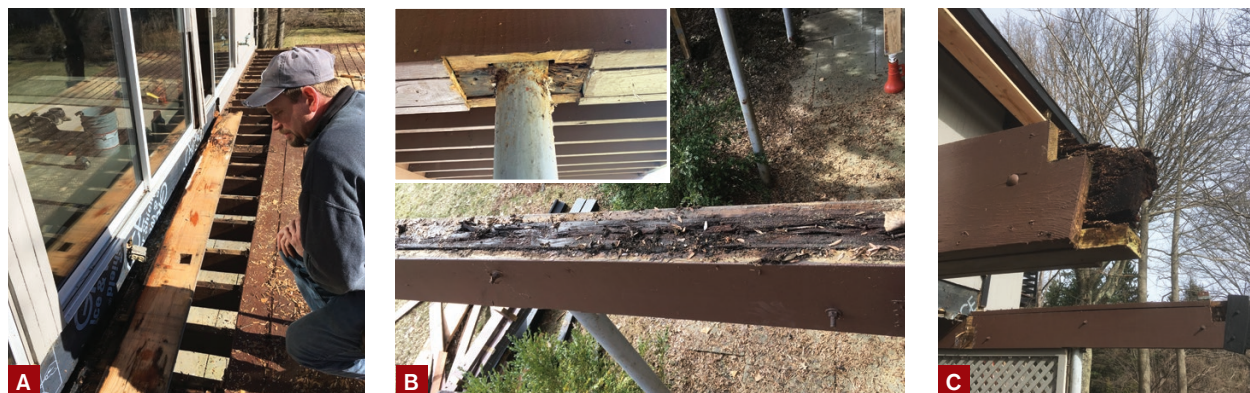
Figure 1. While removing the existing decking (A), crew members discovered the home's original 4x12 fir beams were encased in pressure-treated stock, not flashed, and severely deteriorated (B, C). The steel column connections that helped support the cantilevered ends of the beams had sunk into the rotted Douglas fir (B, inset).

When we started removing the PT decking, we discovered the exterior portion of the home's original fir beams had been left in place when work was done on the deck and were severely deteriorated. The previous builder had sandwiched the original 4x12s between two PT 2x12s (through-bolting them together) and ran a PT 2x4 on the bottom, encasing the fir

in a pressure-treated “U.” In addition, the builder omitted cap flashing, allowing years of moisture to rot the Doug fir into something verging on compost. This was particularly dangerous because the saddle connections welded to the steel columns were “secured” to the rotted ends of the fir beams. It wasn’t out of the realm of possibility that—loaded with partygoers—the 8-by-50-foot deck could have collapsed (**Figure 1**).

Starting out, we installed seven 4x12 preservative-treated Parallam Plus PSLs to support the cantilevered 6-foot portion of main-level floor and the 8-foot-wide replacement deck. We inserted the PSLs in the pockets vacated by the demoed

fir beams at the grade-level wall at one end and set them in the existing saddles welded to the steel columns at the other. For cap flashing, we installed aluminum coil stock with a brown finish to make it less visible between the new deck boards.

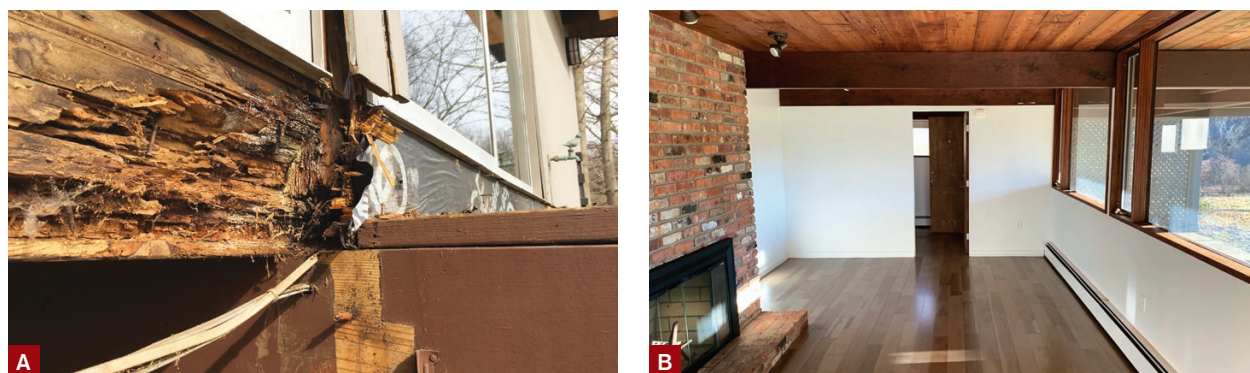
Figure 2. Years of water infiltration had damaged the raised thresholds under the sliding doors (A). From the interior, the 4x12 fir beams that span the width of the home look intact (B), and it was assumed (wrongly) that the 14-foot "cantilevered" lengths of fir (which supported the cantilevered floor and original deck) had been removed when the original deck was replaced.

At the other end of the beam supporting the home’s cantilevered main-level floor, the rot hadn’t migrated under the conditioned space and compromised the structural integrity of the home, let alone damaged the floor assembly. Even so, the raised thresholds under the slid-

ers were heavily damaged from years of water infiltration (**Figure 2**).

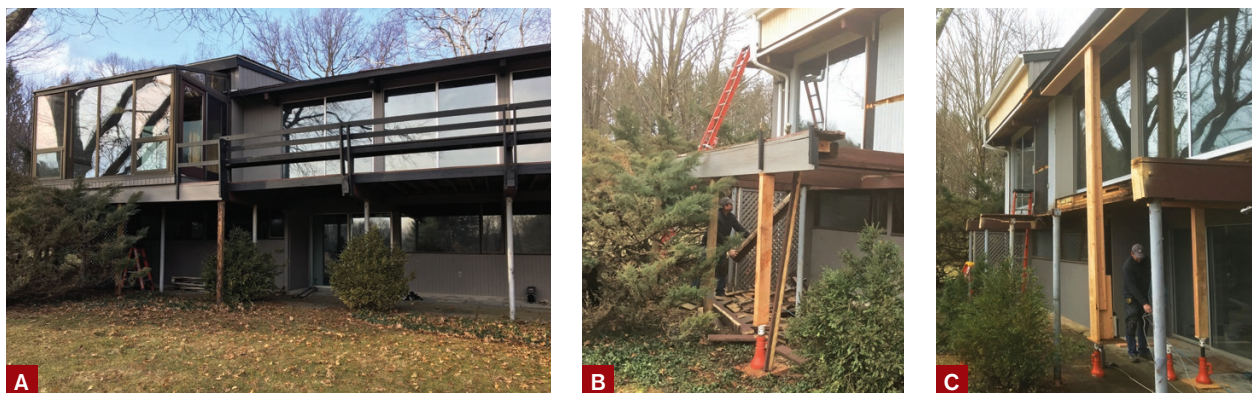
Figure 3. An ill-suited sunroom, not in keeping with the home's style, that had been built on the deck (A) was removed (B), as well as the bump-up transition on the main roof. During the project, workers posted up the cantilevered floor and roof as necessary (C).

Starting from scratch. We demoed the four easier deck bays (on the right) first, posting up the deck and roof as necessary. An enclosed sunroom had been built on top of two of the joist bays on the left side, and included an ugly pop-up roof on the main house that accommodated the sunroom’s roof slope. We demoed the sunroom and pop-up and began the deck replacement from scratch (**Figure 3**).

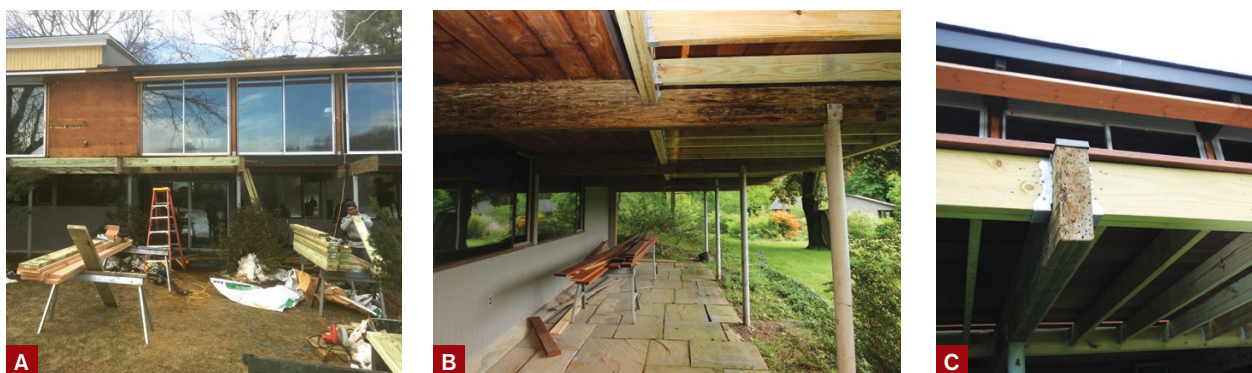
Figure 4. The cantilevered main-level floor and replacement deck are supported by seven 4x12 parallams, then flush-framed with 2-by pressure-treated stock (matching the previous deck's framing layout) (A, B). The existing steel columns were reused to support the ends of the parallams, while the new beams were cap-flashed to prevent rotting (C).

Between the Parallams, we matched the flush-framed layout of the previous deck. We installed double PT 2x8s perpendicular to the 4x12s at the main-level wall and at the deck’s outer edge, then infilled with 2x6 joists 16 inches on-center parallel to the main beams (**Figure 4**).

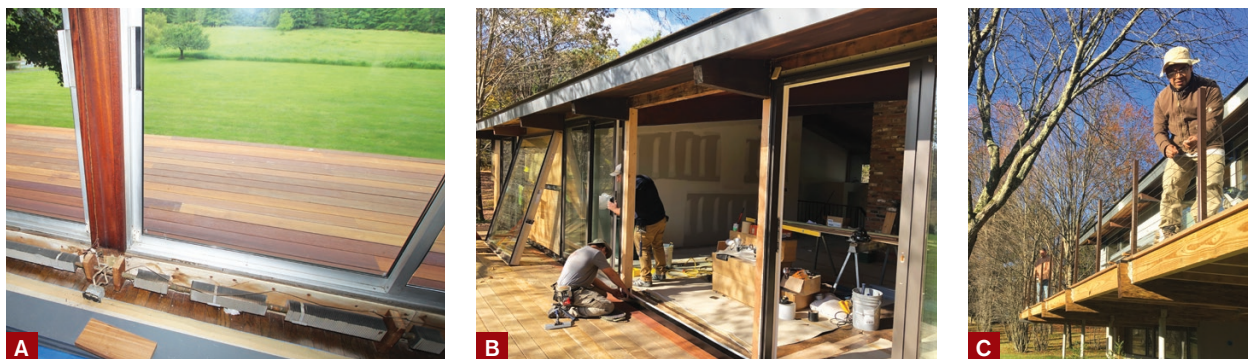
Figure 5. At the sliding doors, workers removed the 8-inch-high rise that accommodated hydronic baseboard (A) and replaced the three existing sliders with two Marvin Ultimate sliding patio doors flanking a fixed glazed center panel (B). Crew members installed a stainless steel cable-railing system (C), shown here before the ipe top rail was installed.

The 8-inch-high rise had been needed to accommodate hydronic baseboard run under the length of the glazed wall. We removed roughly 20 feet of finned tube baseboard and cut the raised threshold down to the tongue-and-groove deck, then installed a trim piece to infill the remaining void. The hardwood trim lipped onto the existing oak strip flooring and was rabbeted so we could run the hydronic loop underneath. The infilled repair resulted in a threshold slightly higher than normal, but it was a much improved egress experience (Figure 5).

Eliminating the step. Next, we installed the mahogany decking, which gave us a work platform as we replaced the sliders and removed the awkward step at the thresholds. We secured the 5/4x6 mahogany with Tiger Claw hidden fastening clips (fastenmaster.com), being careful to avoid fastening through the cap flashing covering the new Parallam beams.

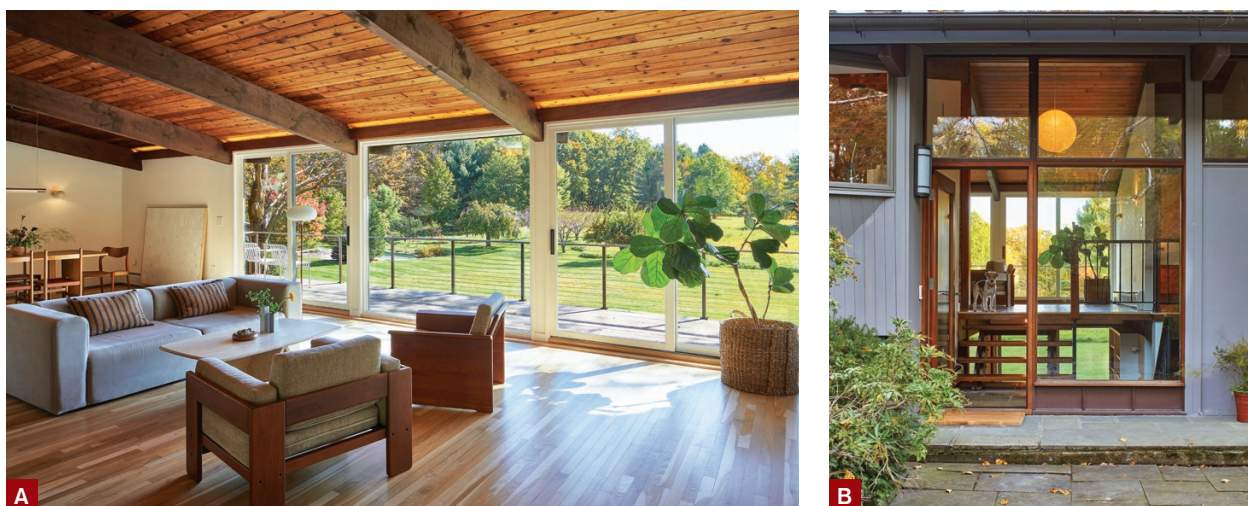
Figure 6. Shown here is the finished living-dining area with the replacement deck beyond (A). Signature “deck house” features such as exposed beams, a tongue-and-groove ceiling, an open floor plan, and lots of glass help connect the home to its scenic backyard, both from the interior and from outside the home’s front elevation (B).

deck with ¾-inch mahogany, covering all exposed pressure-treated framing and the ends of the Parallams. In a departure from restoring the deck with an “in-kind” replacement, we installed a stainless steel cable railing system with a 4-inch-wide ipe top rail (atlantisrail.com). Its sleek design was in keeping with home’s modern aesthetic and offered unfettered views of the property’s expansive backyard. (Figure 6). ❖
