Rebuilding a Box Bay Window

BY EMANUEL SILVA

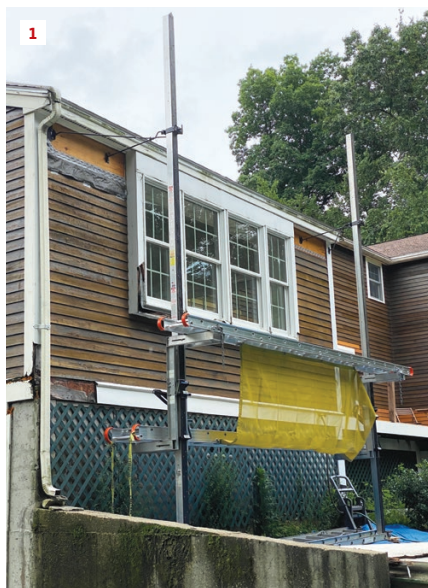
The clad windows in the existing box bay were in good condition, but there were signs of water damage to the trim on the exterior (1). More signs of water stains and rot were visible on the subsill once the stool was removed (2).

The box-bay framing had a number of problems, such as a lack of sheathing, inadequate flashing, and no structural support for the 2x12 subsill other than the 2x6 wall that it was resting on. But the main problem was that water from the roof flowed down the fascia and behind the exterior head casing used to trim the windows. From there, it worked its way down the 2x4 jack studs separating the windows and collected on the 2x12 subsill. As a result, the subsill was rotted and split, and the bottoms of the 2x4 studs were rotted. At both sides of the opening, the 2x12 trimmers had virtually disintegrated, so once I removed the trim, nothing was holding the windows in place.

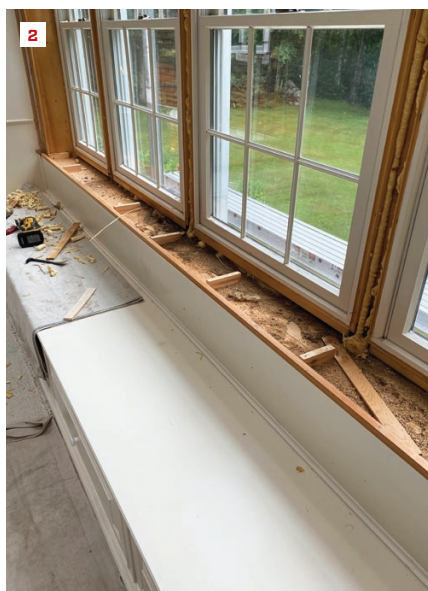
Based on experience, I suspected that the leakage problem was worse than it appeared. My hunch was confirmed as I started pulling off the interior and exterior trim to look at the framing. On the interior, water stains were visible above and below the windows, and when I removed the windows' stool, it looked like mice and ants had taken up residence in the space between the stool and the subsill—never a good sign. Still, the worst of the damage remained largely hidden until I started removing the exterior trim and uncovered extensive rot in the 2x12s that had been added to the rough opening in the home's 2x6 wall to create the box bay.

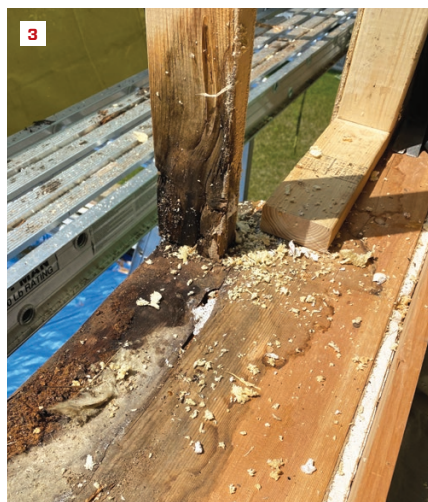
The extent of the rot damage to the framing was clearly visible once the windows were removed (3). The author stripped the siding and window trim from the wall (4), then re-framed the box bay with new 2x12s (5). After reinforcing the subsill with a layer of 3/4-inch CDX plywood, he framed the individual window openings with double 2x4 jack studs (6) and used cripple studs to fill in the gap between the flat 2x12 “header” and the soffit (7). The author then completely covered the opening with sheathing to make it weathertight while he waited for the new windows to arrive (8).

Reframing the box bay. After removing the windows from the opening and stripping the siding from the wall, I dismantled what remained of the box-bay framing. I made some minor repairs to the existing framing and sheathing where there was rot damage, then reframed the opening with new 2x12s, capping the 2x12 subsill with a layer of $\frac{3}{4}$ -inch plywood to give the assembly a little more strength and keep the subsill from splitting.

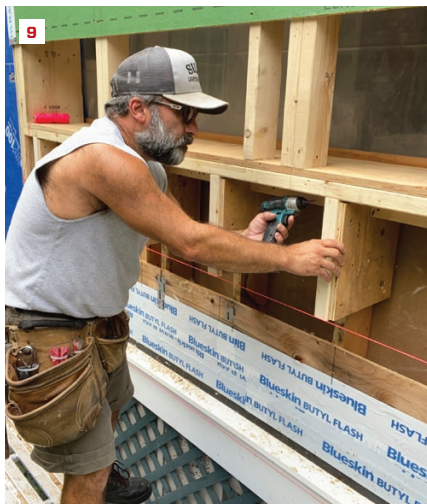
Reinforced with plywood and notched to fit, 2x12 blocks were installed to provide support for the 2x12 subsill, which cantilevers out over the 2x6 wall framing (9). A string line keeps the bottoms of the blocking aligned (10). The author notched the new sheathing to fit around the blocking (11), nailed it in place, then insulated underneath the subsill with rigid foam and filled the gaps with spray-foam insulation (12). After sheathing the entire box bay, he flashed it with self-adhering butyl tape (13). Once the windows arrived on site, the author cut out the window openings, installed a section of cedar clapboard ripped to 4 inches wide at the bottom of each opening, and then completed flashing the openings (14).

box bay, I cut away a 2-foot-high section of sheathing below the 2x12 subsill, removed the existing fiberglass insulation from the stud bays, then sistered 18-inch-long 2x12 blocks to the 2x6 wall framing below the window opening using structural screws. To reinforce the connection and prevent the blocks from splitting, I added a 3/4-inch plywood layer to each block, again with plenty of structural screws. I notched the blocking to fit snugly around a 2-by strong-back that I had installed beneath the subsill over the existing wall sheathing to stiffen the opening. While installing the blocks, I set
