## Air-Sealing an Ice-Prone Home

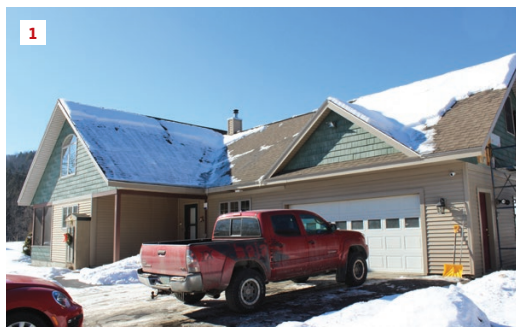
Their modified Cape-style home, built in 2006, was situated on a fairly exposed lot in central Vermont. The homeowners said the ice damming seemed worse on the roof sections above the home's garage wing. (The garage wing's roof planed into the main house, forming an L-shaped roof with two valleys. Ice would form along both eaves of the wing, in the bottom of the valleys, and along portions of the north-facing cantilevered eaves of the main house, which served as a covered entry (1, 2).

The main house of the L-shaped Cape is in the background, and the garage with the bonus room is on the right (1). Ice damming was worst on the garage wing and in valleys abutting the main roof (2). The main house was insulated on the slopes (3), while the garage wing was insulated on the ceiling flat and bonus-room knee walls (4, 5).

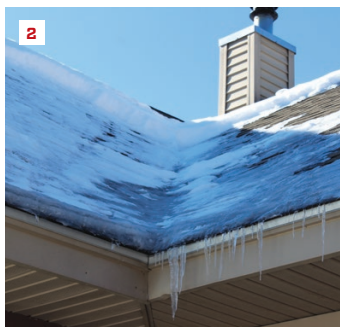
ture was in the mid-30s). In a corner of the room was a Modine gas heater, which the homeowners said was used intermittently. The garage wing was 26 feet wide by 34 feet long. The unheated garage comprised roughly two-thirds of the wing, while the remaining third was conditioned space. The homeowners mentioned that a bonus room ran the length of the second floor above. I surmised that warm air exfiltrating from the conditioned space and the garage was finding its way to the underside of the roof sheathing and melting the snow, causing icicles and ice dams to form along the entire garage wing and in the two valleys.

lowering the thermostat and using set-backs to help reduce the ice damming, though this would not eliminate the problem.

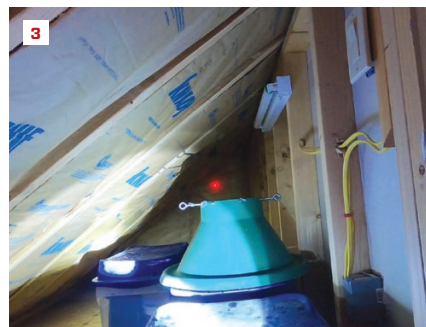
In the main house, the homeowners used the triangular-shaped space behind the knee walls for storage, which they accessed via well-sealed but uninsulated hatches. I crawled into the storage spaces and found that the original builder insulated on the slopes (the kraft-faced fiberglass batts were exposed to the interior) (3). In the rafter bays, he ran insulation baffles and fiberglass insulation from the soffits to the small attic space above the narrow, flat ceiling. The Propavent baffles provided a channel for airflow from the soffit to the ridge vent.

Work on the main house, such as properly sealing the existing Propavent baffles to prevent wind washing of the insulation and covering the exposed kraft-faced batts (a potential fire hazard) with drywall would be done at a later date, in warmer weather. I also recommended installing 4 inches of XPS insulation on the bottom of the garage ceiling to act as a thermal break and increase air-sealing. This too was pushed to the "Phase II" portion of the energy retrofit work.

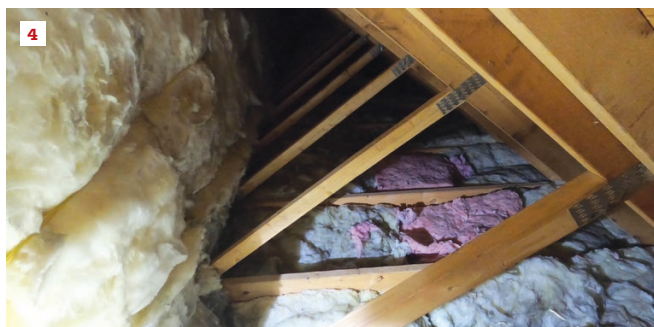
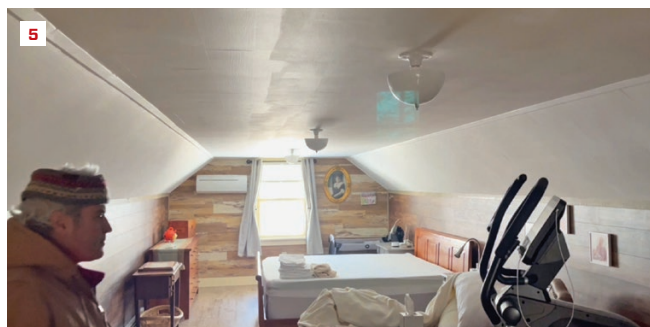
Conversely, the garage wing was insulated on the ceiling flat and the bonus room's knee walls (4, 5). After squeezing into the space behind the bonus-room knee wall via the adjoining storage space under the inside corner of the L-shaped roof, I was surprised to find that the builder had used two different insulation methods for the home. Typically, builders choose one installation method or the other when insulating Cape-style homes in the area where I work. He may have decided it would be easier to insulate the garage wing's 2-foot-on-center attic trusses on the flat and knee walls.

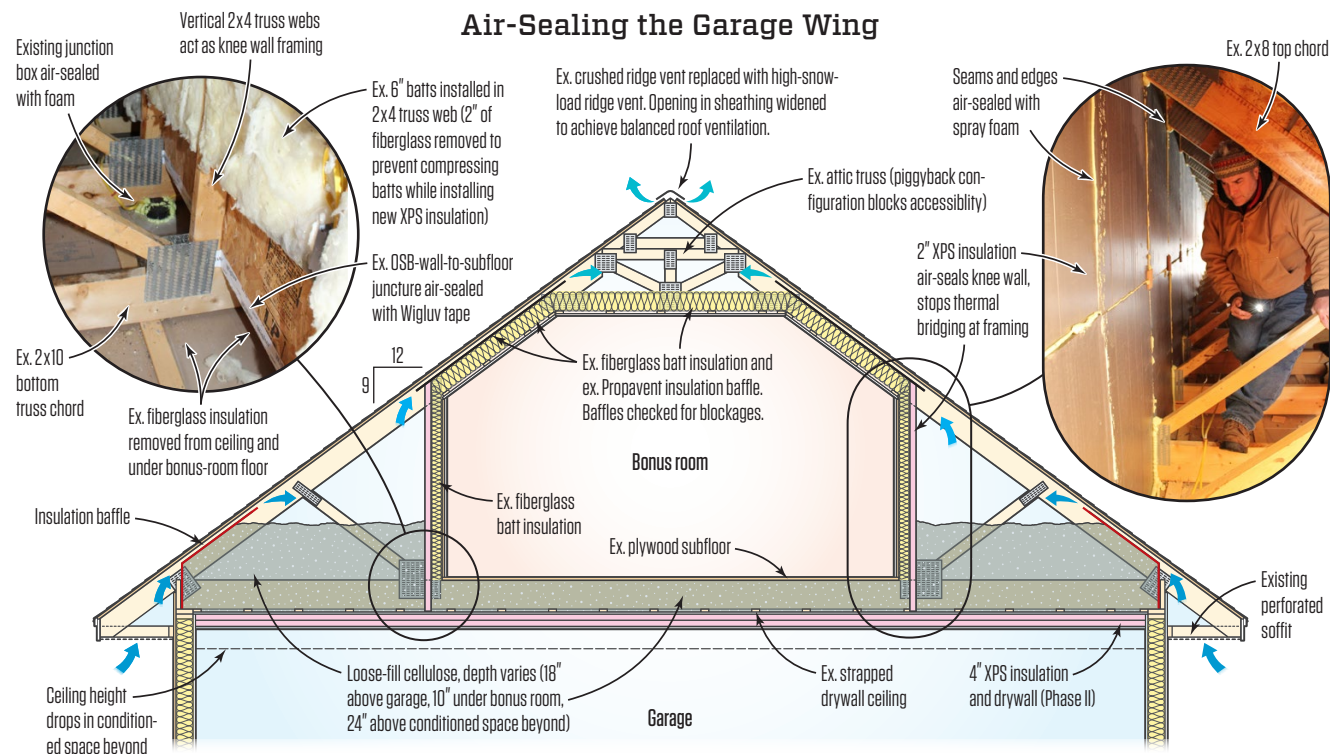
**Phase I.** Ideally, I would have preferred to move the thermal envelope to the slopes and triangular cheek walls in the garage area, but after analyzing the attic trusses, I determined the 2x8 top truss chords were too shallow to easily vent and insulate on the slope. Also, two-thirds of the garage wing space was located over a cold garage, so I reluctantly proposed keeping the insulation layer on the flat and the knee walls (see illustration, below).

A layer of 2-inch gray DuPont XPS insulation serves as the primary air barrier between the bonus room and cold space behind the knee wall. The bonus room runs the length of the second floor (section taken through garage portion of the garage wing).

I assembled a work crew and we started out by making two holes in the gable-end wall of the garage wing to access the spaces behind the bonus-room knee walls. We removed fiberglass insulation from the ceiling and under the bonus-room floor. In the bays of the vertical 2x4 web members of the attic trusses (which acted as the knee wall), the previous builder had stapled 6-inch-thick, kraft-face R-21 batts. We removed 2 inches of fiberglass from the back of the batts to prevent compressing them when we installed a layer of 2-inch XPS insulation; the XPS would serve as the primary air barrier between the bonus room and the cold space behind the knee wall.

We carefully cut and dryfit rigid XPS pieces to make sure they were relatively tight around the attic trusses and the insulation baffles at the top of the knee wall, then screwed them in place through insulation washers and air-sealed all the seams and panel edges.

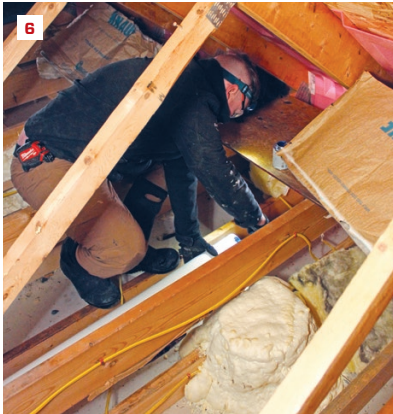
A crew member replaces a length of 4-inch flex duct run from a bath fan with 4-inch rigid PVC piping. The PVC duct sloped  $\frac{1}{4}$  inch per foot toward the soffit vent. In the foreground, a recessed light is air-sealed with a site-built OSB cover foamed in place (6).

**The usual suspects.** Along the eaves, we air-sealed the top plates from above and installed new insulation baffles. We taped the fragile Propavents at their articulated bends to help prevent them from breaking. At recessed lighting and bath-fan locations, we foamed in either site-built OSB or manufactured covers. The two fan units vented out through long lengths of 4-inch flex duct, which we replaced with 4-inch rigid PVC sloped  $\frac{1}{4}$  inch per foot toward the soffit vents (6). Rounding off the usual air-sealing suspects, all the partition top plates and knee-wall outlets were foamed in.

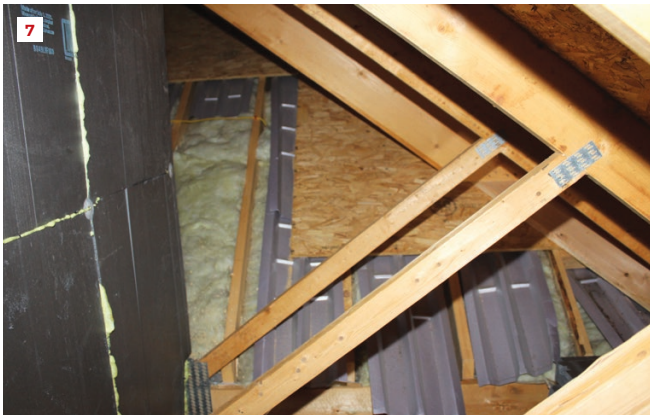
Note the existing ineffective thermal control where the garage wing intersects with the main roof, with large areas of exposed fiberglass and loosely placed Propavents (7).

**The not-so-usual suspects.** Where the two insulation methods interfaced at the intersection of the garage wing and main house, the original builder seemed to have thrown in the towel with regards to completing the thermal envelope. He left the main roof under the stick-framed section forming the valleys partially sheathed with large areas of exposed fiberglass and Propavents loosely placed (7). To cover the exposed batts, we taped Majvest diffusion-open membrane (siga.com) with Wigluv high-performance tape (siga.com) on the back of the existing baffles, then taped the Majvest to the sheathing to create a continuous air-seal; we needed to make sure the existing baffles would keep venting to the main roof's ridge vent (8).

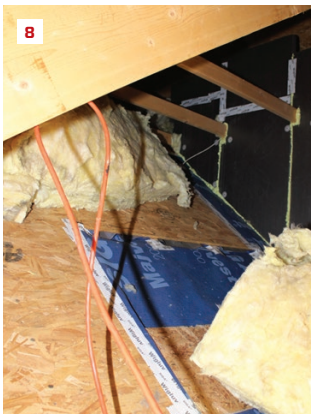
Exposed batts were covered with Majvest membrane where the garage wing and main house intersect (8). The exposed, "cold" end of the LVL is foamed with froth pack to stop condensation from forming and leaking into the house (9).

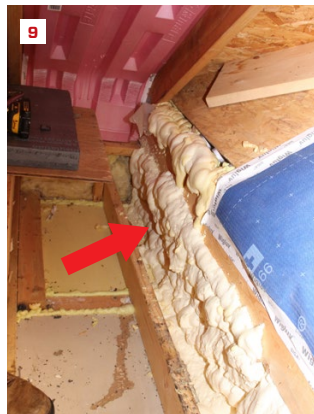
Another unusual find was an interior leak that was caused by condensation forming on the LVL beam supporting the cantilevered eaves of the main house. When conditions were right, condensation would form on the "cold" LVL where it entered the attic space (the beam was not air-sealed or covered with insulation), causing water to drip through the gaps between the framing and damage the drywall ceiling below. We air-sealed the end of the LVL with foam using a froth pack (9).
