Rescuing a Failing Structure

How an underbuilt roof led to destruction of first-floor joists

BY JAKE LEWANDOWSKI

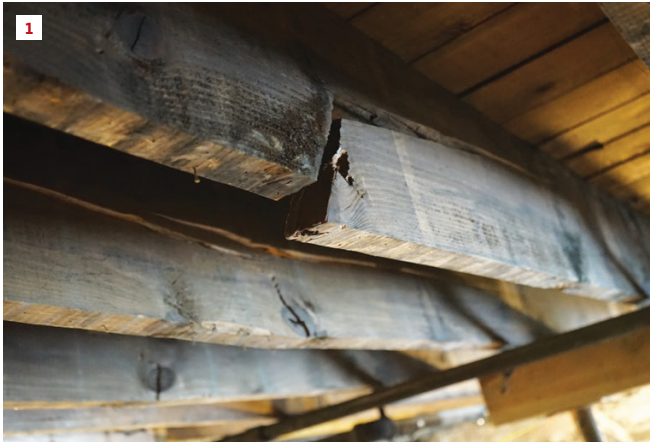
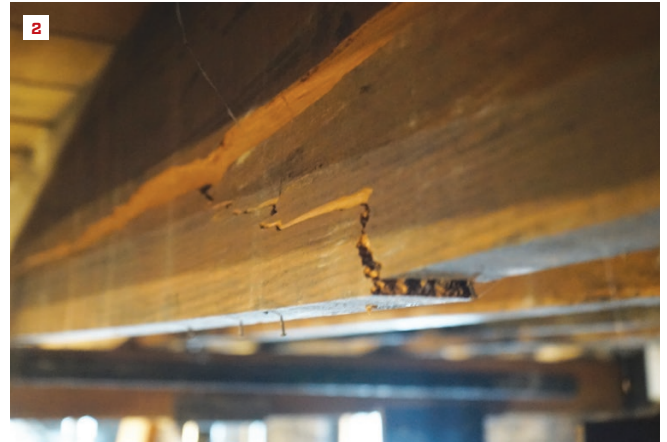
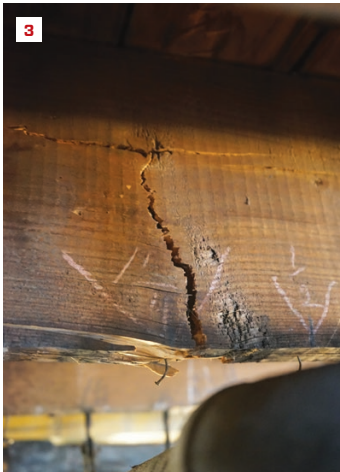
Our company regularly performs structural repairs on 19th- and early 20th-century residential brick buildings in the Chicago area. This one was a three-story, 60-unit apartment building with wood-framed partition walls and floors and a nearly flat and severely underframed roof. The 2x10 joists, running front to back, didn't need to sag much before they were bearing on 2x4 ceiling joists. The partition walls beneath this ceiling were only meant to hold up plaster and lath but had become bearing walls supporting roof loads. The added live and dead loads transferred all the way to the first-floor joists, which had zero support under them and, over the years, had been cut up by previous contractors. You can see the extent of the damage this caused in the photos at the top of the facing page. Most of the joists directly below a full-height partition wall at midspan had failed, with many joists splitting along the centerline. The failure was especially noticeable at knots and other defects, which create a weak link in the lumber.

A partition wall, which sits directly above these damaged first-floor joists, was not designed to bear the added loads imposed by an underbuilt roof (1-3). To begin repairs, the crew erected emergency shoring (4) on each side of where a steel beam will be placed to support the loads.
