Repairing a Termite-Damaged House Fixing the trail of destruction left by these hungry critters is a team effort

BY ROBERT MIGNOGNA

REPAIRING A TERMITE-DAMAGED HOUSE

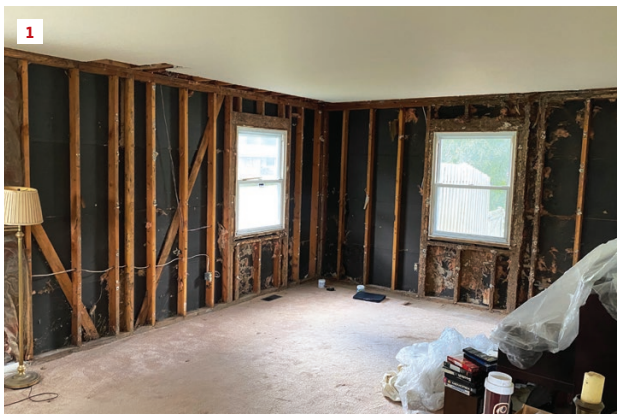
Most of the termite damage to the framing occurred on the ground floor in the living room (1). Damage was also found around a second-floor window (2), so the author removed the drywall and insulation along the bedroom wall to determine its extent (3). In several structurally significant areas, termites had transformed the wood framing into a papier-mâché-like material (4, 5).

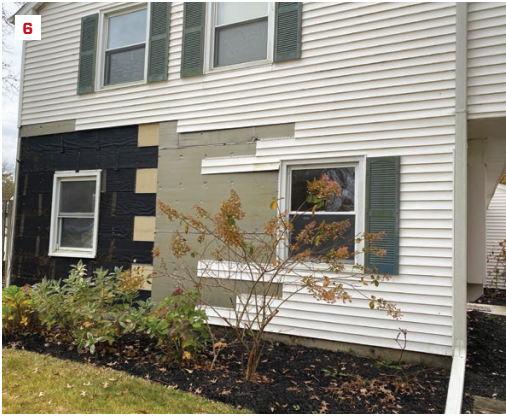
On the exterior, workers carefully removed vinyl siding from the damaged area so it could be reused (6); the mulched planting bed next to the foundation probably contributed to the termite problem. Before tackling the damaged wall framing, the crew supported the second-story floor system, which had sagged almost $\frac{3}{4}$ inch (7). To repair the damaged rim joist (8), they fastened a doubled 2-by “ledger” to the second-floor studs as a lifting point for 4x4 posts bearing on hydraulic jacks (9). Once the rim joist had been repaired with new 2-by material, the rest of the wall framing came apart easily, all the way down to the disintegrated plates where the termites had first gained entry (10).

In our area, code requires slab-on-grade foundations to be no less than 6 inches above finish grade. On older homes like this, we often find dirt and—even worse—mulch (we call it termite candy) against the siding, thereby putting the grade above the slab and even with, or slightly above, the wall. This provides a path where termites can construct mud tunnels directly into the wall framing, thereby avoiding sunlight. Here, we found that along the damaged walls, grade measured only between 2 and 4 inches below the top of the slab and even closer to the bottom plate due to an offset in the concrete slab. This condition more than likely contributed to the termite infestation.

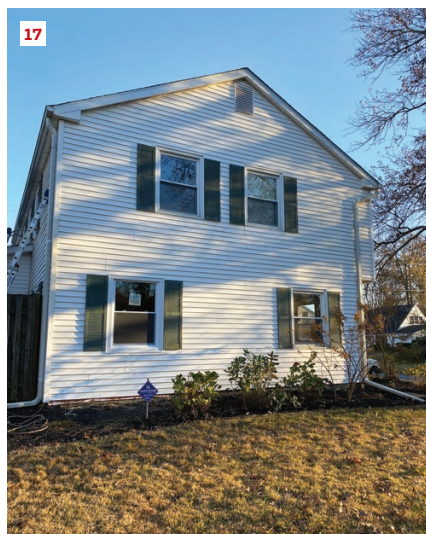
After sheathing the walls (14) and installing the new windows (15), the crew wrapped the new window trim with coil stock to match the existing windows and reinstalled rigid foam insulation and vinyl siding (16). The repaired wall looks like it had never been damaged (17).
