## A Twin-Turret Roof Restoration

BY DARIN KUNS

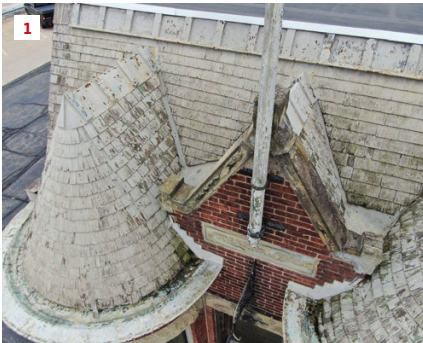
**Existing conditions.** Elastomeric paint had been smeared over the shingles, valleys, gutters, and ridge caps in a poor attempt to increase the life of roof (1). A view between the central gable and one turret shows the cricket, which drained out a small hole beneath the central gable's limestone cap (2). A brick ledge at the intersection of the roof plane and the adjacent building had been a difficult place to flash well and, where it died into the gutter at the base of one turret, it created a trap for leaves and other debris that impeded drainage (3).

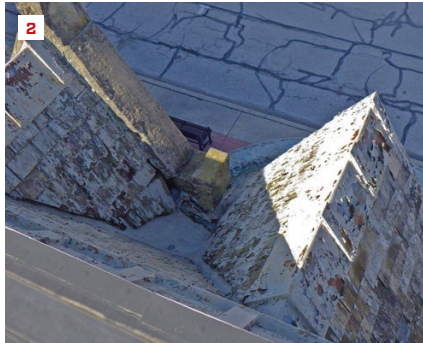
**Gable intersections.** The way the sloping sides of the turret roofs intersect with the sloping sides of the masonry dormer creates an awkward drainage area that had been sheathed over, cricket style, to drain water out through soldered-metal drainage holes on each side of the small gable. Debris collected in these holes, causing water to back up behind the gable, which resulted in rot in the corners.

After fixing all the rotted areas, we flashed everything in with ice-barrier membrane, running it up high to tie in shingle-style with membrane running down the valleys at the turret intersections. We then wrapped the area in a self-adhering underlayment. Installing the ice membrane and underlayment was a painstaking exercise in advanced origami, with overlapping courses woven across the front of the turrets.

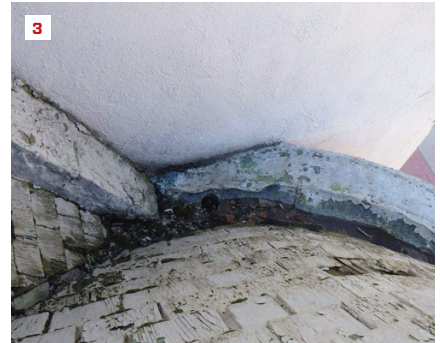
**Sidewall intersection.** The other awkward detail we had to correct was where the building abutted a larger commercial building. The intersection had been formed by a buildup of brick that had been poorly flashed to the roof and, over the years, it had been coated with stucco and roofing tar to try to seal the connection. We took the brickwork down below the level of the roof deck and sheathed over the brick so we could properly step flash and counterflash with a reglet let into the intersecting wall. At the base, the reglet tied in and was soldered to the copper gutters, effectively eliminating the trapped corner that had originally impeded drainage (see photo 3, opposite).

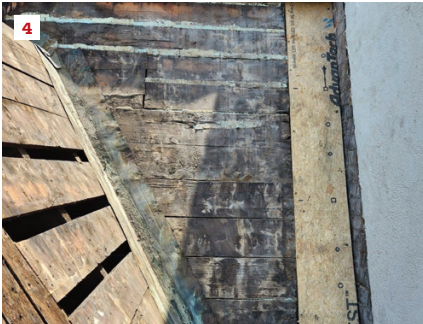
**Reroof.** The author's crew removed the brick ledge, sheathing over this area (4). A view of one turret after the roof had been stripped shows the ridge that ties the top of the turret back to the Mansard-type roof plane (5). After installing ice-barrier membrane, self-adhering underlayment, and copper flashing, the crew began installing shingles on the turrets using a story pole that hooked over the top of the turret so it could be rotated around the front to keep the shingle courses even (6).

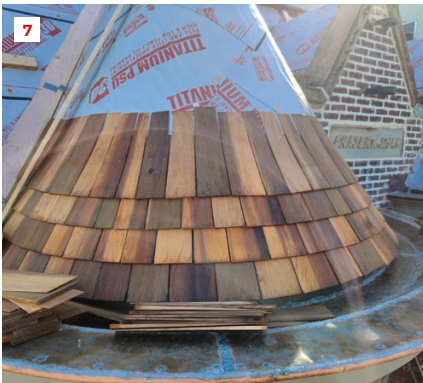
The author special-ordered extra-long, thick shingles that the crew cut at an angle on each side (7). Before being installed, each shingle was hand-dipped into a tub of a borate-based wood preservative. This photo (8) shows the step flashing at the intersection of one turret and the central brick gable. Note the extended copper spout below the limestone capping. A view of the completed roof (9) shows the ribbed ridge caps and soldered copper gutter assembly.

**Shingle work.** We special-ordered extra-long and thick cedar shingles and hand-dipped each one in a tub of Woodlife, a borate-based wood preservative, before installing it. For the turret shingles, we cut each side at a shallow angle so they could be installed tight at the butt end without overlapping at the top end. A story pole, with a metal hook that we fashioned at the top to allow us to rotate the pole around the curved fronts, helped us keep the coursing straight.
