Peeling Back the Layers of a Kitchen Remodel An old house presents a host of framing and water-control challenges

BY MIKE WHALEN

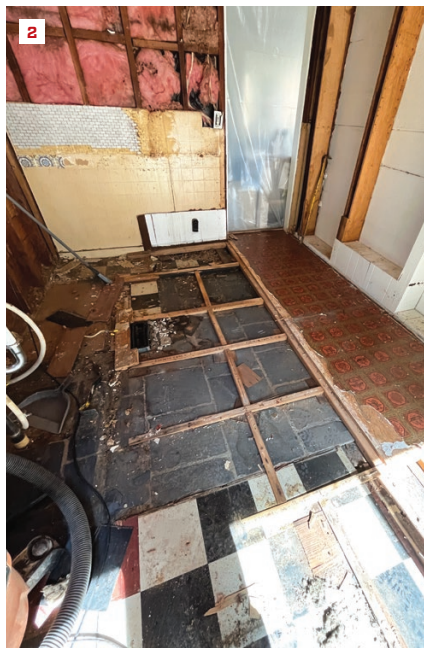
A view of the existing kitchen interior at the beginning of the demolition phase (1). Over the years, this room had numerous floor coverings, including vinyl, slate, an old linoleum tile, and the original plank subfloor (2). The discovery of the old tile prompted a test for asbestos, which proved positive, requiring a pause in the renovation to remediate the asbestos (3). At the end of demolition, the old porch framing had been removed, and only the original framing of the main floor remained (4).

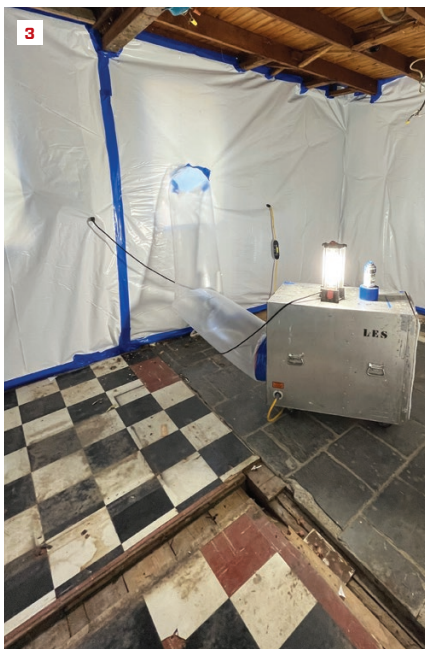
To address a host of structural and water-related problems, we had to take the room down to the studs and joists, removing many layers of flooring and even several layers of ceilings. In our initial walk-through, we had discovered old flooring tiles that we suspected contained asbestos. We tested these and our suspicions proved correct, so we began by removing what we could without disturbing that layer of flooring, and then turned the jobsite over to an asbestos abatement crew. (For a detailed discussion on asbestos abatement, see my article “Managing Asbestos During a Remodel,” Jul/Aug/21). We also tested for lead paint but didn’t find any, despite the age of this house. It’s likely that an earlier remodel, which eliminated the original plaster and lath and the original trimwork, took care of that.

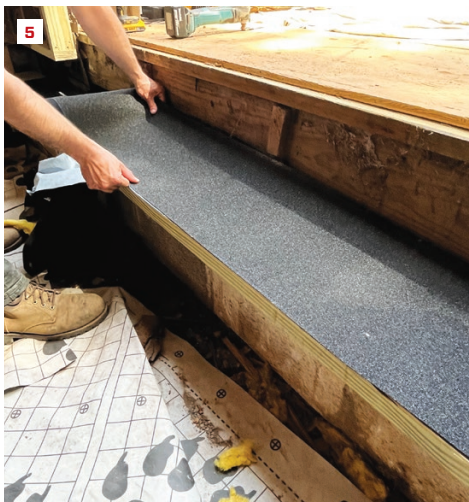
The sill beneath the exterior door opening had also suffered a lot of water damage. We had to tear out a considerable amount of rot from the sill, rim joist, and some stud ends and tie in new, pressure-treated wood. We also used pressure-treated for the new floor framing over the old porch area because the dirt crawl area had the potential to become wet, and there would be no access to it.

Reframing the floor began with rebuilding the sill where it connected to the deck. After digging out the rotted framing, the crew installed an ice-barrier membrane on a new rim joist (5) and then flipped it up to face the exterior (6). While reframing this area, the author set cross-strings to check the plane of the door opening and corrected for a splay in the wall (7). The main house floor was reinforced with sister joists (8), and the old porch floor was completely demolished and reframed (9).

of the scope of work. This meant we had no access to the rim joist and ledger from the exterior. An existing pressure-treated ledger was in good shape, but the rim joist needed to be replaced. To flash the new rim joist, we adhered ice-barrier membrane on new pressure-treated framing material, then flipped it up with the membrane facing the exterior, working from inside the door opening.

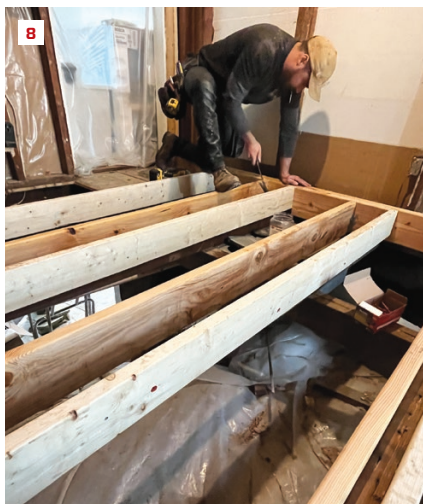
The floor joists under the main house were in better shape, but this area of the floor was about 3 inches out of level. Once the framing was level, we would have a step down into the adjoining living room to keep the same kitchen floor elevation as the deck surface. This was a consideration we made sure the homeowner understood going into the design phase of the project.

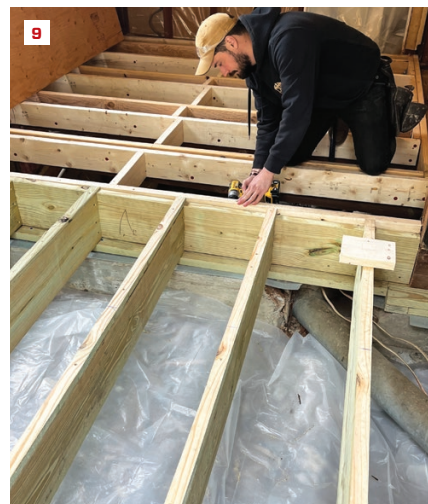
Once the asbestos flooring was removed, we continued with the floor demolition. All of the old porch floor structure was vastly undersized and had suffered a lot of water damage, so we tore it out completely.

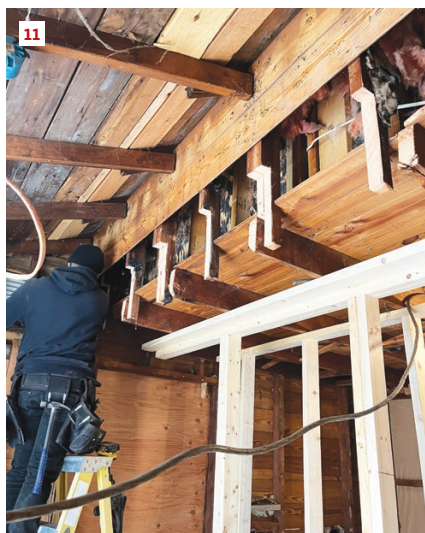
surprises. We knew we had to install an LVL header in the exterior wall and an LVL beam at the far end of the kitchen where we opened the wall to the adjoining living space. We also suspected we would need to reinforce the intersection of the old porch roof with the main house. But we were surprised to find that there was no structural member at all holding up the roof/floor/wall intersection in this area, and the second floor was almost 2 inches out of level across the width of the room.

The owner wanted to raise the roof where the old porch roof had been to create a partially cathedralized area (10). There was little existing support at this intersection, requiring a new LVL beam tied into the second-story wall section (11) to support the upper floor and the roof loads (12). This beam landed on top of a new LVL header for new windows (13). Once all the structural work was completed, the exterior walls, roof, and floor were insulated (14).

To remedy this condition, we started by jacking up the second floor and building temporary shoring walls. We were able to take up some, but not all, of the sag out of the floor above, and then installed a built-up LVL beam, which posted down to the original foundation at one end. The other end of the beam was engineered to bear on the new LVL header over a triptych of new windows in the exterior wall. Following the architect's engineering design, we intentionally built the window header out of level to provide strong bearing
