BY MARK PARLEE

Tracing a Troublesome Window Leak

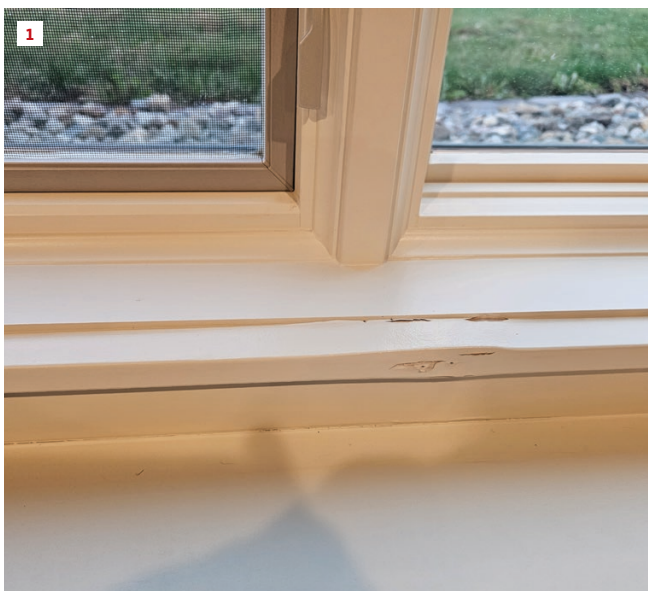
The author was called to investigate what the builder believed was a window leak that caused the interior MDF sill trim to expand and the paint to crack near one mullion **(1)**. From the exterior, there were no apparent leaks **(2)**. It's worth noting that splash back from roof runoff was an unlikely contributor to the problem, as this house has a functional gutter system.

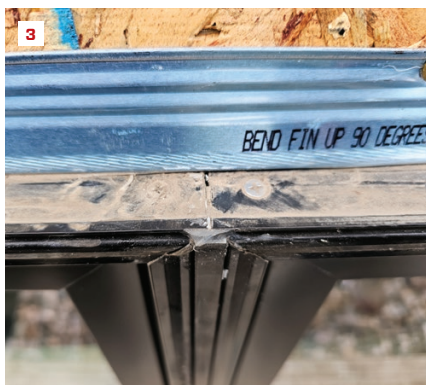
On my return visit, we observed a slight opening on top of the window at the mullion where two windows joined—a clear point of water entry **(3)**. The other mullion in the three-window array had been sealed all the way to the nail fin, and there was no visible swelling on the interior.

Once the exterior window trim was removed, the author observed a slight gap above one mullion (3). Some silicone sealant had been used here, but it did not fully seal the gap. With the interior trim removed, the author conducted a light water test (4). Then, using a moisture meter, he mapped the moisture content (MC) along the bottom of the window. The MC was highest (44%) below the gap in the mullion (5) and was elevated wherever there were wood shims (6). The author used a flat bar to push a folded piece of paper towel to the exterior (7) during the water test, and it came out sopping (8).

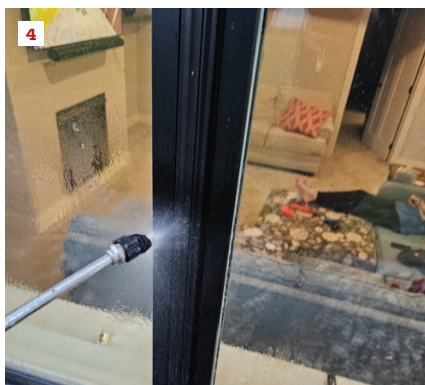
The exact path of the leak to the interior still wasn't clear until the builder removed the interior trim. On a third visit, I conducted a light water-spray test with a simple pump sprayer and observed water dripping at the base of the window almost immediately. During the test, I directed the spray at the mullions, starting

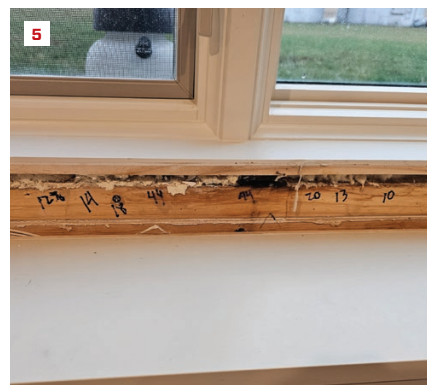
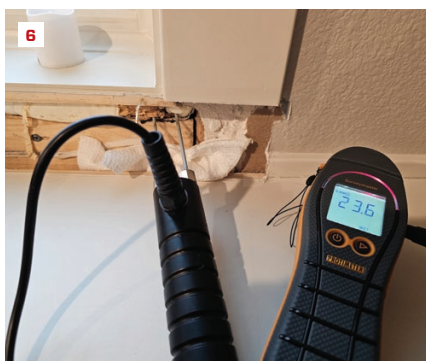
Working from the interior after spraying the mullions, I used a moisture meter to map the moisture content along the entire base of the window. The moisture content was highest at the location of the failing interior trim (44% MC) and was elevated (around 24% MC) at locations at or near shims. Between shims along the sill, the moisture content remained within the range of normal (below 16% MC). Clearly, the shims were part of the problem, but that was not all.

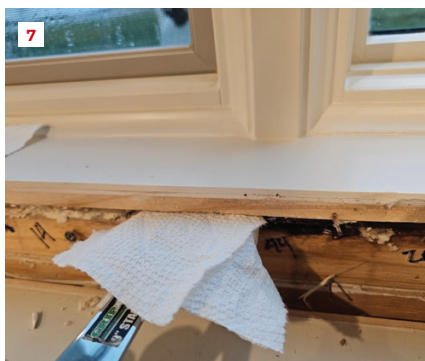
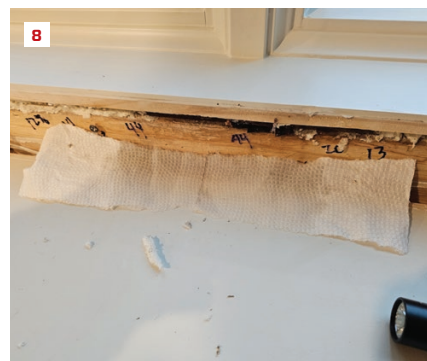
Window shims. The window was set on wood shims, as it should be. However, the shims were pushed out all the way to the metal nail fin. During the water test, we could see water running down the interior side of the nail fin, and it was evident that the shims were wicking moisture along their length to the interior,

and this water saturated the interior trim. The shims effectively compromised the drainage gap around the window and interrupted the path for water to drain to the exterior. Instead of draining down and out, as it should, the water was able to flow to the interior by wicking through the wood shims.

For preventing the shims from short-circuiting the water drainage, I recommend using composite shims, which are impervious to water. Make sure they are installed so they do not touch the window's nail fin. In addition, it's important to hold the shims back from the interior. This will maintain an even space around the entire window perimeter so the window installer can include continuous backer rod and sealant. This tight seal is important as both a water seal and an air seal; neither function can be realized when the seal is interrupted by shims.
