INSPECTING SLOPED ROOFS

How to spot current or future problems when inspecting residential steep roofs

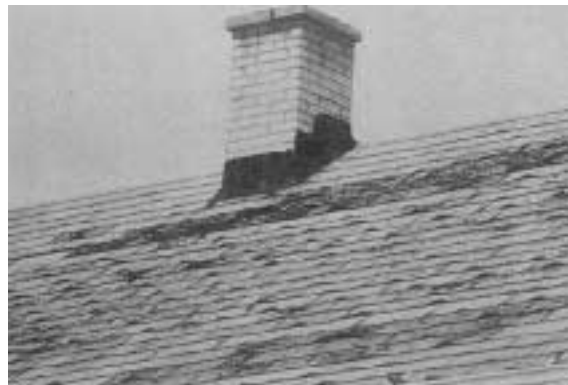
These shingles have buckled into "birds' mouths," caused by aging and a lack of attic ventilation.

Cupping, curling, or "bird's mouth" are other conditions we often observe. This is where the edge of a shingle has turned up or under, or where the corners have separated, resembling the beak of a bird. We believe they are caused by manufacturing the shingles with an inadequate amount of asphalt coating on the underside. The condition is accelerated by a lack of ventilation. The best defense is to use a good grade of shingle and assure proper roof ventilation.

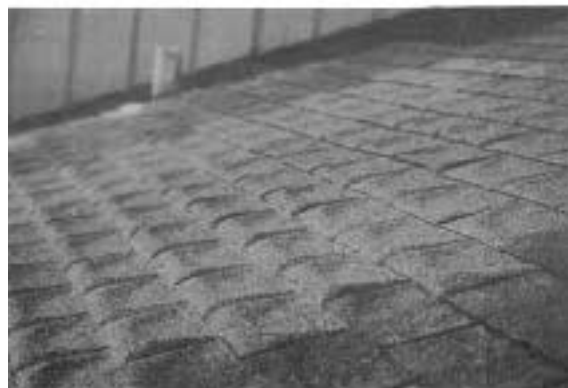
In the 1970s, some manufacturers skimped on the amount of asphalt coating on the underside of the shingles—causing them to cup.

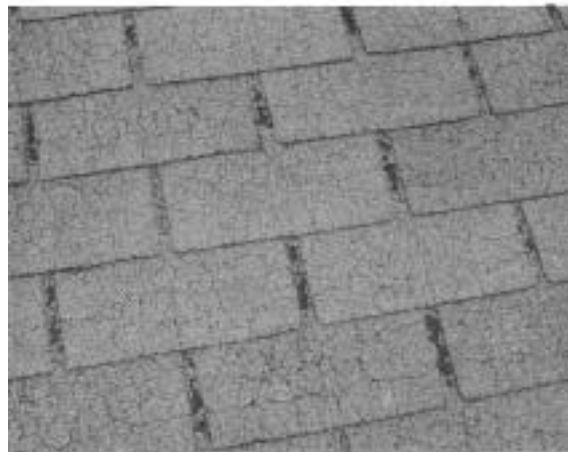
Asphalt shingles wear out first at the slots between tabs—where the water runs. Note where the granular surface has worn away.

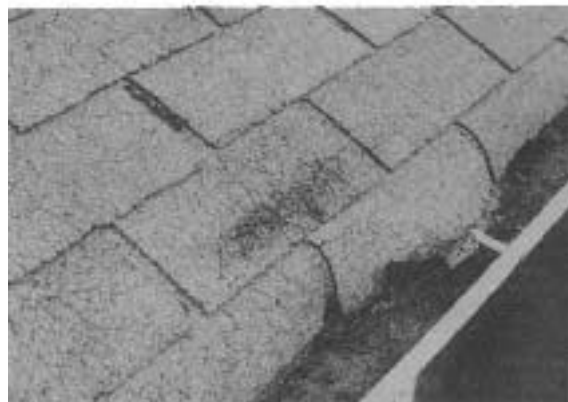
These drooping shingles lack support from either a wood or metal starter course. A properly installed metal drip edge will support the first course and direct rain into the gutter.

The first course of shingles is another trouble area we often notice. Many times the first course has bent down into the gutters, or edges have broken off or worn prematurely. In older construction, a wooden starter course was used to stiffen the first layer of shingles, but over the years this wood may have rotted, allowing the roof edge to droop. Today, a metal starter course or drip edge is used and works significantly better than the old method. A properly installed metal starter course will direct the drip line to the center of the gutter.

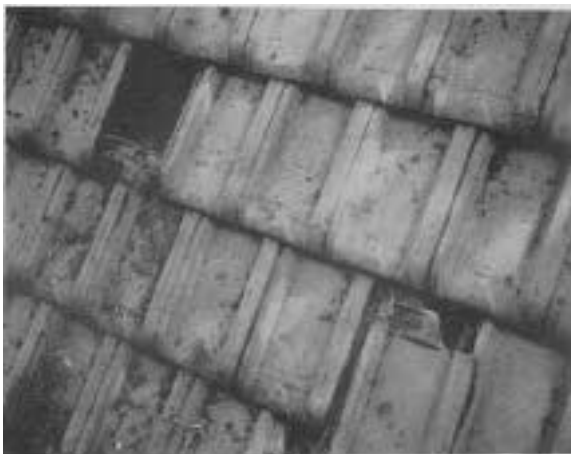
Clay tiles, like slate, are vulnerable to physical damage. Since clay tile is not waterproof, the membrane beneath the tile must also be inspected for leakage.

most expensive of the materials used. Clay tile is not waterproof, and must therefore have a sub-roof below the tile to keep the structure watertight. As a result, an inspector often finds the tiles in good condition, while the sub-roofing beneath is worn out and prone to leakage. In most cases, the only cure for this problem is to replace the entire roof surface. Damage to tile roofs is similar to that seen on slate roofs and the maintenance procedures are the same.

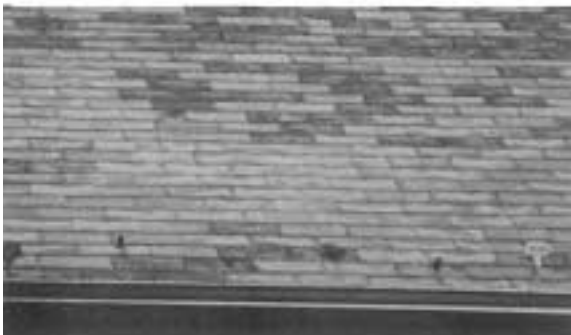
Not all slate is created equal. White efflorescence and brown stains indicate that these 40-year-old slates are delaminating and absorbing water, and have only ten or so years left of useful life.

In order to evaluate the longevity of a slate roof, it is helpful if a home inspector knows the origin of the slate materials. Buckingham slates from Virginia tend to be longer lasting than the Bangor slate produced in Pennsylvania. Some of the signs of wear that can be observed in slate are white rings that form on each slate, indicating approximately fifteen years of life left. When the white stains turn to brown, the roof has eight to twelve years remaining.

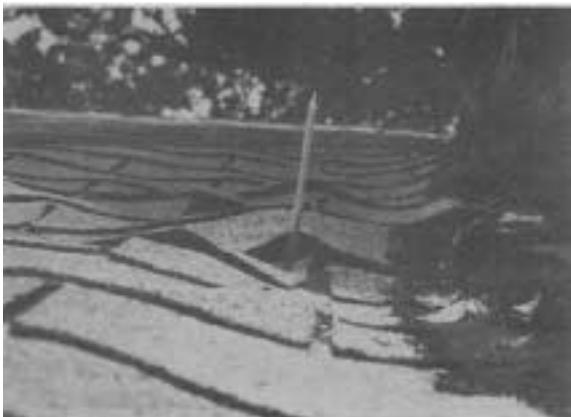
Older chimneys were flashed through to the flue tile. Few modern chimneys, however, are flashed correctly. Common mistakes are no base flashing, no counter-flashing, or too shallow penetration into the masonry. Leakage around this chimney led to rotted plywood decking.

One of the most surprising problems we find in our inspections is that in some new construction, the flashing around chimneys has been entirely omitted! This is rare on older structures, since the flashing was often built-in when the chimney was built.

During periods of extended rains, the chimney structure can only absorb so much water before it begins to shed the water to the interior of the building. The old flashing method of returning the counter flashing into the flues prevented this from occurring. The method used today of tucking the counter flashing into a raked-out brick joint, which usually extends no more than ½ inch into the brick face, offers no protection against extended rains.

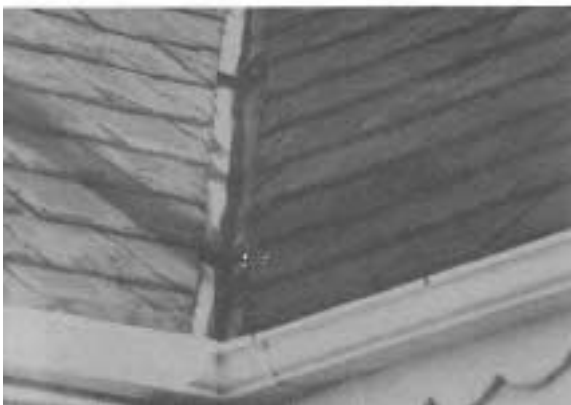
The cold-tar repairs to this valley will not last long. The flashing is copper and is appropriately installed in stepped sections—but it still failed before the slate roofing.

Often, rips or tears develop in flashing, and the most common remedy is roofing tar. However, this is only a temporary solution, and proper flashing should be put in place as soon as possible.
