PROBLEM CLINIC:

WOOD, VINYL, AND ALUMINUM SIDING

BY PAUL COVE

UNDERSTAND THE MATERIALS YOU'RE USING IF YOU WANT TO STAY OUT OF TROUBLE

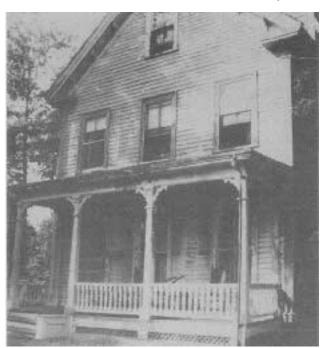
When riding around New England we see houses with wood siding that has stood up to the elements for over 50 years (Figure 1). We also see new houses with wood siding that has failed in less than five years (Figure 2). We see many houses, old and new, that have been resided with other materials that have also failed. This article will discuss why some siding applications have such short lives, and how to prevent these premature failures.

Figure 1. Good quality wood siding easily lasts 50 years if protected from the weather by finishes and building overhames.

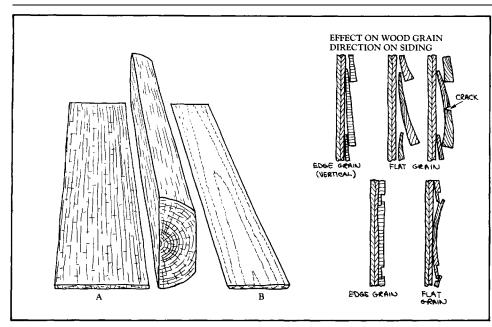
Many older wood sidings performed successfully because they were cut from the heart of the tree where the wood is hard, dense, and less absorptive (heartwood). Also they were cut across the edge of the grain (Figure 3), making "edge-grained" or "vertical-grained" siding, which is inherently stable dimensionally. Many new wood sidings fail because they are cut from the sapwood, a softer wood that is more absorptive to begin with, and cut across the grain ("flat-grained"), making it still more absorptive. When it is applied rough side out, the added surface area also adds to its tendency to absorb

Figure 3. Edge-grained or vertical-grained lumber (A) has better dimensional stability and is less absorptive than flat-grained wood (B). Also, wood from the center of the tree, called heartwood is harder, denser, and less absorptive than the outer wood, called sapwood. To prevent cupping and curling (right) pooret grade sidings should be prefinished when dry.

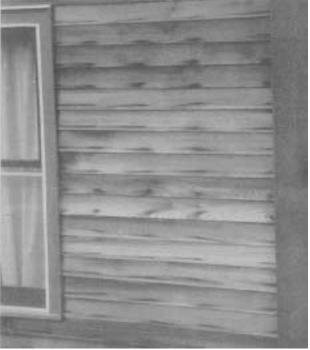
Another cause of failure is uncoated or cheaply coated nails. The black stain around these nails is not all rust, it is also a chemical reaction that destroys the wood cell structure around the nails and eventually causes a siding failure (Figure 5).

Figure 5. Uncoated or poorly coated nails look lousy when they bleed. The iron oxide also deteriorates the

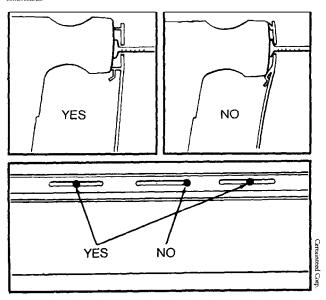
Figure 11. To allow for thermal movement, vinyl should be nailed loosely (top) and the nails should be centered in the slots (above).

Vinyl siding is made with nailing slots and a lock joint at the top and a locking joint at the bottom. The bottom of each panel hooks to the top of the next lower panel. Vinyl should be hung on the nail, not pulled up tight (Figure 11). The nail must be in the center of the nailing slot.

The nails should be out about 1/8 inch to allow the siding to expand and contract as the temperature changes. The nail heads should be at least two times the width of the nailing slot to prevent pulling over the nail heads.
