# Framing Hardware Dos and Don'ts

by Jim Mattison

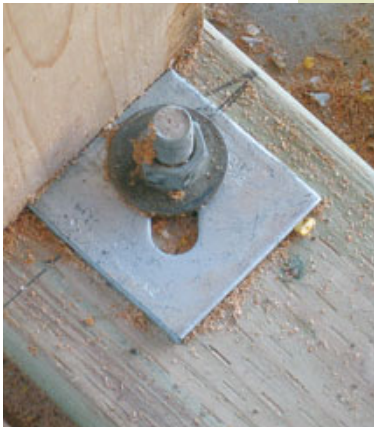
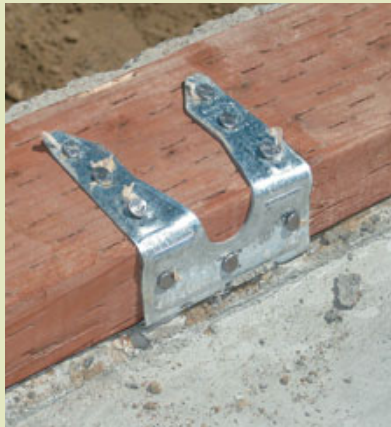
Typically a standard cut washer and hex nut are all that's needed to attach mudsills to embedded anchor bolts. In seismic regions, though, code requires 3-inch-square bearing plates .229 inch thick. Installed in place of the washer, these plates are intended to keep sills from splitting during earthquakes.

When anchor bolts are not carefully located, the bearing plates can extend beyond the edge of the sill or conflict with framing. To address this problem, some carpenters simply notch the rim, joist, or stud around the plate and anchor bolt (top), but this is a crude fix that weakens the framing and can lead to a failed inspection. A better solution — and one allowed by code — is to use a slotted plate that can be shifted out of the way (far left).

Another acceptable option is to use strap-like mudsill anchors instead of anchor bolts. These anchors are cast into the foundation, field-bent around sills, and then fastened in place with nails (left). Their low profile eliminates framing conflicts, and they have a lower installed cost than anchor bolts. In most cases they can be spaced about the same distance apart as  $\frac{1}{2}$ - and  $\frac{5}{8}$ -inch anchor bolts.

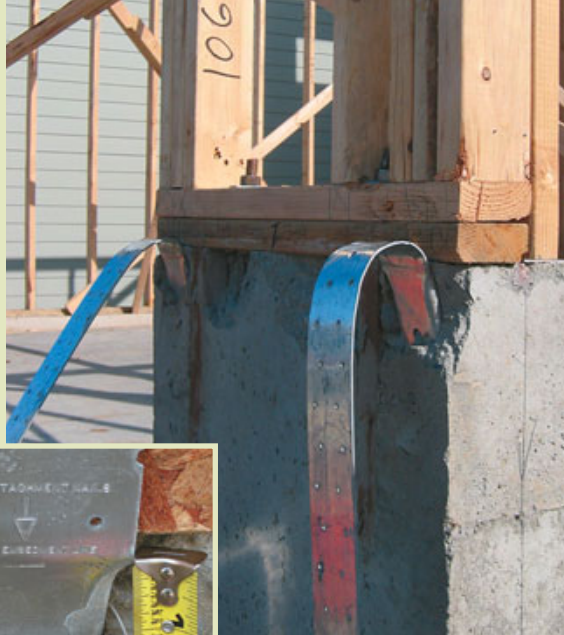
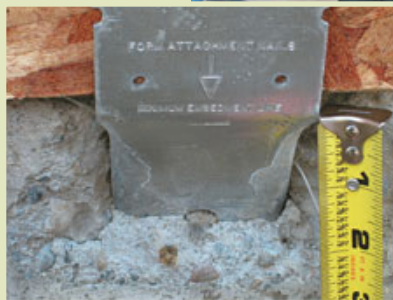
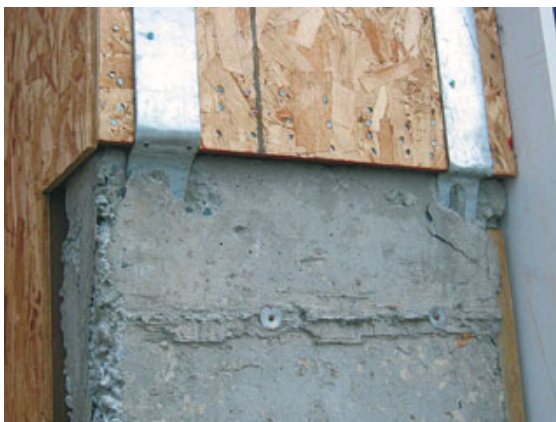
Shear walls must be anchored with hold-downs to prevent wind or seismic loads from overturning them. In many cases, the anchors are strap-tie hold-downs embedded in the concrete foundation and nailed to the framing. If the hold-down is wet-set or bent out of the way while the concrete is green, it can cause spalling in the concrete (top right).

Small spalls — less than an inch tall — will not affect the load capacity of the hold-down. However, spalls between 1 and 4 inches tall (bottom right) reduce the hold-down's capacity by 10 percent. If a spall of this size is present, the building designer can make a quick determination as to whether the hold-down can still handle the required load.

No data exists for spalls more than 4 inches high, so when spalling is severe it may be necessary to retrofit an epoxied threaded rod or a mechanical anchor. Given recent changes in the building code, it's best to have an engineer specify the appropriate anchor.

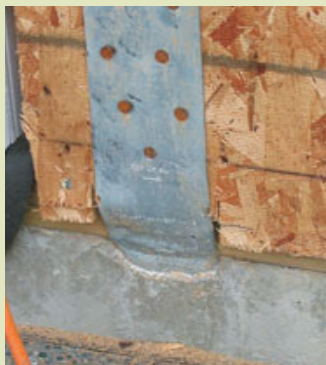
Strap-tie hold-downs are attached either directly to the framing or on top of the structural sheathing. When they're installed over the sheathing, it's sometimes necessary to bend them horizontally — especially if the mudsill hangs past the edge of an out-of-square foundation.

Only a small offset is permitted — up to  $\frac{5}{8}$  inch. Easing or lightly notching the panel edge, as was done here (left), and nailing upward will prevent the strap upward and keep wall movement to a minimum. More than one 90-degree bend (far left) is not allowed.

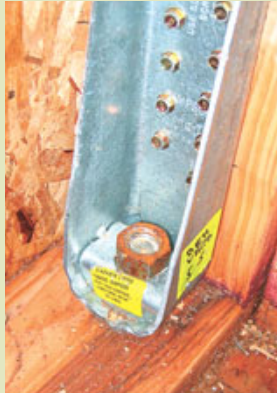
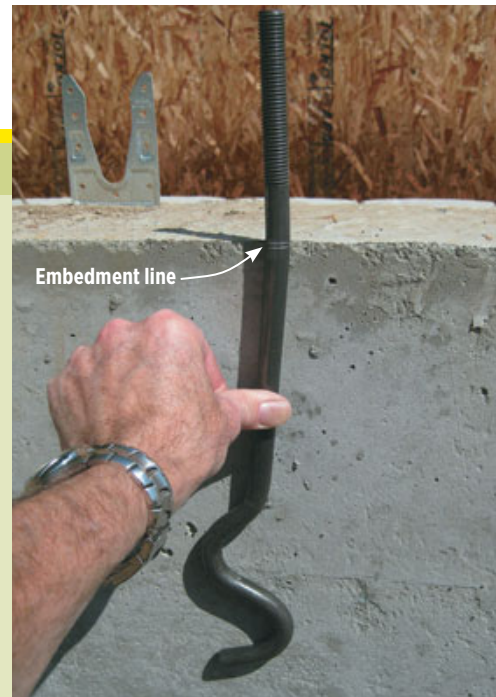
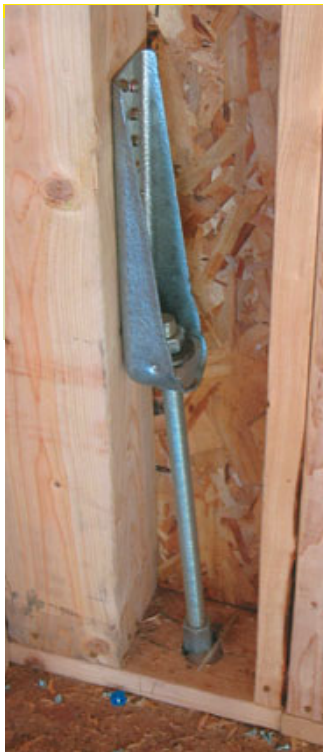
When an anchor bolt is set too low in the concrete, there's not enough exposed thread to properly connect the hold-down. To achieve full strength, the nut must be threaded a minimum of one full bolt diameter, so that the bolt is flush with or projects beyond the top of the nut. In this connection (right), the bolt is too short; extending it with a coupler nut and threaded rod and raising the hold-down above the sill may be a good fix. (Check with the manufacturer to make sure a specific hold-down is approved for this use.) A simple way to make sure there will be adequate thread is to use an anchor bolt that has the embedment depth clearly marked on it (far right).

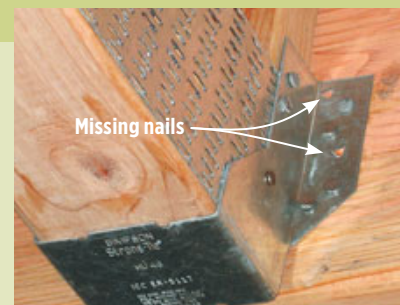
The most common fastening problem I see is that hardware is missing nails. If nail holes are left unfilled, the connector won't fully resist the loads it was designed to handle and may deflect, resulting in damage to floor and ceiling finishes. Worse yet, the connector may fail. Unless otherwise noted on the plans, it's best to fill all the holes in the framing connector. The truss hanger shown here would support an additional 500 pounds if the four triangular holes (two in each side) had been filled.

I sometimes see hardware installed with the wrong size and type of nails, often because someone decided to save money by using standard collated nails. This reduces the load the hardware can carry; smaller-diameter fasteners are less resistant to shear, and shorter ones are less resistant to withdrawal.

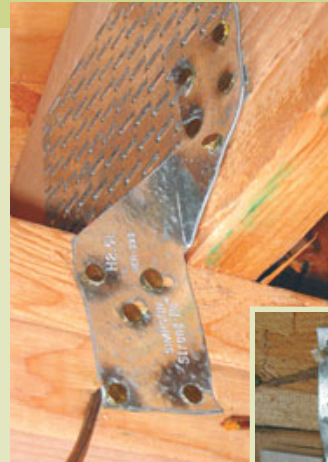
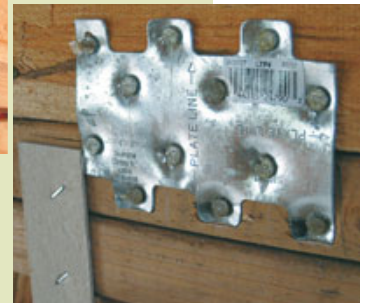
When a nail misses the factory-punched hole and makes its own hole — as happened to this hurricane connector (top right) — it reduces the shear capacity. If you install a lot of framing hardware, invest in a gun designed to accurately place nails in the factory-punched holes.

The excessive dimpling on this connector (bottom right) is the result of overdriven fasteners, which can weaken the hardware by fracturing the steel around the nail hole. To check for excessive dimpling, lay a straightedge across the nail head and the metal on both sides. If there's any gap between the top of the nail head and the straightedge, it's time to lower the gun's driving depth.

The collated nails designed for use in dedicated hardware nailers come in reduced lengths —  $2\frac{1}{2}$  inches versus 3 or  $3\frac{1}{2}$  inches for hand-driven nails. In most cases, these lengths are okay as long as the nail achieves the minimum required penetration into the framing (not counting the sheathing). For example, a .148 x  $2\frac{1}{2}$ -inch nail needs about  $1\frac{1}{2}$  inches of penetration.

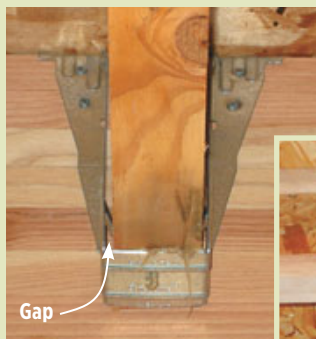
Hangers not only need to have enough load capacity — they also must be sized to fit the framing members they carry. This hanger (below left) is too wide for the I-joist, which could allow the joist to move side-to-side and lead to callbacks for a squeaky floor. The bad fit could also cause the hanger to deform, because it's designed for the joist to bear across the entire width of the seat.

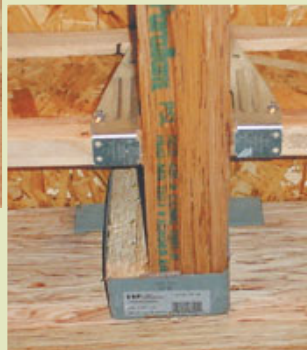
Sometimes you can shim the carried member to fit the hanger — but never shim it off-center (below right), because that loads the hanger unevenly.

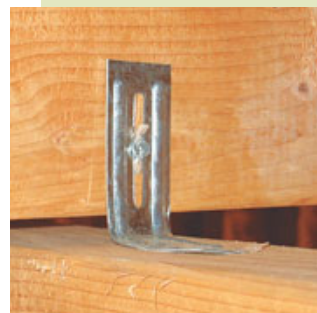
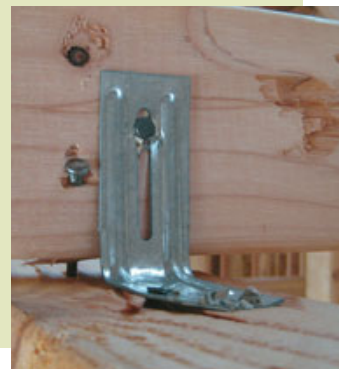
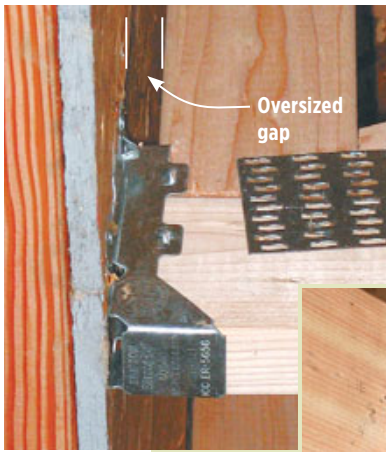
Sometimes cracks appear where partition walls meet trusses. This could be due to differential shrinkage or settling of framing members, improper drywall installation, or truss uplift. An effective way to allow for vertical movement at this location — while laterally supporting the wall — is to use slotted truss clips.

These clips must be correctly installed, with the nail in the center of the slot (left), or they will restrict truss movement. A few of

the common errors I see are nailing too high in the slot, driving the nails in the slot all the way home, and toenailing the truss to the partition (right).

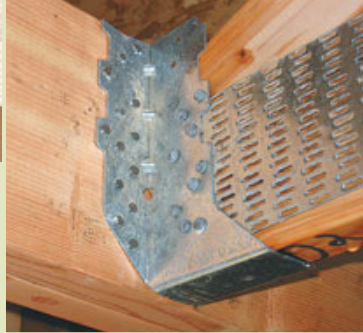
Most hangers are designed so that the gap between the end of the joist (or truss) and the back of the hanger is no greater than  $\frac{1}{8}$  inch. An oversized gap — like the one at the back of this truss (top left) — places the downward force further from the supporting header, increasing the rotational force on the hanger and reducing its load rating.

Luckily, there are ways to deal with oversized gaps. For starters, a number of joist and truss hangers have been tested with gaps of up to  $\frac{3}{8}$  inch and the reduced loads published. When oversize gaps occur, the designer should compare the design load to the published load and determine whether there is a problem.

It may also be possible to shim or build out the header, though such field repairs should be approved by the building or truss designer. A third option is to use a hanger that has a deep seat and added nailing capacity, and can handle gaps up to  $\frac{1}{2}$  inch (left).

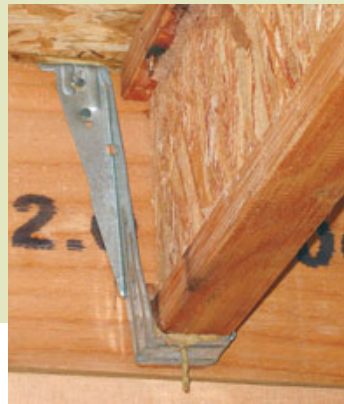
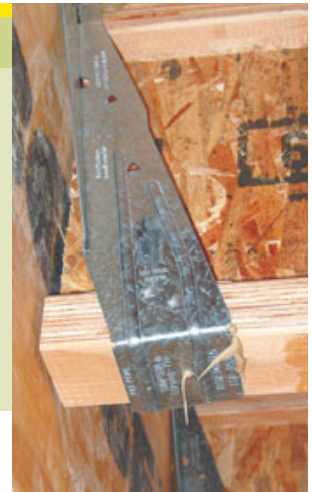
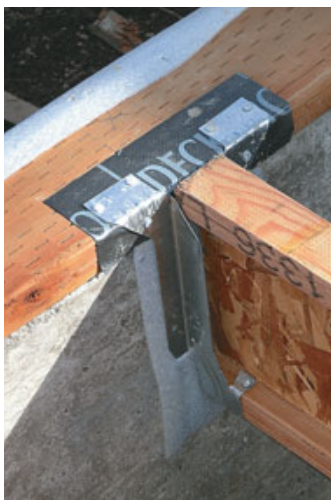
Because of their flexibility, top-flange hangers are often installed with the sides splayed open (right). This lifts the seat, which puts bumps in the floor and creates the potential for squeaks. A similar problem occurs when the bottom of a top-flange hanger is not tight against the header. Not only does this put a lump in the floor — it also reduces load capacity. When the framers dropped the I-joist into this hanger (far right), they should have pushed it back against the header.

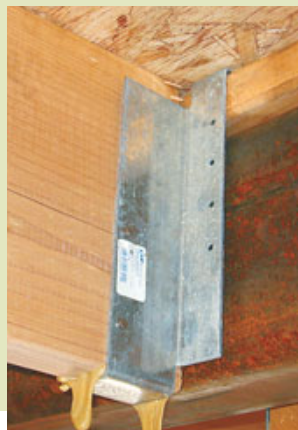
Top-flange hangers frequently hang from sills or plates attached to foundations and steel I-beams. Keep in mind that the edge of the nailer should be flush to the edge of the supporting concrete or beam, or overhang it by no more than  $\frac{1}{4}$  inch. If the plate overhangs too far, it may split. It's also important to select a hanger rated for use with a wood nailer and to install it with the right fastener. The installation instructions for the hardware include a table identifying the suitable nails, depending on whether the nailer is a single or double 2-by or a 4-by. Here, the hanger on the foundation wall is correctly installed (far left), but there are several problems with the hanger on the I-beam (left). The nailer projects too far beyond the beam, and the empty holes in the flange indicate that an inappropriate hanger was used. There should be 16-penny nails in those holes.

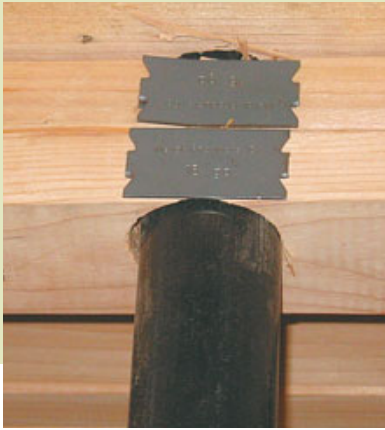
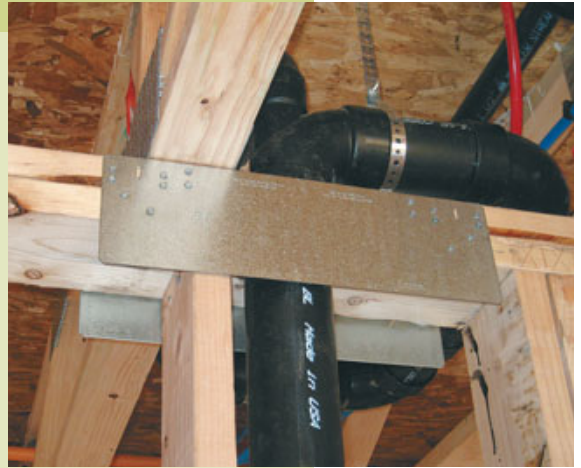
Well-intentioned trade contractors usually try to repair top plates at mechanical and plumbing penetrations, but they don't always do it correctly. Under IRC section R602.6.1, when more than 50 percent of the width of a top plate is drilled or notched out, the plate must be reinforced on both sides with a 16-gauge metal strap attached with eight 16-penny nails on both sides of the hole or notch. IRC section

P2603.2.1 specifies that any pipes that aren't cast iron or steel within 1½ inches of the edge of the framing must be protected by a 16-gauge steel plate that extends 2 inches past the top and bottom plates. The small nail stoppers on this wall (left) meet neither requirement and should be replaced with a protecting shield plate like the one shown (above).

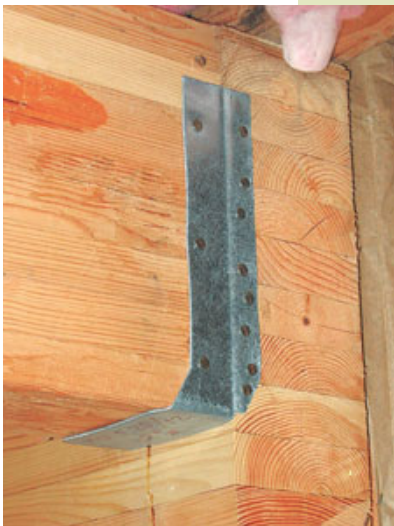
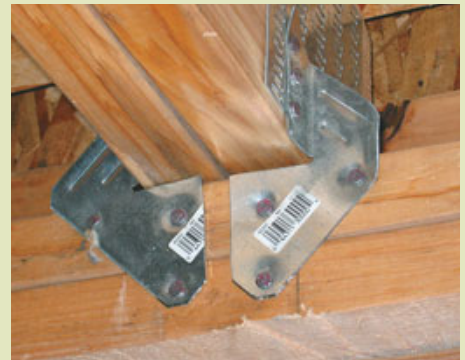
Unique and unexpected framing connections always seem to come up at just the wrong moment. While it may be tempting to save time and trouble by modifying a connector that is already on site, don't do it. Bending can cause fractures, changes the geometry of the connector, and may reposition fasteners into weaker areas of the lumber. The side flange of the hanger supporting this glulam beam (left) was hammered flat, and someone cut this hurricane tie (right) in half to make it fit a double truss. Both pieces of hardware will have to be replaced, because no manufacturer will warrant or guarantee the performance of modified connectors unless they're specifically engineered for field sloping or skewing.
