# A Cost-Effective Energy Retrofit

With careful air-sealing and the right insulation details, a leaky older home becomes a tight and thrifty one

by Terry Nordbye

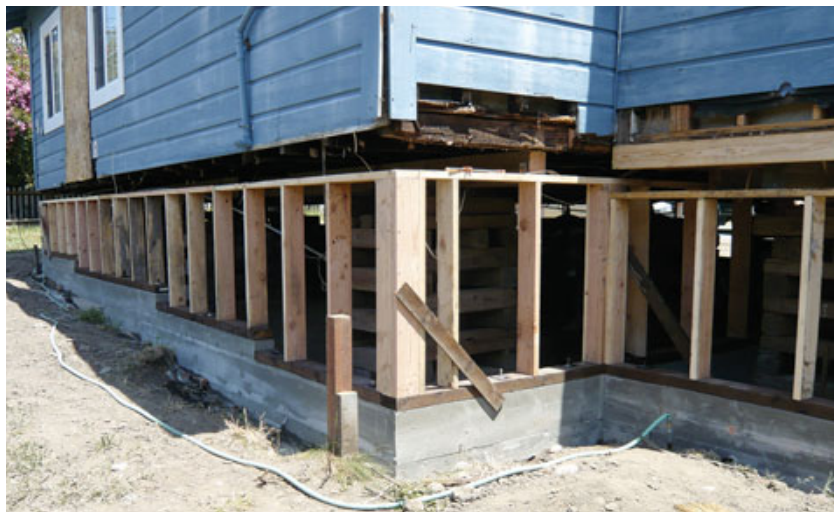
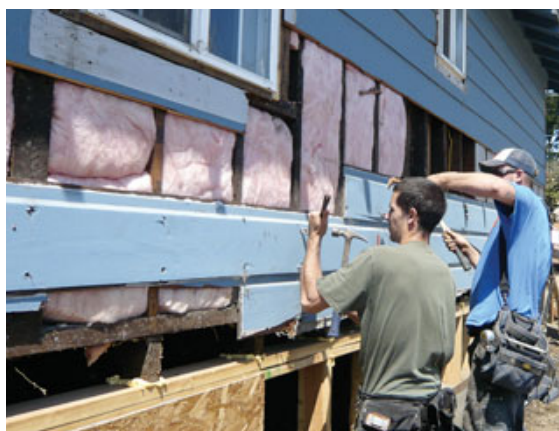
**Figure 1.** After placing the house on a new foundation and pony walls (above), the crew removed the siding (left) so they could access the stud bays for air-sealing and then install sheathing.

We began the project by replacing the foundation — a common repair in this area. After a house mover lifted the building onto cribbing, we removed the rotted pony walls and crumbling grade beams and poured reinforced concrete footings and stem walls capped by new pony walls (see Figure 1, next page).

**Room to move.** Although the building's footprint didn't change, the new foundation raised the structure by 2½ feet. Unlike the original crawlspace, which was only 1 to 2 feet high, the new one was tall enough for our crew and subs to do a good job replumbing, rewiring, and air-sealing from beneath the existing floor.

After the house mover lowered the building onto the new pony walls, we pulled off the old siding and carefully removed the doors and windows so they

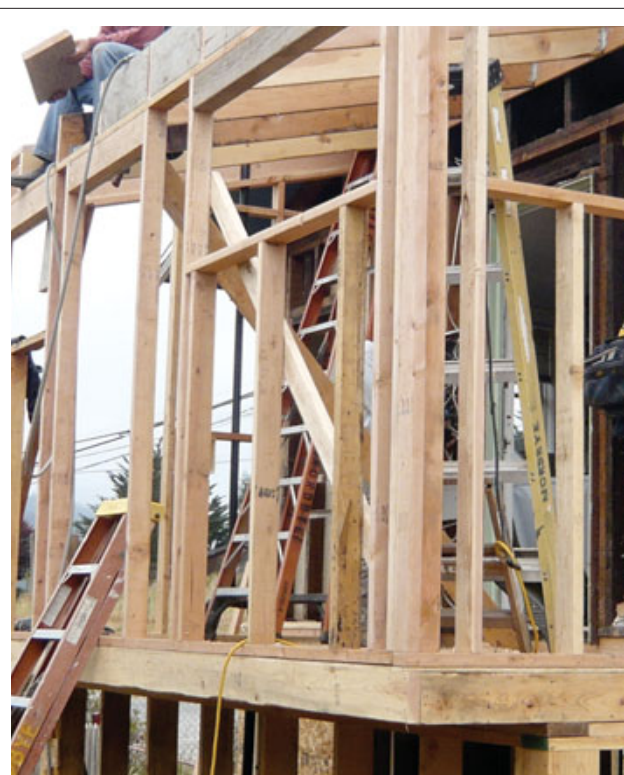
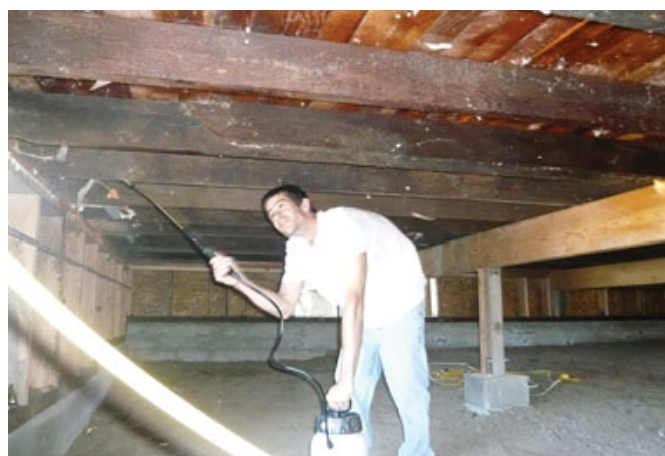
**Figure 2.** The back laundry room was rebuilt with optimum value engineering (OVE) framing, a method that reduces thermal bridging and saves material. With OVE framing (left) there is 24-inch stud spacing, a single top plate, two-stud corners, right-size headers, and no jack studs. All of the framing in the house was sprayed (above) with Borrada LP, a low-toxicity glycol-borate preservative that kills termites 4 inches into the wood and prevents new infestations — a task made much easier by the additional crawl-space height provided by the new foundation.

could be reinstalled later. We made various repairs to the framing, then turned our attention to the small front porch and a shed-roofed laundry room off the back of the house. Although the front porch was in good condition, the laundry room was so infested with termites we had to completely rebuild it. To conserve material and reduce thermal bridging, we framed it using the OVE (optimum value engineering) method (Figure 2).

**Termite treatment.** To prevent future infestations, we sprayed exposed framing with a glycol-borate preservative and termiticide called Borrada LP (281/892-2500, controlsolutions.com). According to its maker, the product has low toxicity to humans but kills insects up to 4 inches into the wood. We've since learned that Borrada LP has been discontinued, but similar termiticides are still available. Two of the better known glycol-borate products are Bora-Care (800/264-0870, nisuscorp.com) and Bor-ram (919/226-1195, sostram.com).

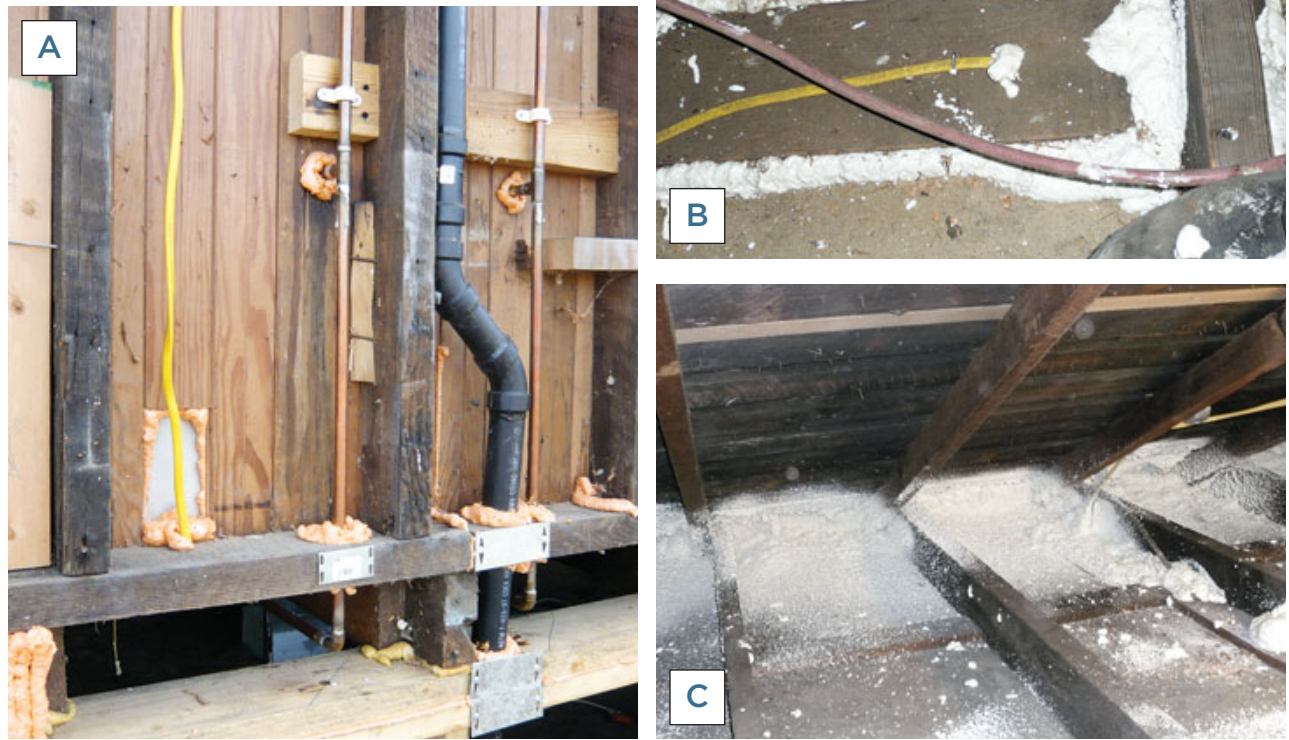
**Figure 3.** The author used one-component canned spray foam to seal plumbing and electrical penetrations through the walls (A), floor, and attic (B). To seal leaks at the eaves and provide added R-value in an area where insulation depth was limited, a thicker buildup of two-component foam was applied at the intersection of rafters and top plates (C). The holes through existing electrical boxes were plugged with a nonhardening putty (D) designed for sealing ducts.

We began air-sealing by spraying canned polyurethane foam into the gaps surrounding pipes, wires, and electrical boxes where they penetrated framing and drywall (Figure 3). In the attic, we used two-component spray-foam kits from Touch 'n Seal at the eaves (800/325-6180, touch-n-seal.com). The kits come in several sizes; we used two of the largest, each of which yields about 600 board feet (50 cubic feet) of foam. In addition to sealing the penetrations, going with foam here increased R-value in an area where the low angle of the roof limited the amount of insulation that would fit.

We filled the holes in the backs of existing electrical boxes by plugging them with

Arlington Industries' Duct Seal Compound (800/233-4717, aifittings.com), a soft putty that does not harden over time.

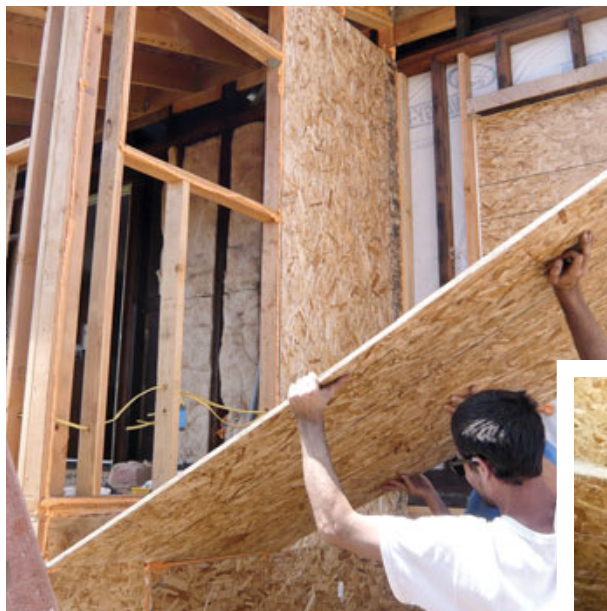
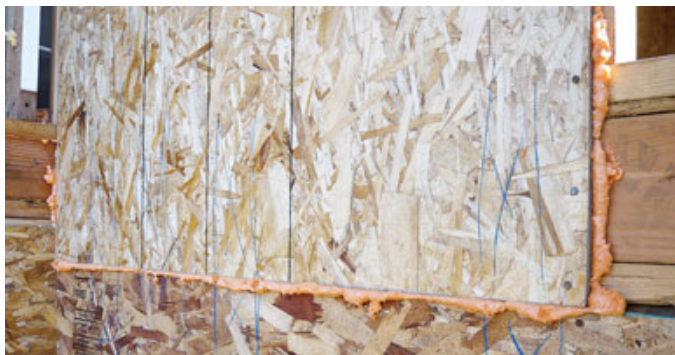
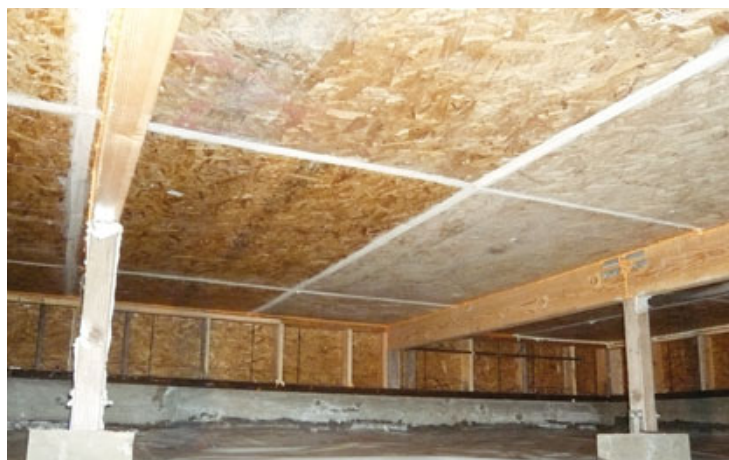
**Figure 4.** The carpenters installed the sheathing over beads of fresh spray foam (above), which expanded to fill any gaps (above right). The seams in the OSB on the underside of the floor joists (right) were sealed with strips of paper drywall tape laid into a coating of duct mastic.

After sealing every crack and penetration we could find, we sheathed the exterior walls and crawlspace ceiling with OSB, having already removed the original fiberglass batts from the framing cavities to make room for the dense-pack cellulose that would be blown in later. To further cut back on air leaks, we installed the wall sheathing over freshly applied beads of canned one-component spray foam, which expanded to fill the gaps between sheets (Figure 4, next page). There was no edge-blocking in the crawlspace ceiling, so we sealed the joints not backed by framing members with paper drywall

tape embedded in a coating of DP 1010 duct mastic (800/641-0808, designpoly.com). The gap at the perimeter of the ceiling was too large for mastic, so we sealed it with more spray foam.

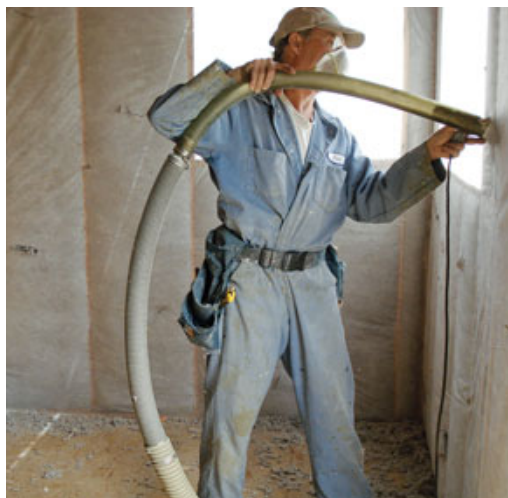
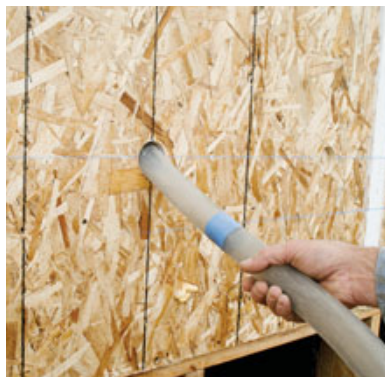
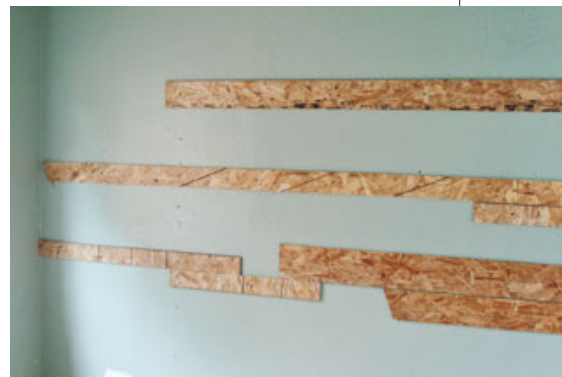
**Figure 5.** The insulation contractor used the dense-pack method to insulate the newly framed back porch, blowing cellulose through slits in mesh fabric that had been stapled across the studs (left). Where drywall was already up, he blew insulation through holes in the sheathing (below left). The crew screwed temporary braces (below) across the existing drywall to keep it from popping off while cellulose was being packed into the wall.

**Inside out and outside in.** Our insulation contractor used that conventional method on the walls and ceiling of the newly framed back porch (Figure 5). In areas where the drywall was already up he worked from outside, blowing cellulose through holes drilled in the sheathing. Early in the process, however, we found that the pressure exerted during installation could be enough to push the drywall off the studs. To prevent this from happening, we screwed temporary battens across the inside face of the wall. After the stud bays were filled, we patched the holes in the sheathing by inserting wood plugs and sealing them with duct mastic and mesh drywall tape.

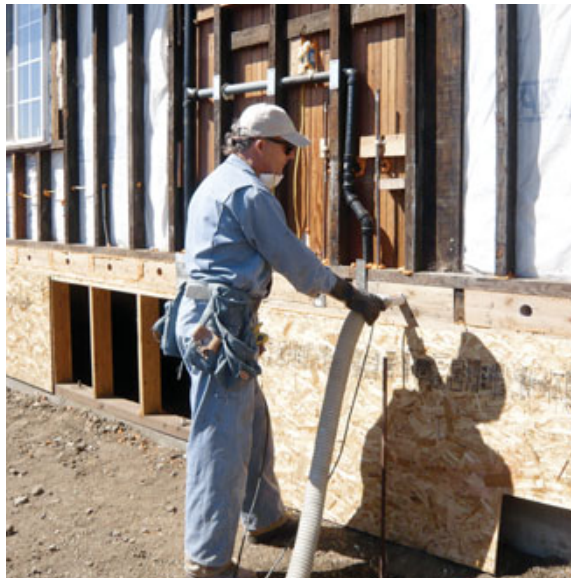
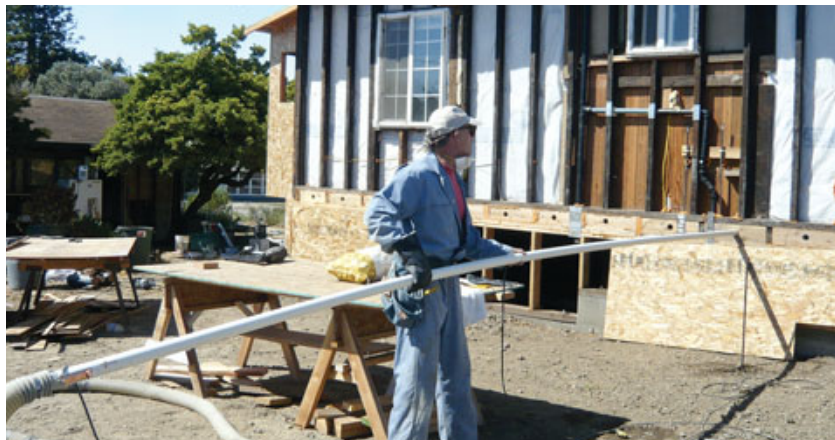
**Figure 6.** The floor was insulated with dense-pack cellulose blown through holes in the joist blocking. To ensure the cavities were completely filled, the insulator connected a PVC pipe to the hose and began blowing from the far end of the bay (left), withdrawing the pipe as he went (below).

sub worked through holes bored in the blocking that served as a rim joist. To ensure that the cellulose reached the far end of the framing cavity, it was blown in through a long piece of PVC plumbing pipe attached to the end of the hose (**Figure 6**). The insulator started with the pipe all the way in and slowly withdrew it as the joist bay filled with insulation.

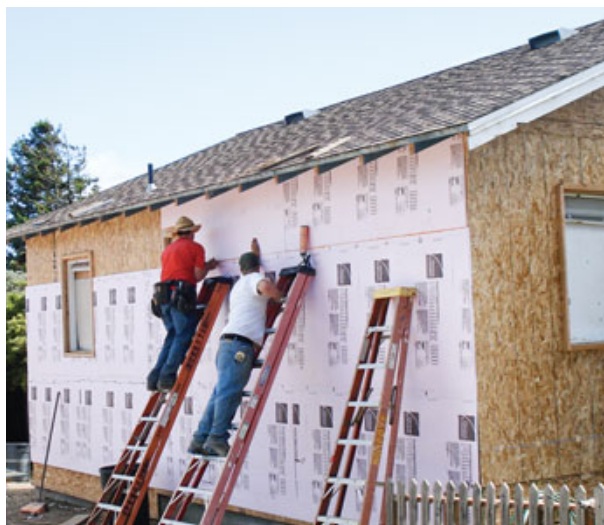
**Figure 7.** A one-inch layer of rigid XPS foam covers the wall sheathing, providing added R-value and a thermal break. Flat roof vents and a pair of gable-end vents supply attic ventilation.

**An exterior thermal break.** To provide a thermal break and an additional R-5 of insulation value, we covered the wall sheathing with one-inch XPS foam board, which was notched around the rafter tails (**Figure 7**). We cut the front porch free from the building and moved it temporarily away from the wall so the foam could be applied behind it without interruption. In framing the rear laundry room, we cut the rafters flush with the top plate so there would be no breaks through the foam. An overhang with short decorative rafter tails was later fastened to the wall from the outside (**Figure 8, next page**).

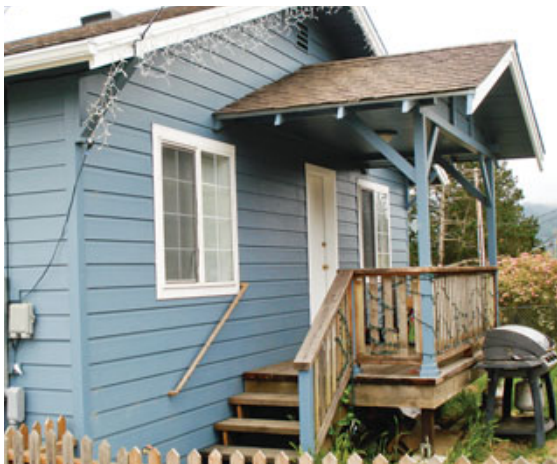
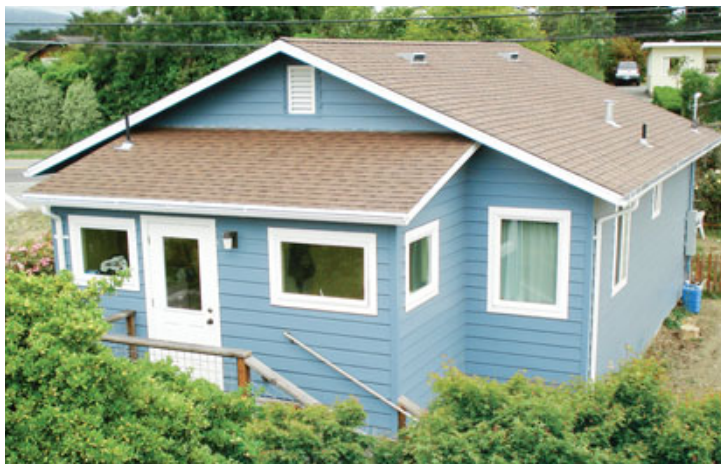
**Figure 8.** To maintain the continuity of the exterior rigid foam, the small front porch — shown here (left) with the siding applied — was cut free of the structure and then reattached after the foam had been slipped behind it. The back laundry room — a former porch — is fully insulated and lies within the building's thermal envelope (right).

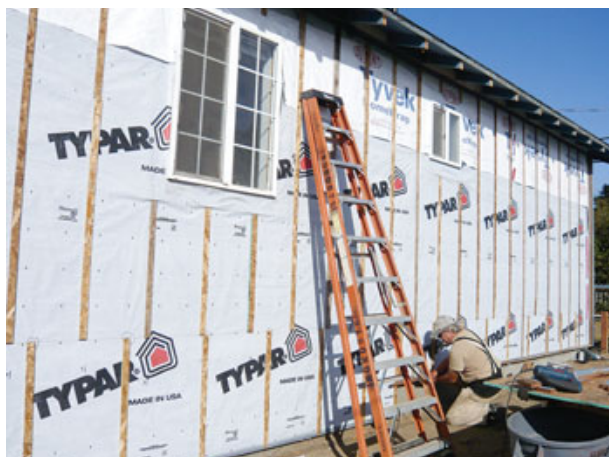
**Figure 9.** After reinstalling the existing windows, the crew covered the rigid foam with housewrap and vertical battens, which provide an air space and drainage plane behind the siding.

To increase the durability of the wall assembly, we installed the exterior finish rain-screen style — that is, over a ventilated air space (**Figure 9, page next**). This allows any moisture that gets behind the siding to drain to the bottom of the wall and promotes rapid drying of the back of the siding itself. We began by nailing spacers ripped from scraps of OSB over the foam at the perimeter of the openings and fastening the windows to them. Next, we covered the foam with housewrap, taking care to lap it over the window flanges and spacers. The remaining spacers went on over the housewrap at the stud locations,

with window-screen material stretched across the open ends to keep insects from entering the air space. We completed the exterior by reattaching the front porch and nailing the casings, corner boards, and siding over the spacer strips.

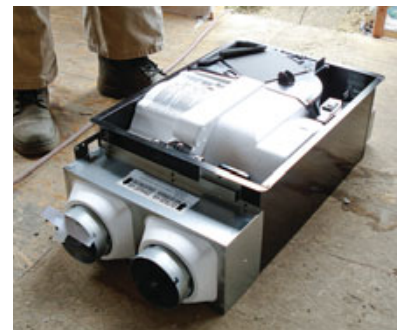
**Figure 10.** To improve indoor air quality in the now-tight house, the author installed a Panasonic energy-recovery ventilator in the ceiling of the living area. This small, inexpensive unit installs like a bath fan, except that there are two ducts to the exterior instead of one.

A house this tight should be equipped with mechanical ventilation. The budget on this project didn't allow for a fully ducted whole-house HRV, so we put a continuous-duty Panasonic FV-04VE1 in the main living area. This low-cost energy-recovery ventilator sells for about \$350 and has a maximum capacity of 40 cfm. Except for the presence of a 4-inch outdoor air intake, it installs in the ceiling in much the same way as a bathroom fan (**Figure 10**).
