Tightening Up a Two-Family Home

Chasing down and fixing energy leaks in an old house can be tricky and expensive, but utility incentives may help

by Brian Butler

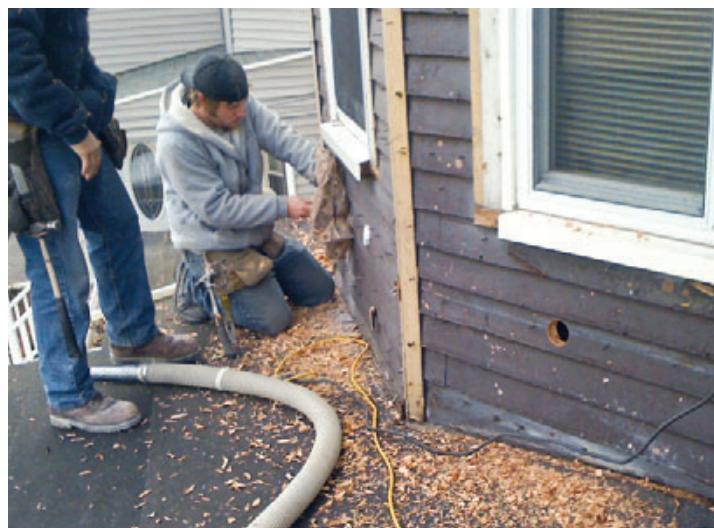
The first step was to have a cellulose contractor dense-pack the uninsulated 2x4 wall cavities from the exterior (see **Figure 1**). Then, after stripping off several layers of existing siding, we covered the $\frac{7}{8}$ -inch board sheathing with a carefully lapped and taped layer of HardieWrap weather barrier. To head off air infiltration between the framing members in the window openings, we also lined the rough openings with strips of HardieWrap, which we sealed to the housewrap outside and to the interior plaster on the inside.

Figure 1. Because the original balloon-framed walls had never been insulated, dense-pack cellulose was easily blown into the empty stud cavities from the exterior.

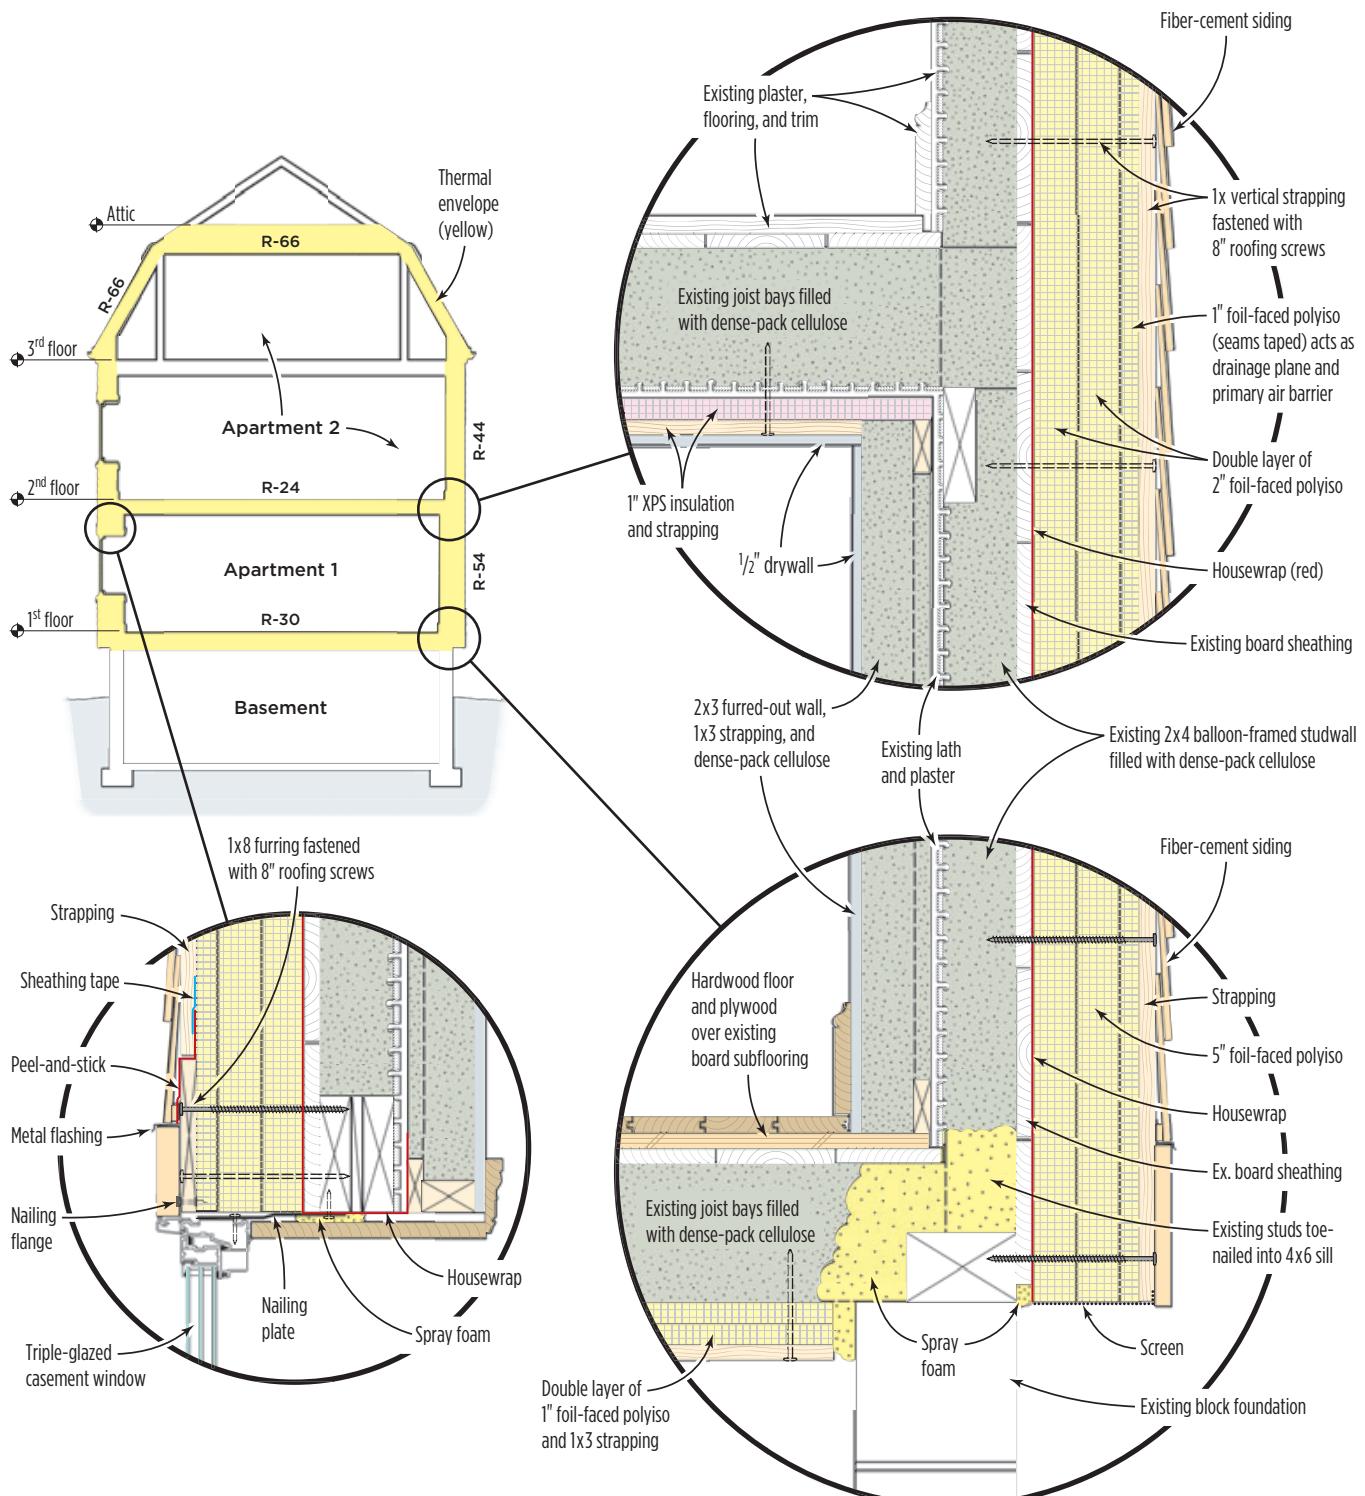
Adding Thermal Layers to an Old House

Both the owner's downstairs apartment and the rental unit upstairs received new high-efficiency windows, dense-pack cellulose in the uninsulated framing cavities, and a thick exterior layer of rigid foam. Airtight drywall and an additional layer of cellulose in the lower unit increased the R-value of the wall system only modestly — but reduced air infiltration to a fraction of that in the unit above.

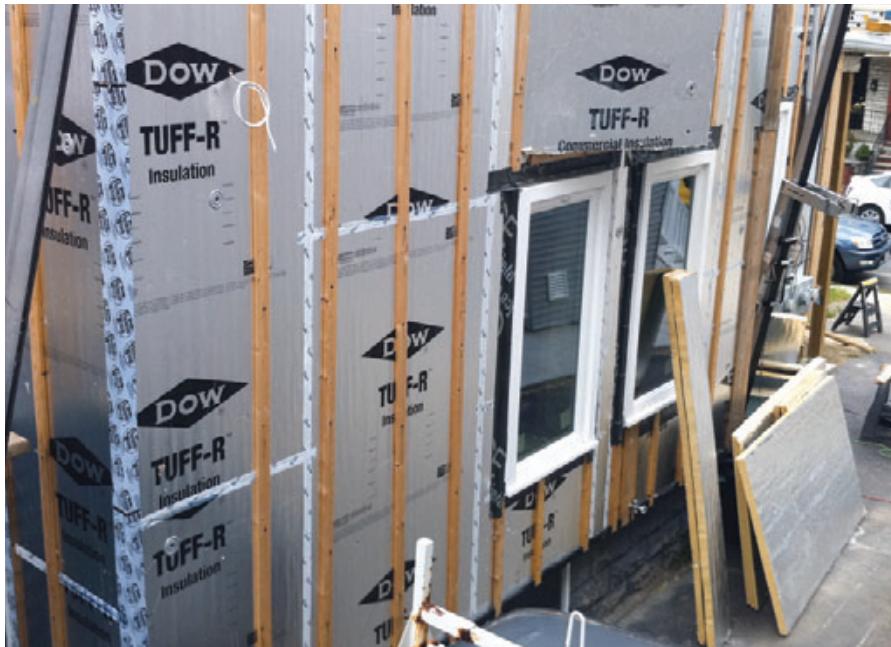
Next came two layers of 2-inch foil-faced polyiso board and a single layer of 1-inch, with the seams between layers staggered and sealed with Dow Weathermate tape. We used as few screws as possible for the first two layers, but screwed the top layer to the sheathing with a roofing cap at each corner. Finally, to provide a ventilated nailing base for the fiber-cement siding and to better secure the foam, we fastened vertical 1x3 strapping through all three layers and into the studs with 8-inch-long roofing screws (**Figure 2, page 56**).

Figure 2. Energy-efficient casement windows were cantilevered beyond the original rough openings, secured with metal ties, then surrounded with snug-fitting rigid foam, which also serves as the wall's drainage plane.

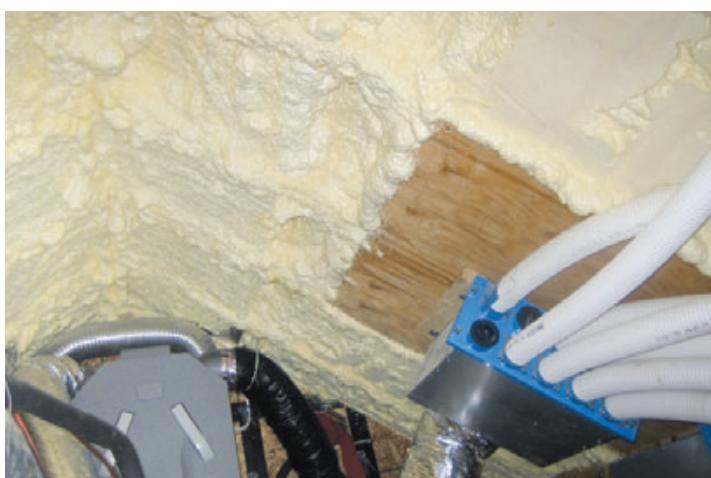
Figure 3. The roof framing in the attic mechanical room is encapsulated in a thick layer of closed-cell spray foam, bringing all the hvac equipment and ductwork within the building's thermal envelope. Plywood panels, fastened to blocking before the foam was applied, provided solid mounting surfaces where needed. To meet the fire code, the exposed foam was coated with intumescence paint.

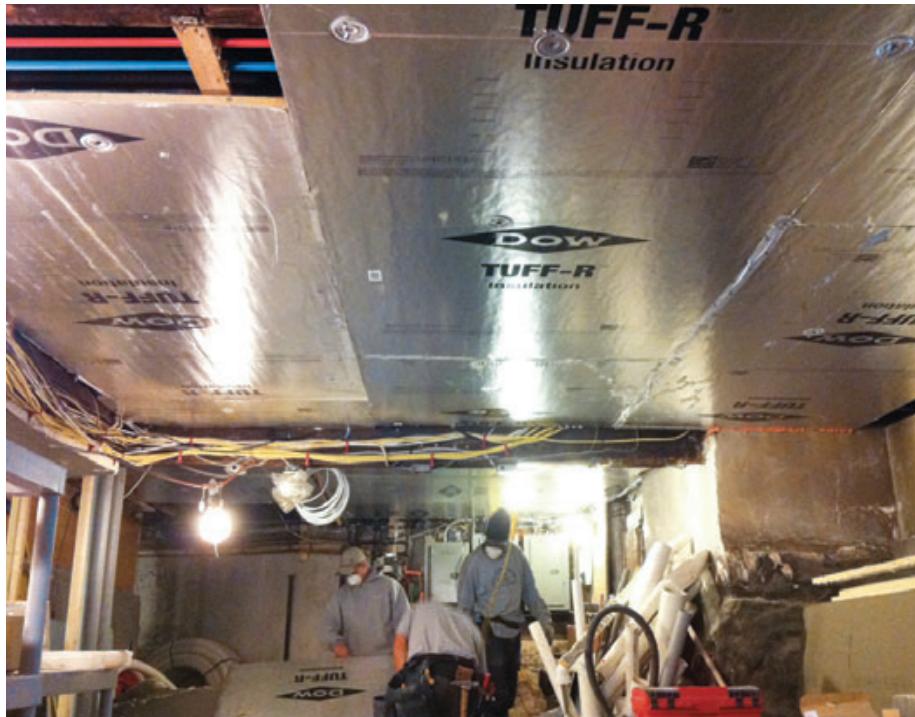
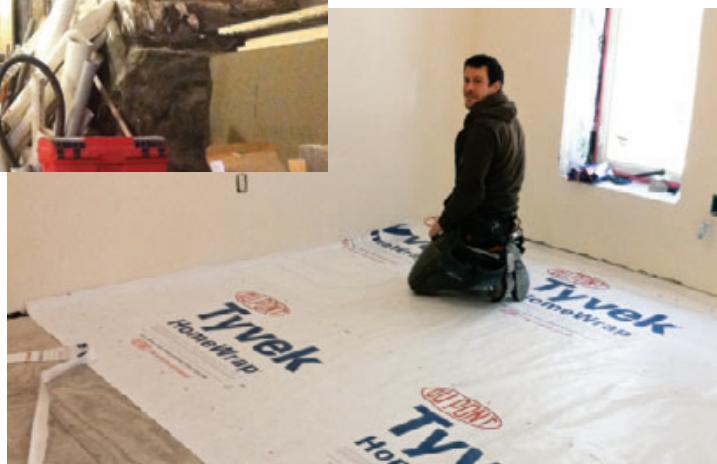
Figure 4. Working in the cellar, the crew applied foil-faced rigid foam to the bottoms of the first-floor joists, then sealed around the perimeter with spray foam; the joist cavities were later dense-packed (left). To further reduce air movement between the basement and living space, the author laid housewrap across the sub-floor above, taping the seams and sealing it to the drywall perimeter before laying the finish flooring (below).

Because the house is balloon-framed, with its studs toenailed to a 4x6 sill, the first order of business was to spray closed-cell foam from a five-gallon kit against the exterior sheathing around the sill, filling the space where the studs and joist ends meet (but taking care not to let the foam expand beyond the bottoms of the joists themselves). Next, we fastened a layer of 1-inch foil-faced polyiso to the bottoms of the joists (Figure 4). We held the edges of the sheets an inch or so back from the sill, then filled the gap with more foam, which expanded enough to become continuous with the foam applied earlier. Later, after the enclosed bays were filled with dense-pack cellulose, we applied a second layer of rigid foam followed by strapping.

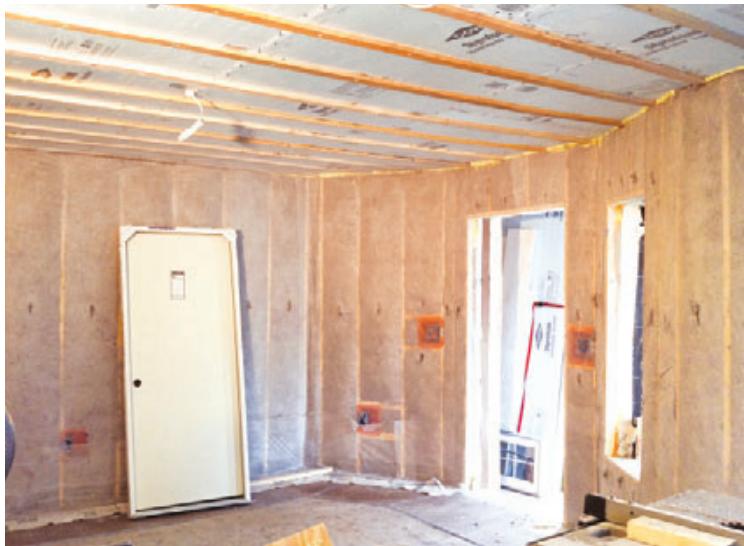
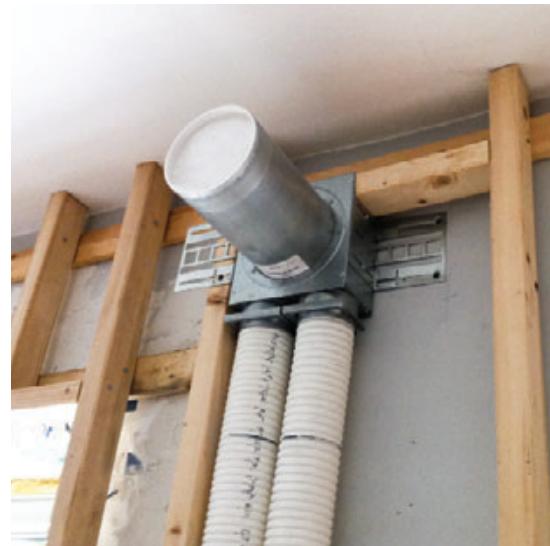
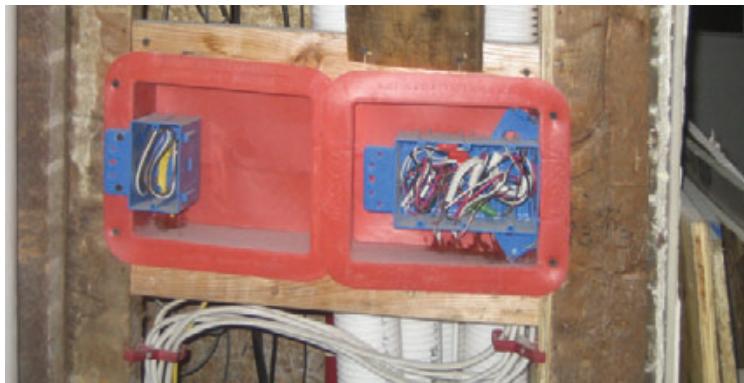
Although the shell was now well-insulated, we furred out the exterior walls of the downstairs unit to provide space for wiring and mechanicals and another 4 inches of cellulose (Figure 5, page 60). We first mudded over any cracks and abandoned receptacles in the original plaster, then nailed up three courses of horizontal strapping to each wall — one at the bottom, one at mid-height, and one just below the intersection with the ceiling. We

Figure 5. An air-sealed layer of XPS in the down-stairs ceiling minimizes heat loss to the upstairs unit (above left). The exterior walls of the first-floor apartment were also furred out with 2x3s to provide room for additional cellulose, as well as space for the HRV ductwork (above). To tighten the wall assembly even more, the author used an airtight drywall approach, installing receptacle boxes inside airtight Lessco boxes (left).

Still, that figure was higher than our original downstairs goal of 187 cfm (a target that would have allowed us to hit a Passive House standard for old buildings). On investigation, we found that a good deal of that leakage was coming in around the electrical boxes, which apparently weren't caulked well enough when the drywall was hung. In hind-

We have our own blower door, so we've been able to track down most of the leaks with a smoke pencil and seal them with caulk or canned foam. In the case of the outlets, this involves removing the cover plates and injecting canned foam around the perimeter of the boxes through a straw inserted in the gap between the wallboard and the rough-in box, taking care to keep the foam out of the electrical boxes themselves. The master bedroom hasn't yet been tiled and finished, so there's still some low-hanging fruit available that should help us close the remaining gap.
