A Historic Building Gets an Energy Upgrade

Satisfying the commissions while bringing an 1840s building up to 21st-century energy-efficiency standards presented a challenge

by Andrew Borgese

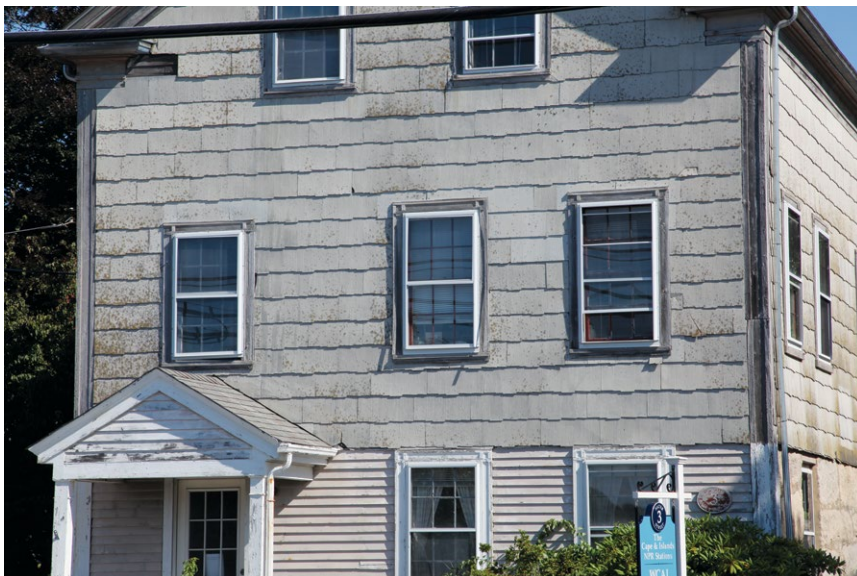
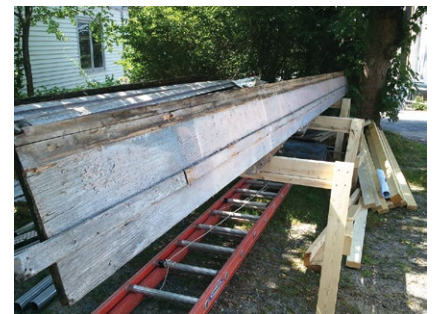
When WGBH took over the building in 2009, it was clad with asbestos shingles (see Figure 1) and the asphalt roof was failing. The walls and roof had little or no insulation, most of the exterior trim needed replacing, the two brick chimneys were crumbling, and the original double-hung windows were in poor condition. In short, the building had serious structural and energy-efficiency problems, as well as a lack of wheelchair accessibility. But its location within a historic district meant that any work done to the exterior of the

Figure 1. Before the renovation, the building was essentially sound, but the years had not been kind to it. Asbestos shingles covered the walls (left), and much of the trim had deteriorated beyond saving. As the exterior layers were peeled back, any of the original cypress trim that still had life was set aside to be reinstalled later (above).

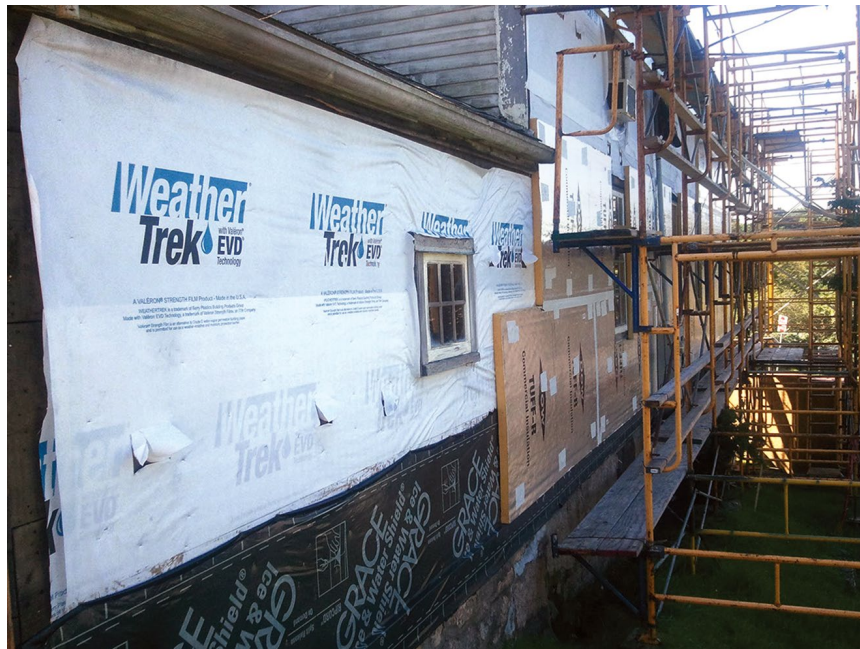
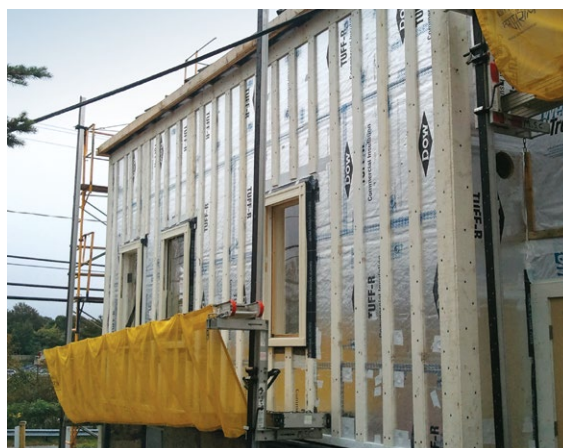
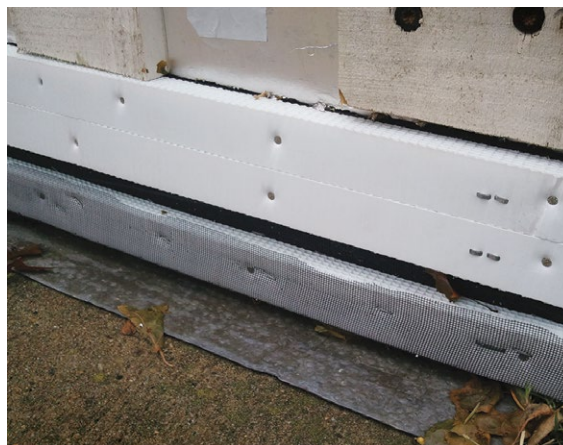
Figure 2. Before the nailing strips went on, cellulose insulation was blown into the walls; housewrap was attached to the original sheathing (above) to keep the cellulose from leaking out. Then the walls were wrapped with foil-faced foam and the seams taped. Vertical strapping was screwed through the foam and into the framing to attach the siding and trim (left). Extra stock was later added around window and door openings for nailers. Vent strips were installed at the top and bottom of each wall for drainage and to allow air to flow freely behind the clapboards (bottom).

The Standards for Rehabilitation require that materials be repaired and reused wherever possible, so as the outer layers of the building were peeled back, we set aside any such material. Once the original board sheathing was exposed, we were able to fill the empty stud cavities and rafter bays with dense-packed cellulose insulation from the outside. Next we wrapped the walls and roof with a layer of 2-inch foil-faced polyisocyanurate foam insulation, taping the seams to complete the air and moisture barrier and provide a thermal boundary (Figure 2).

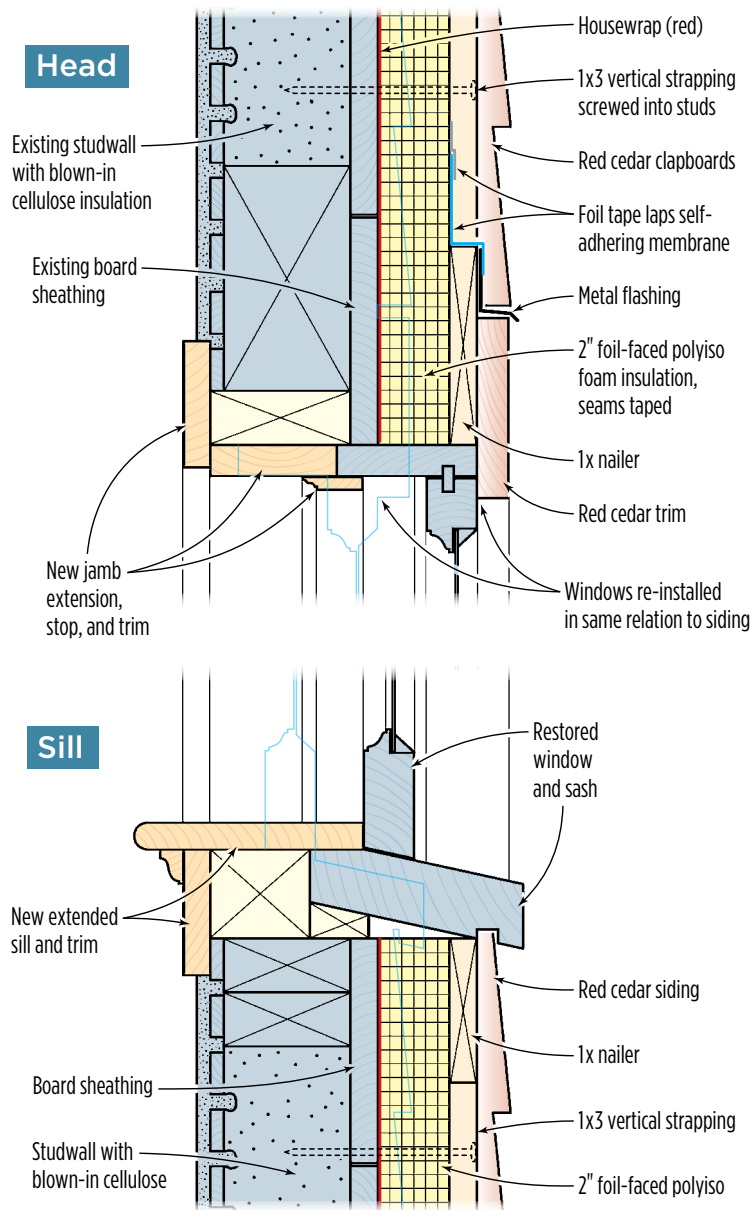
Window Installation Details

Reinstalling the windows.

To match the original building façade, the restored windows were mounted flush with the furring strips. This required jamb extensions (top) and deeper sills (above) to accommodate the thicker wall.

One area where the commissions left no room for compromise was the windows. They insisted that we reuse every window deemed original. And they insisted that the windows be re-installed in the same relation to the siding as on the original building (see illustration, left). Therefore, all original windows were taken off site and painstakingly restored before being reinstalled. Non-original windows were replaced with new units that closely matched the originals. Though single-glazed, the restored windows were much more airtight than they had been previously, and interior storm panels improved their performance even more.

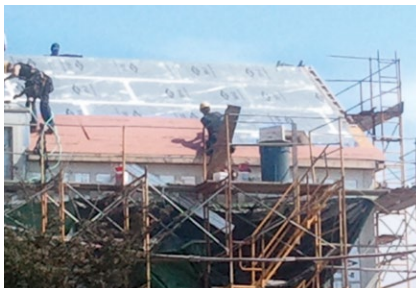
Figure 3. Plywood sheathing, screwed through the foam insulation on the roof and into the rafters, provided continuous nailing for the red cedar roof shingles. The seams were taped per the manufacturer's instructions, and a mesh drainage layer went between the sheathing and the shingles.

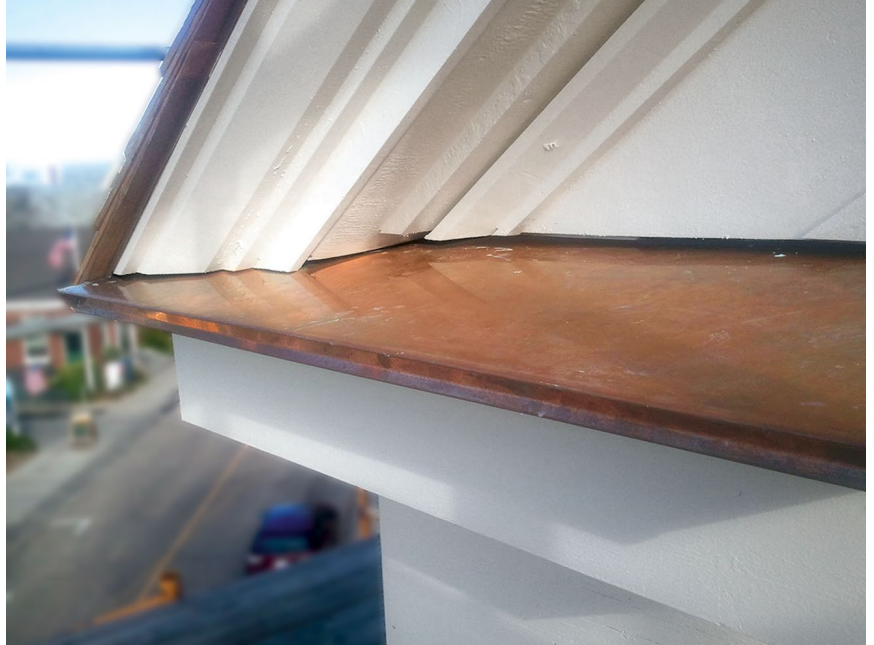
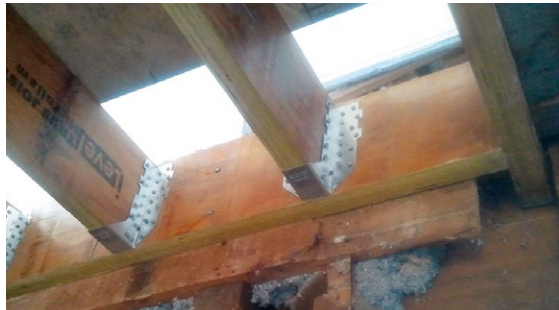
Figure 4. When the trim went back on the building, original detailing was followed as closely as possible based on archival photos and the trim that was removed (above). Metal connectors and beams were added where the old structure needed strengthening (left).

added about 5½ inches to the overall width and length of the building and 2½ inches to the height, changes that both commissions found acceptable as long as we faithfully reproduced the eaves, rake, and return details (**Figure 4**). The original trim on the building was cyprus, and we repaired and reused what was salvageable. We used red cedar for any replacement trim, a choice that was cost-effective and met the commissions' requirements. (Neither synthetic trim nor non-wood siding was an acceptable option.)
