How to Be a Flashing Success

by Henri de Marne

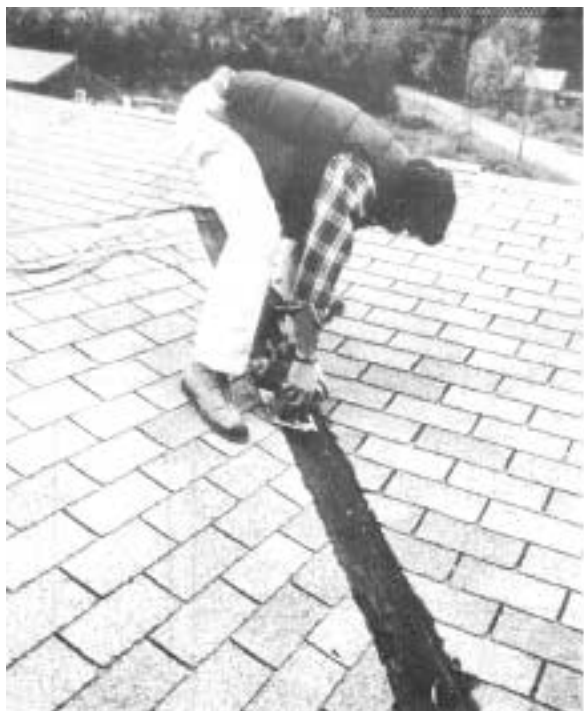
Phase 1 of a new valley-repair technique. At left, the old valley is cut with a masonry knife. Above, with the old valley cut, a new piece of flashing is inserted on one side.

casional advice, Sal and his outstanding crew slit the old, leaky and heavily asphalt-coated valleys down the middle with a masonry blade set for a shallow cut, then inserted the replacement valley pieces, which had been fabricated by a local metalsmith to my specifications.

The replacement consisted primarily of a set of pieces shaped with a vertical leg about one inch high for one side of the valley, and a flat portion measured to cover half of the valley and to extend a few inches under the shingles without interfering with the nails holding the existing shingles. This flat piece terminated with a half-inch upward hem left slightly open.

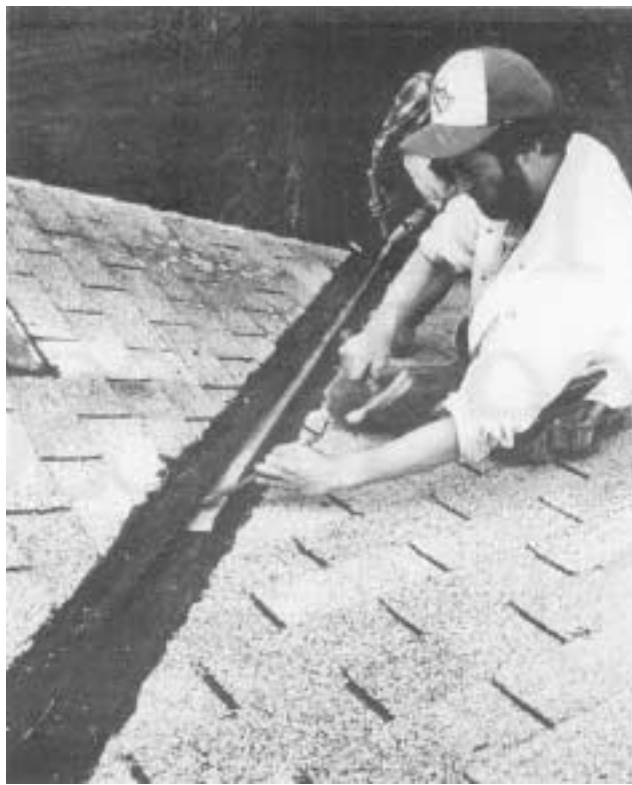
A carpenter inserts replacement pieces on one side of the old valley.

The pieces for the other side of each valley had one difference: the top leg continued with a one-inch flat top bent at 90 degrees. The idea was to bend the flat top of these pieces over the adjacent sister pieces to lock the system and rivet the components together.

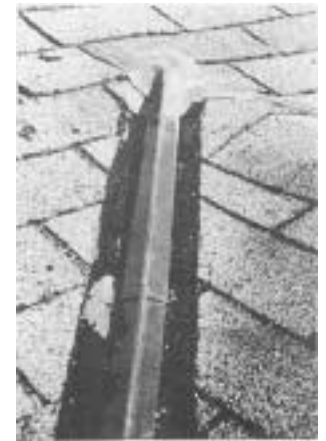
The completed job, with lead flashing at the joint of the two valleys and the U-shaped valley cap in place. The old, tar-coated valley is still visible.

At the top, where the two valleys meet, a piece of lead flashing was inserted beneath the upper roof shingles and shaped to cover the new flashing.

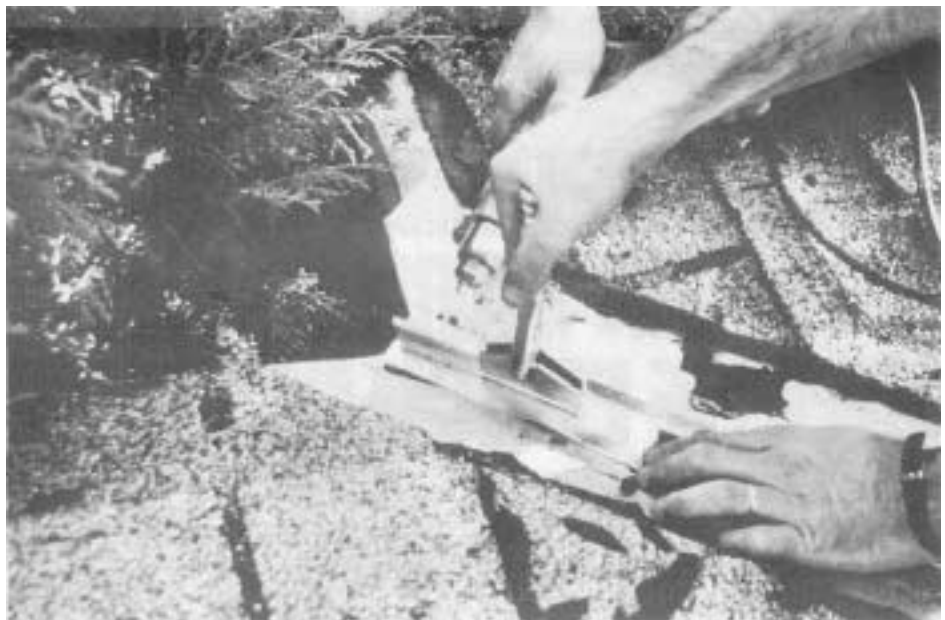
With the new inverted-U cap in place, a carpenter squeezes the pieces shut while another worker drills a hole for a pop rivet.

Time for a quick field decision to remedy the problem. With the crew's blessing, I rushed to the nearby metal shop and had the man make us pieces shaped like a thin "U" but with flared legs.

While I was away, the workers completed bending over the flat tops, so when I returned they were ready to put the caps on, drill them in a few places, and fasten them to the valley replacement pieces with a few aluminum pop rivets. This went very quickly.

The flared legs pressed the old flashing down while covering part of it, thus creating an additional seal. This is definitely the way to go, we discovered. There is no need to have the flat top on one set of replacement pieces.
