by Walter Lump

# Sandblasting SAVES TIME and MONEY

*Sandblasting can save structural lumber and help eliminate smoke odor in badly-damaged buildings.*

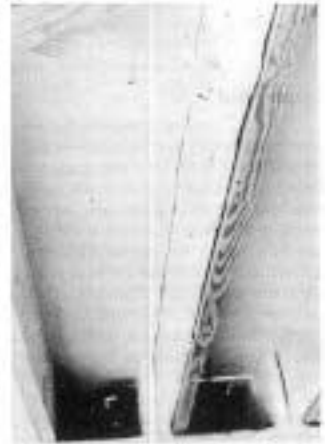
Fig. 2. Sandblasting charred lumber and laminating new structural member to old is a cost-effective alternative to replacement of ceiling joists.

This would be an ideal opportunity to use sandblasting. Through this procedure, the contractor can remove the char, eliminate the smoke residue, and an additional member can then be laminated to the existing member. In this way, the old joists do not have to be removed. The procedure of laminating the new member to the old is referred to as "sistering," and would yield a structural load bearing capacity of *almost twice* the original member (see Figure 2). The most important feature is that it can be accomplished without disturbing the surfaces adjacent to it. This example was an actual job handled by our company, and the cost savings to the customer amounted to \$1,920.

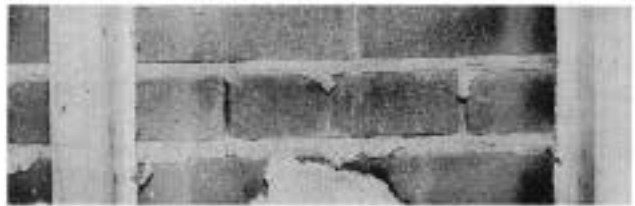
Fig. 3. Sandblasting removes smoke residue and char in cavity between wall

replacement of an exterior studwall connected to a brick veneer. The problem facing him was to remove the charred studs without losing the wall ties. The Code says there must be at least one wall tie for every 16 inches vertically and for every 24 inches horizontally. If more than one or two studs must be removed, the Code can require you to remove and replace the brick in order to replace the wall ties. As our dealer and his staff checked out the damaged area to determine how many studs had been damaged, they recognized the possibility that smoke and odor may have also seeped into the cavity between the wall sheathing and the backside of the brick veneer. From experience they know that this could become a source of odor problems in the future. After removing just a section of the sheathing, they could see that their suspicions were correct (see Figure 3). The rest of the sheathing was removed, and both the brick and the studs were sandblasted to remove the smoke residue and char. New studs were then sistered to the sandblasted studs, and the entire area was treated for odor before the new sheathing was installed. Not only was the contractor able to eliminate the possibility of smoke odor, but he was also able to save the wall ties. The cost savings that resulted from this procedure amounted to \$6,350.

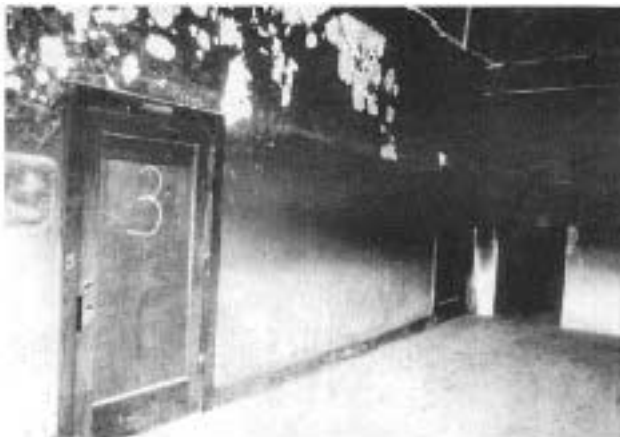
Fig. 4. The central hallway of the McGuffey Art Center in Charlottesville, Virginia was badly damaged during a fire.

An entirely different application of sandblasting can be seen in Figures 4 and 5. The central hallway of the McGuffey Art Center in Charlottesville, Virginia was badly damaged during a fire. Fortunately, the damage to the plaster walls was only to the top layer or white coat. We were able to remove this damaged portion of the white coat by sandblasting at a low pressure level. The area was then treated for odor, and a bonding compound was applied to the sandblasted surface. This was followed by a new white coat of plaster and finally the repaired wall was painted with a resinous sealer. A special note: the resinous sealer must not be put on before either the bonding agent or the new white coat of plaster has been applied. The reason for this is that the sealer has a molecular structure which will keep the white coat of plaster from adhering to the sandblasted surface. Again the cost savings were substantial—\$6,982 in the hallway alone.

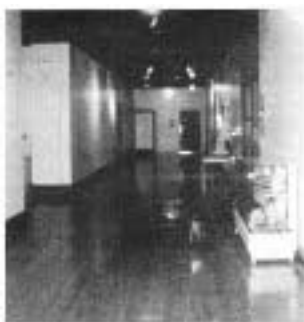
Fig. 5. Sandblasting removed damaged portion of walls. Bonding compound was applied, followed by new coat of plaster and resinous sealer.
