# Peeling Paint Blues

by William A. Lotz, P.E.

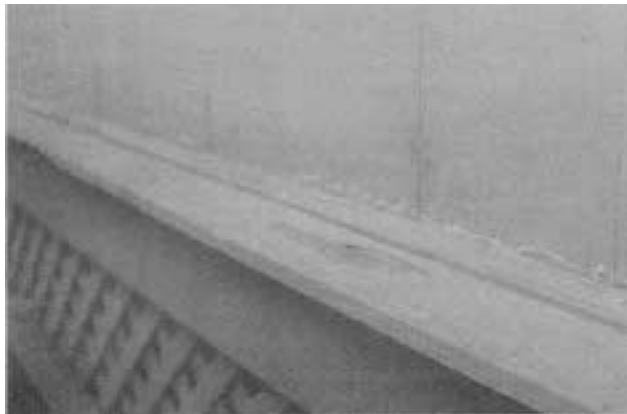
This shelf gets dripped on from the roof and sits in snow all winter. These are tough conditions for even the best paint job.

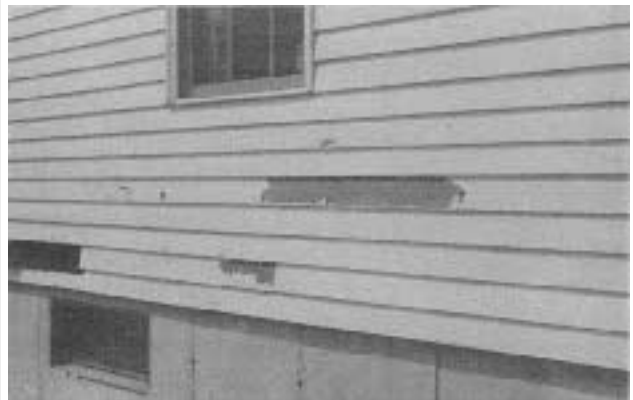
In January of 1987, the paint started to blister and peel. When I saw the house in May, it was a mess. The paint was blistered or peeled everywhere I looked on the north or east sides of the house (see photo). Some paint distress was evident on the south and west sides but it was much less severe. Usually the peeling is more severe on the downwind sides of the building when there is a prevailing wind direction.

The photo shows two problems. First, the two layers of paint (different brands) separated from each other. The two types of paint were incompatible. The primer was applied to the clapboards and then the house was spray painted with a popular brand of white stain.

Second, the primer peeled off from the clapboards in sheets. Moisture readings taken in the wood clapboards ranged from 10 percent to over 30 percent. Moisture readings in the plywood sheathing were off the scale (over 30 percent). I assume "construction moisture" played a part in the wetness of this house—how much is difficult to say until next year. The paint manufacturers took samples of the peeled paint film and stated nothing was wrong with the paint formulation based upon laboratory analysis of the samples.

Completed in the fall, this Mass. house started peeling badly by mid-winter. Two problems are cited: high interior moisture levels, which caused peeling, and incompatibility of primer and paint (actually white stain), which caused the two to separate. Each paint company blamed the moist wood—and the other paint product.

worried builder included: install bath and kitchen exhaust fans ducted outdoors, paint the entire interior of the house with two coats of Glidden Insul-Aid vapor barrier paint plus a finish coat of paint, remove the existing exterior paint and repaint with primer and finish paint of the same manufacturer, and cover the sump pit hole with a moisture-tight cover.
