Sloped Site Drainage

by Michael Lennon

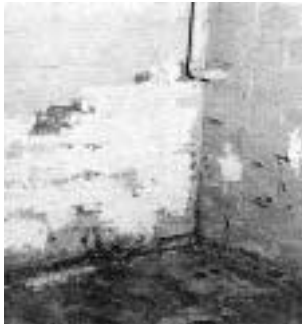
The trouble was with the clues and logic. There I was in the unfinished basement portion of a 20-year-old home looking at the rear foundation wall. It had been coated with one of those products advertised as capable of keeping the basement dry. Much of the material was flaking off in large blisters, and stains were everywhere.

The basement wall coating, which was supposed to prevent seepage, was blistered and flaking off. The cause was less than obvious.

The diagnosis: The water was forced in under pressure, but it was filling up a gravel bed beneath the basement slab and was draining right out again along the sewer and water line trench in the front of the house. It had apparently been doing that for years and accounted for the slight soil consolidation above the trench. A reexamination of those areas in front of the houses also displayed that the grass was growing more vigorously over top of the sewer and water line. The drainage out along that line would also account for the mysterious timing and occurrences. When the water volume was large and occurring quickly, it could not drain out fast enough, so it backed up from the front.

My prescription to the client was the following: add and maintain gutters, spouts, and leader pipes. Build up the landscape grading against the foundation and cut a significant swale in the rear of the rear yard to handle the hillside runoff, and channel it around the home to the street below. As a result, the client was satisfied and paid me. He implemented the work and the problem was resolved. ■
