Decayed Deck Just a Symptom

by John Leeke

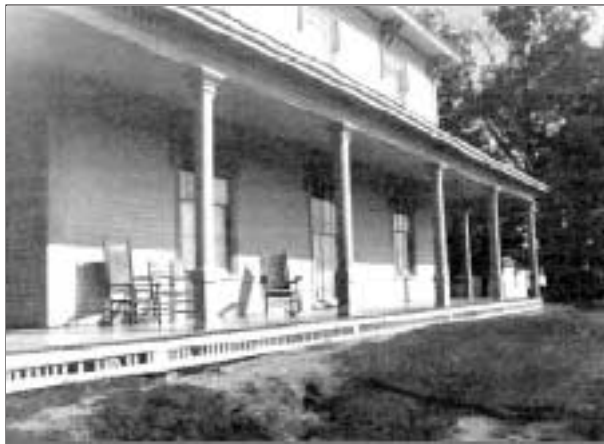
When I looked the situation over, I found the problems with the deck were only a symptom of amore serious drainage problem. It turns out that 20 or 30 years ago the built-in gutters of the main house and porch roof had been covered over during reroofing. Without gutters, all the water collected by the roof dripped on the deck boards below. This water, which sometimes came down in a heavy flow, also eroded the terrace at the edge of the porch (see Figure 1). When water built up on the terrace, it flowed under the porch and washed dirt into the cellar through the stone foundation. Since the porch wraps around three sides of the house, 75 percent of the foundation was affected.

Figure 1. When built-in gutters were roofed over years ago, water flowed from the roof's edge, eroding the terrace.

The drainage work included restoring the original built-in gutters (or use attached half-round metal gutters) and regrading under the porch to eliminate the reverse grade. This improved air circulation, which would keep the deck boards dry (see Figure 3). Restoring the terrace to its original profile was the part of the work that was most visible.

involved grading off a ridge of deposits caused by water dripping from the porch roof above. Then a clayish loam was packed into the eroded gullies. Finally matching sod from another section of the lawn was cut and fit to hold the bare sections of the steep slope in place.

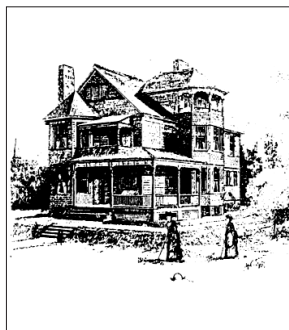
When terraces like the one on this house were originally built, they were quite straight and level with flat plane surfaces and sharp, crisp edges. Over the years the sharp edges became rounded. But no matter how rounded the edges or eroded the embankment, you can always tell a terrace by the way the ridges follow the plan outline of the building (see Figures 1 and 2). Rebuilding the eroded terrace

Figure 2. Typical of 19th-century Italian and Queen Anne-style architecture, the terrace sets the building up on its own little hill and emphasizes the vertical aspect of these style buildings.
