# Keeping Scaffolds Safe

by Paul Fisette

**Scaffold failures injure thousands every year. In many cases, low-grade or damaged wooden planks are to blame.**

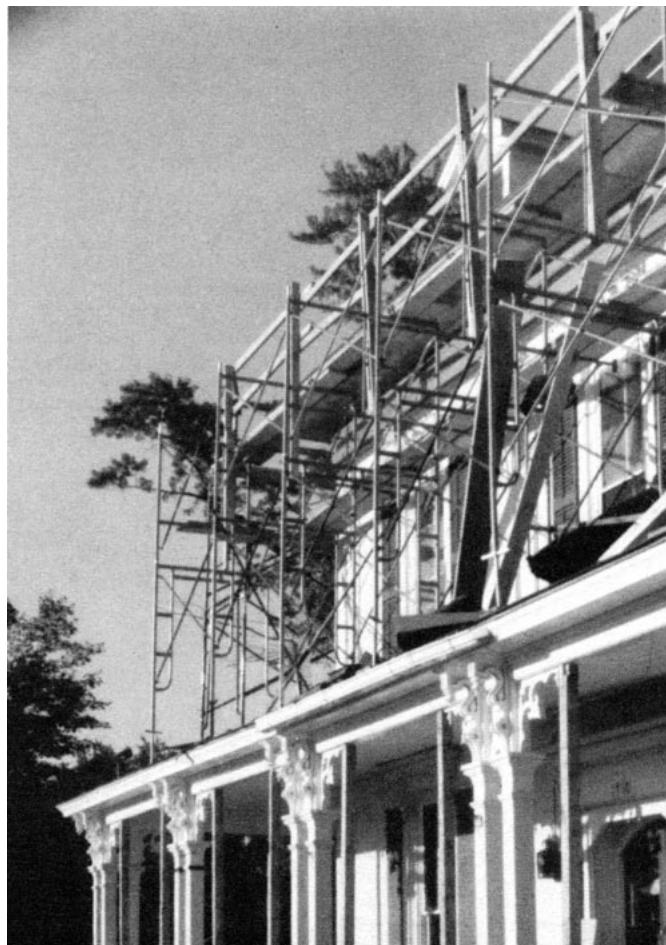
*Storing scaffold planks outdoors will cause them to deteriorate from rot and mold. They should be kept in the dry and stickered.*

Other cases where legitimate scaffold-grade planks have failed point to misuse as the cause of injury. In one failure, decay was found when the plank's fracture was microscopically analyzed. Later it was learned that the general contractor stored the

planks outdoors under a plastic tarp.

Wooden planks should be stored indoors, and should be stickered so air can circulate around the planks. Wood will rot when relative humidity reaches 80%. Stacking planks outdoors and wrapping them in plastic provides fungi with a cozy environment. Avoid this practice; it can be deadly.

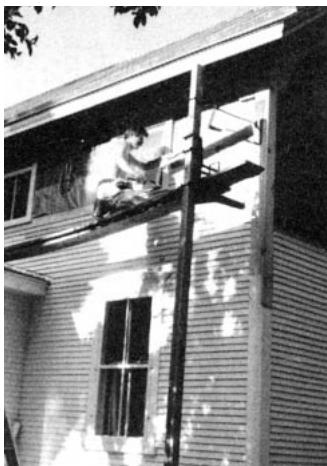
Pump jacks are popular because they're inexpensive and set up quickly. Many setups, however, like this one, contain safety violations: no guard rail, undersized planks, and no support at the bottom. OSHA requirements for pump jack setup are shown below.

OSHA insists that pump poles must be spaced less than 10 feet apart when wooden planks are used. Typically, builders purchase 16-foot planks and space the poles 14 feet apart. Seldom are the prescribed guardrails, midrails, and endrails, and

toeboards installed on residential applications. Poles must be braced at the top, bottom, and every 10 feet along the height of the pole. And the plank ends must be secured to the pump foot. Have you done this lately?

Poles are a weak link in pump staging. They should be made from full-length, doubled Douglas fir 2x4s (or equivalent) that are *straight-grained, clear, and free of cross-grain*. In cases where a pump-jack pole has to be longer than available 2x4 stock, OSHA regulations specify that the spliced poles must develop the full

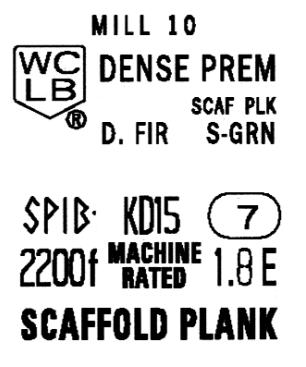
When buying scaffold planks, insist on scaffold grade lumber. Look for the grade stamp, such as these by the West Coast Lumber Inspection Bureau and the Southern Pine Inspection Bureau, or ask to see a certification document indicating a scaffold grade.

**Material selection.** Call the lumberyard and order scaffold planks for your next job. If you live in the Northeast, full-sized, rough-milled 2x10 spruce planks are likely to arrive at the job site. But don't use them. Planks can be dangerous unless they are stamped with a scaffold grade stamp. The Northeastern Lumber Manufacturers Association (NELMA), the primary lumber grading agency in the Northeast, does not publish a scaffold grade. Therefore, many builders in this region use No. 2 spruce as a substitute. Number 2 of any species, however, is not good enough! Other grading agencies such as West Coast Lumber Inspection Bureau (WCLB), Western Wood Products Association (WWPA), and Southern Pine Inspection Bureau (SPIB) include scaffold grades in their rules. Insist on scaffold grade material when you order planks. They should be grade-stamped, indicating OSHA's approval.
