Working the Bugs Out of High-Efficiency HVAC

After years of spotty performance, high-efficiency heating and cooling may have licked the reliability problem

by J.D. Ned Nisson

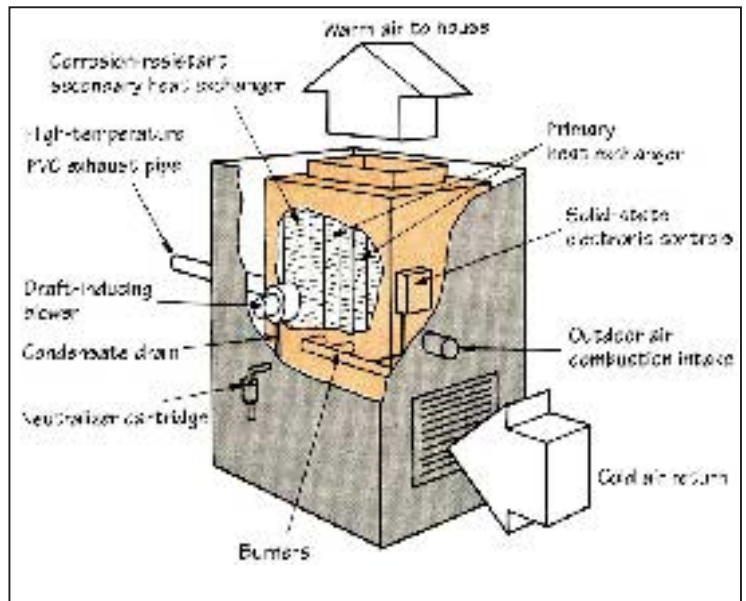
Figure 1: Look inside a high-efficiency furnace and you'll see components not found in low- and mid-efficiency models. The draft-inducing blower plays a key role, drawing air into the combustion chamber for more efficient controlled combustion, then forcing the hot air through the primary and secondary heat exchangers for maximum heat transfer. As the combustion air passes through the secondary heat exchanger it cools to the point where moisture condenses, releasing another burst of heat.

Gas furnaces, on the other hand, have had a long and bumpy journey to high efficiency. Several new major components were added, including secondary heat exchangers, draft inducers, and electric ignition (see Figure 1). Some of the mechanical components in early models were poorly designed and failed regularly. A few models, such as the Amana Energy Command and Lennox Pulse used totally new technology with almost no resemblance to "conventional" furnaces.

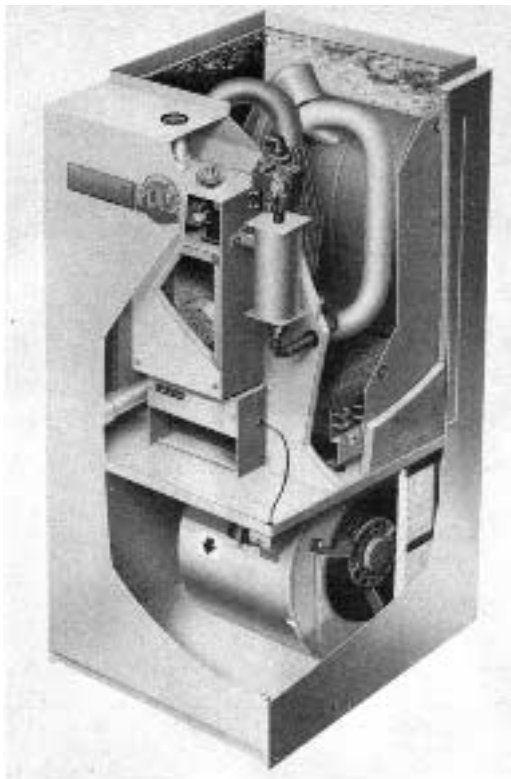
Figure 2. After early problems with noise, the Lennox Pulse turned out to be one of the biggest success stories in high-efficiency hvac.

one of the biggest success stories in high-efficiency hvac (see Figure 2). The first ten years of development, from 1980 to 1990, were fraught with factory recalls, contractor call-backs, and dissatisfied consumers who complained of nuisance shutdowns, noise problems, and poor comfort. Some homeowners even (unfairly) blamed their high-efficiency furnaces for moisture and indoor air quality problems.

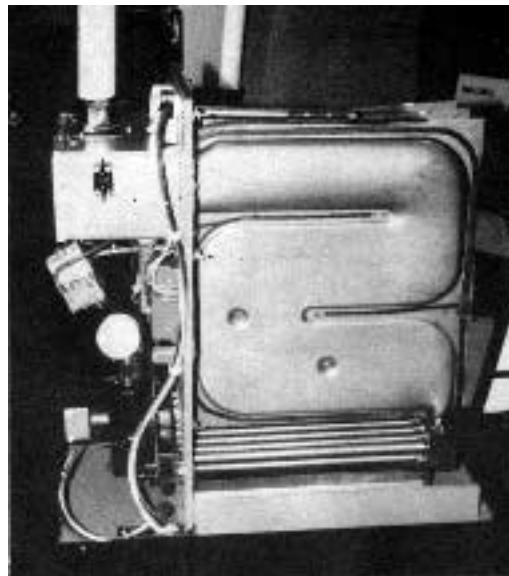
Figure 3. The Yukon oil furnace, one of only two condensing oil furnaces on the market, uses highly resistant (and very expensive) AL29-4C stainless steel for the secondary heat exchanger and 301 stainless steel for the primary.

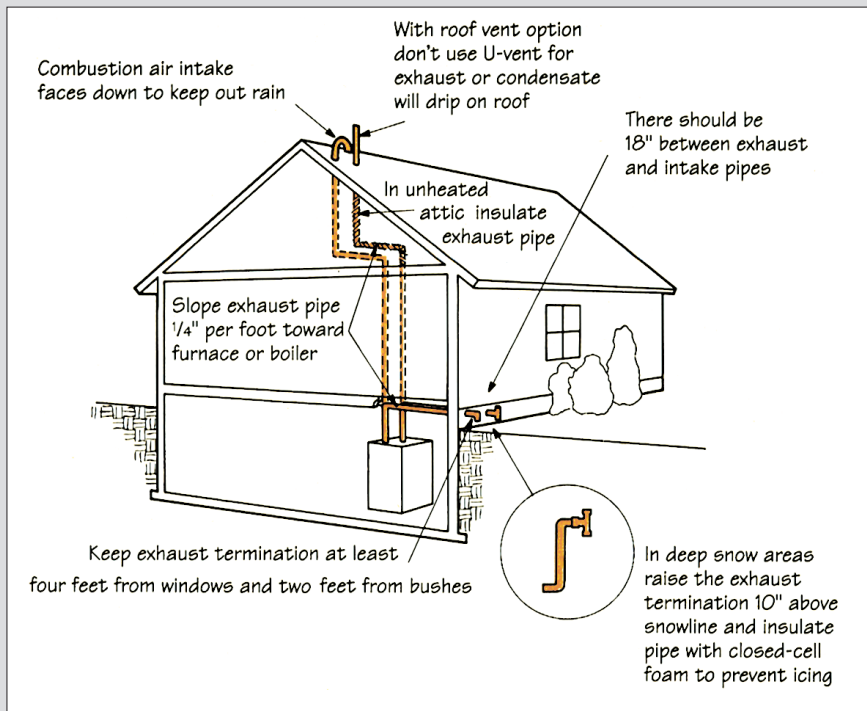
By following a few basic guidelines, most of the annoying problems associated with venting high-efficiency furnaces and boilers can be eliminated.

- Keep vent runs as short as possible. Never exceed manufacturers' guidelines (typically 30 to 40 feet with two elbows).
- On horizontal runs, the vent pipe must slope toward the furnace, allowing condensate to drain back into the furnace.

- Keep the exhaust termination 10 inches from the wall to reduce icing on the wall and to prevent paint damage. If the vent faces prevailing winds, install a protective plate around the termination to protect the wall.

- Maintain about a 2-foot clearance from shrubbery.
- Never use a "U" termination on a roof vent. Dripping condensate can damage roofing and gutters. The roof vent should be a straight vertical pipe. Rain will not be a problem since it will drain through the condensate drain.

- Insulate any section of vent pipe that passes through unheated spaces or extends more than 3 feet outdoors. The vent pipe should also be insulated if an exterior masonry chimney is used as a chase.

- Do not install exhaust vents over anything that cannot tolerate dripping condensate. This includes walkways, windows, air conditioners, gas meters, etc.

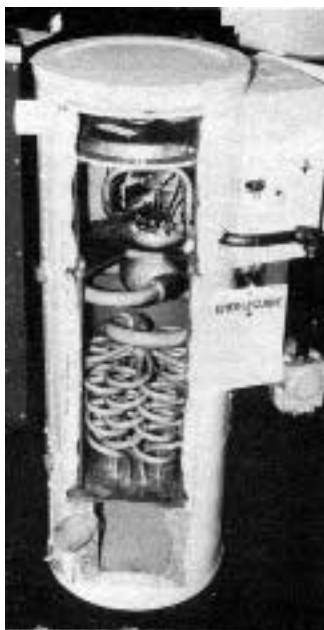
Figure 4. The Hydropulse is the first and only residential pulse boiler. Like its furnace cousin, the Lennox Pulse, it has enjoyed a relatively trouble-free history.

Despite some radical departures from conventional design, high-efficiency boilers have been relatively trouble free (see Figure 4). One nagging problem that plagued the first high-efficiency systems was condensate formation in the heat exchangers and flue pipes.

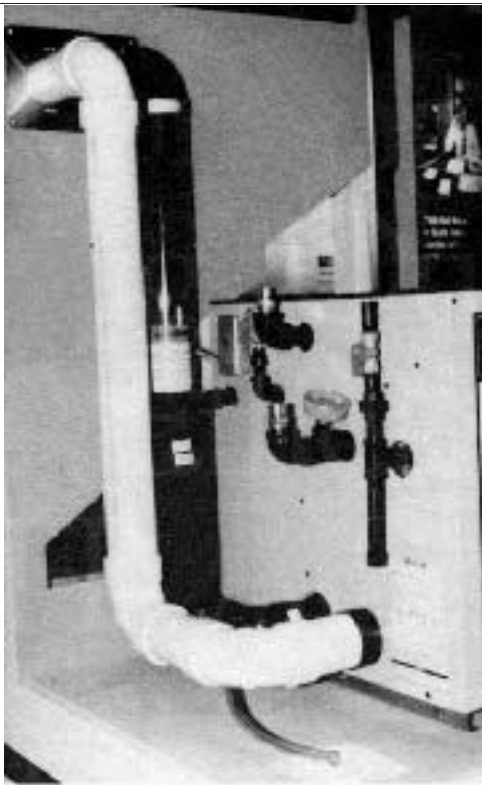
Figure 5. Corrosion-free venting. To prevent corrosion in a high-efficiency boiler, such as the Weil McLain GV model shown here, the venting system must be Ultravent or Plexvent high-temperature plastic vent pipe (the black pipe in the photo). Made of GE Ultem plastic, these vent systems can withstand temperatures up to 480°F. The white pipe is the fresh air intake, which is made of ordinary Schedule 40 PVC.

To eliminate flue corrosion, literally every manufacturer now recommends high-temperature plastic flue pipe made of GE "Utem" resin (see Figure 5, next page). Some manufac-

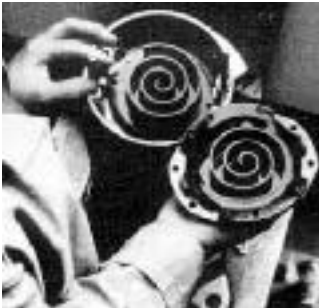
Figure 6. The new Copeland Compliant Scroll compressor is more efficient and reliable than conventional piston compressors. Most major heat pump manufacturers now sell models equipped with scroll compressors.

The most noteworthy development was the scroll compressor (see Figure 6, next page), which was first introduced by Lennox in 1987 in its HP-20 heat pump. Most of the other major equipment manufacturers quickly followed. Using far fewer parts than conventional piston-type compressors, scroll
