# AFTER THE STORM: HARD-WON LESSONS

**DESPITE THE HELLISH WINDS,  
EXPERTS AGREE THAT MUCH  
OF THE DAMAGE FROM  
HURRICANE ANDREW WAS  
PREVENTABLE.**

**STRICTER AND CLEARER CODES  
AND BETTER TRAINING OF  
BUILDERS AND INSPECTORS  
ARE NEEDED TO AVERT  
DISASTER NEXT TIME.**

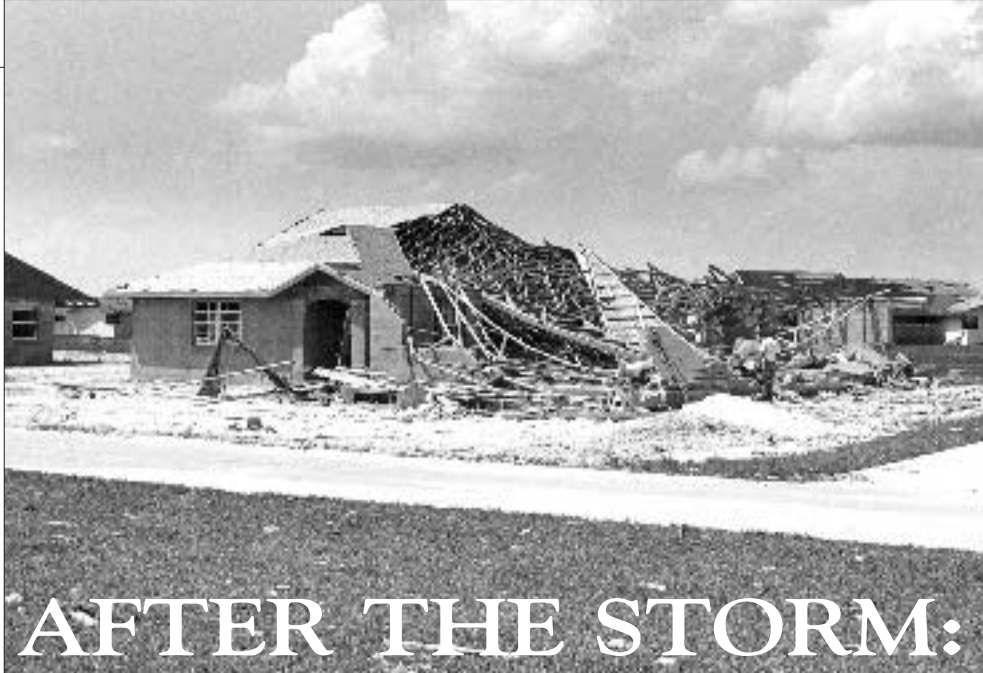
*In many cases, once the roof's gable ends had buckled, the neighboring trusses collapsed like dominoes. New nailing specs for roof sheathing and better details for truss blocking aim to avert such damage in the future.*

In many cases, once the gable end of the house had buckled, the whole truss system folded in on itself like an accordion (see photo, page 27). Structural experts agree that much of this additional damage would have been averted had there been sufficient blocking between the trusses, especially in the first two spaces nearest the gable end. Installed and nailed properly, such blocking would increase the diaphragm action of the two roof planes and ceiling plane, thereby strengthening the trussed roof structure (Figure 4, next page).
