A Retrofit Ridge Beam

A giant LVL ridge beam solved the roof load problems on this two-story addition

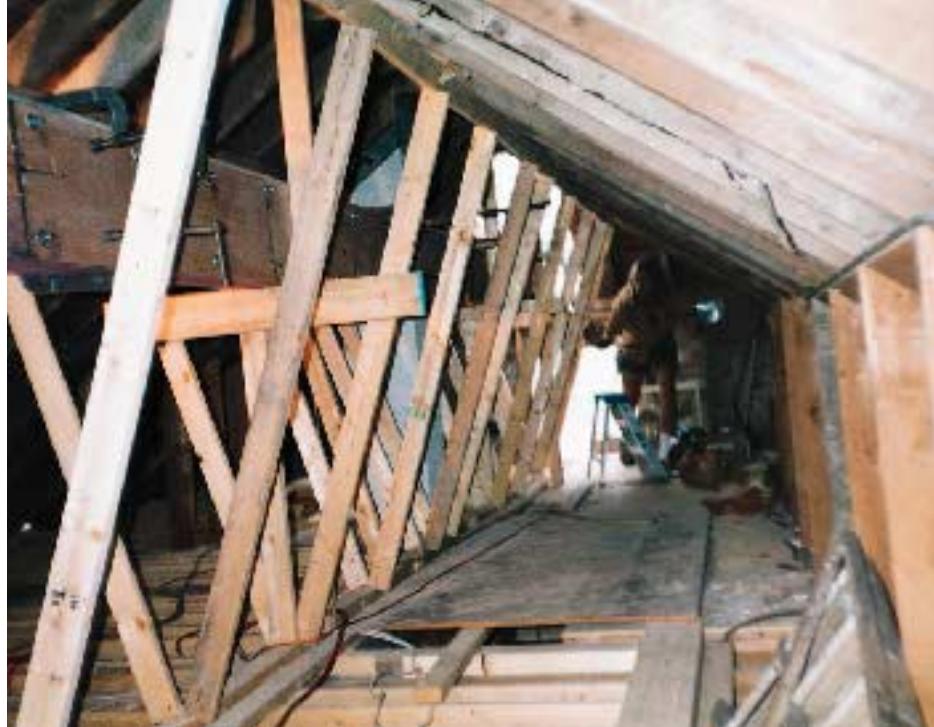
Before cutting away the peak of the existing roof, the authors built angled kneewalls on each side of the ridge. With horizontal 2x4s nailed across them, the kneewalls also served to support the built-up LVL beam while it was bolted together and lifted.

To support the LVLs, we installed some waist-high horizontal 2x4s across every fourth or fifth pair of kneewall studs. That way, we could slide the individual LVLs off the lift truck right onto this 2x4 cradle, where we could assemble the beam for final lifting.

We also installed vertical 2x4s between the horizontal ones and the rafters to prevent the beam from rolling as we lifted. This kept the raising of the now 900-pound beam safe, accurate, and calm. We used hydraulic jacks, one on each end, to slowly raise the beam. As the beam went up, we nailed additional temporary horizontal supports right below the beam as an extra precaution.

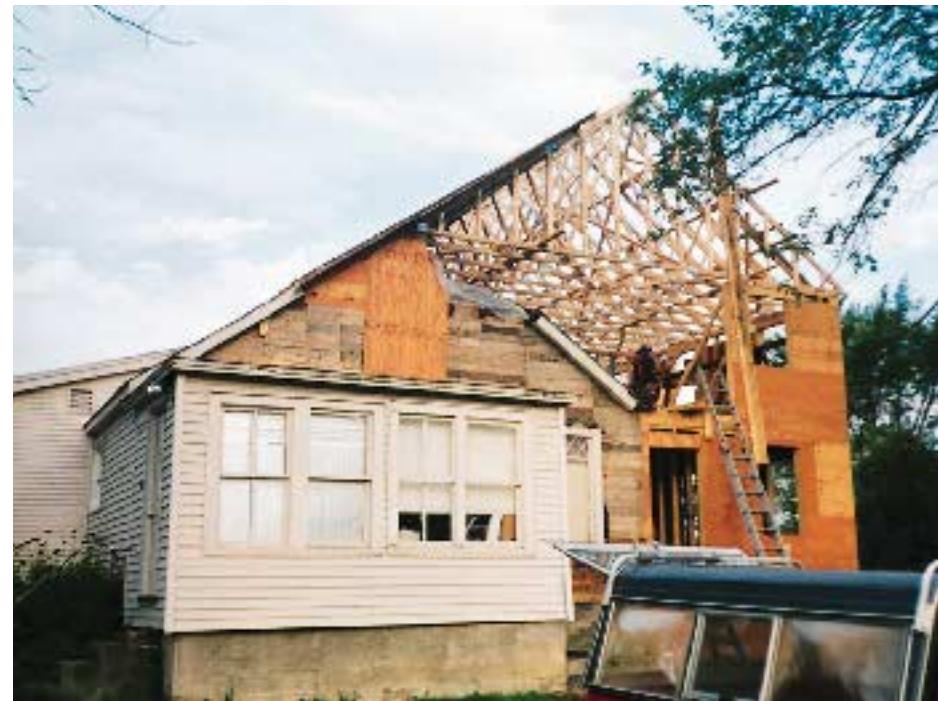
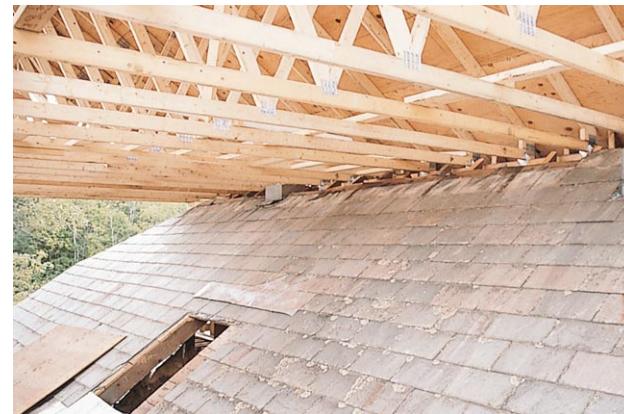
Plywood sheathing spanned the joint between the old roof and the new, tying the two sides together (above). Only a course or two of slates had to be removed to set the trusses (left), leaving the health center below protected.

In preparation for the trusses, we had to remove only a course or two of slates and about a foot of board sheathing along the ridge, which was easily protected from the weather. We were able to set and brace all the trusses in one day, then apply enough plywood and felt paper to protect the junction of the new and old roofs. That day made all of the work in the attic worthwhile.

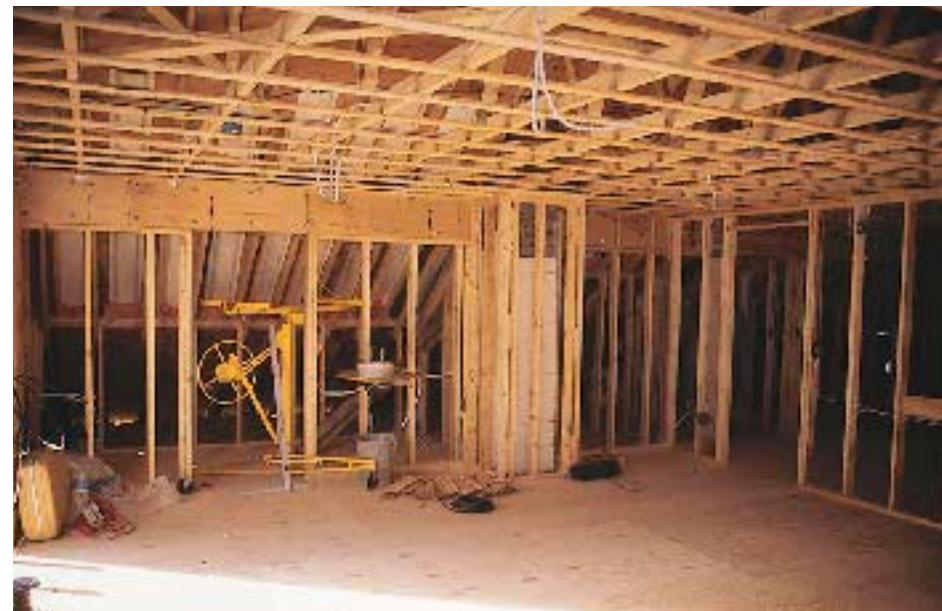
Reclaiming half the existing attic added more than 300 square feet to the renovated building's living space.
