# REPLACING A Main Carrying Beam

by Will Schwarz

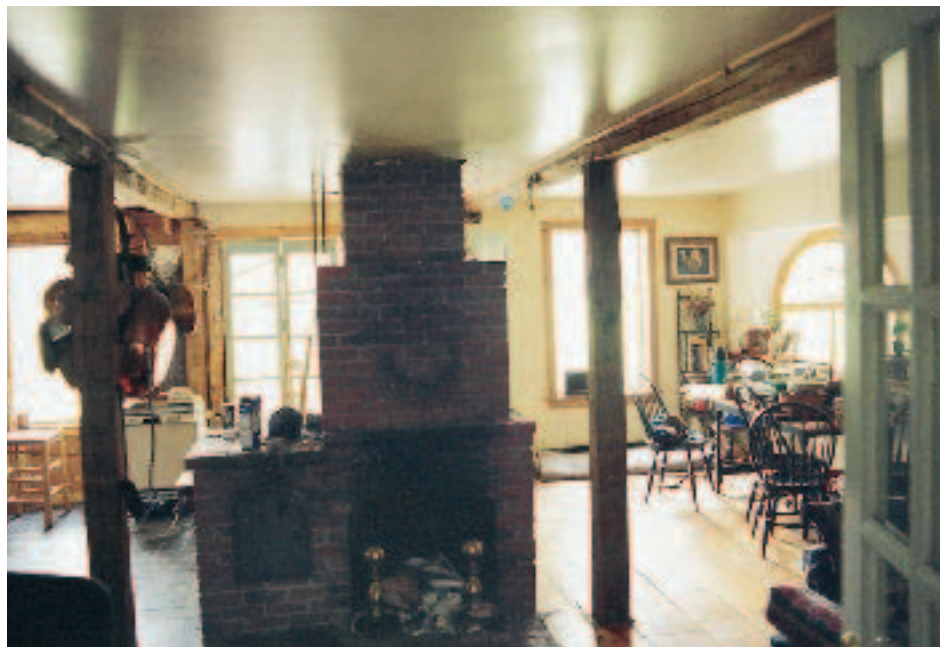
**Figure 1.** The 8x8 carrying beams were spliced over posts that interfered with the design for a kitchen addition and dining room renovation. To avoid the demolition and rigging required to replace the sagging 8x8s with steel, the author opted for built-up replacement beams made of LVLs fastened together in place.

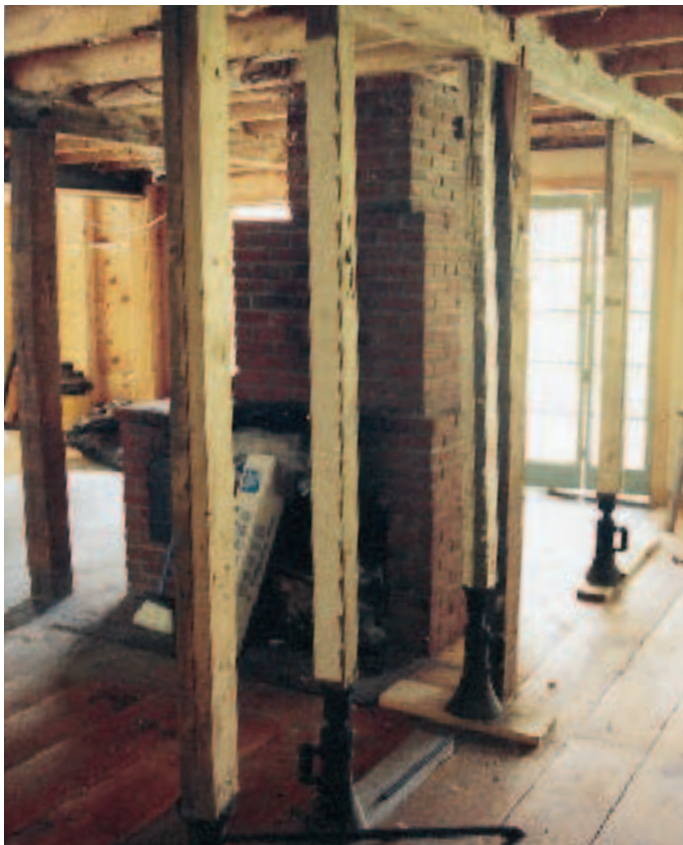
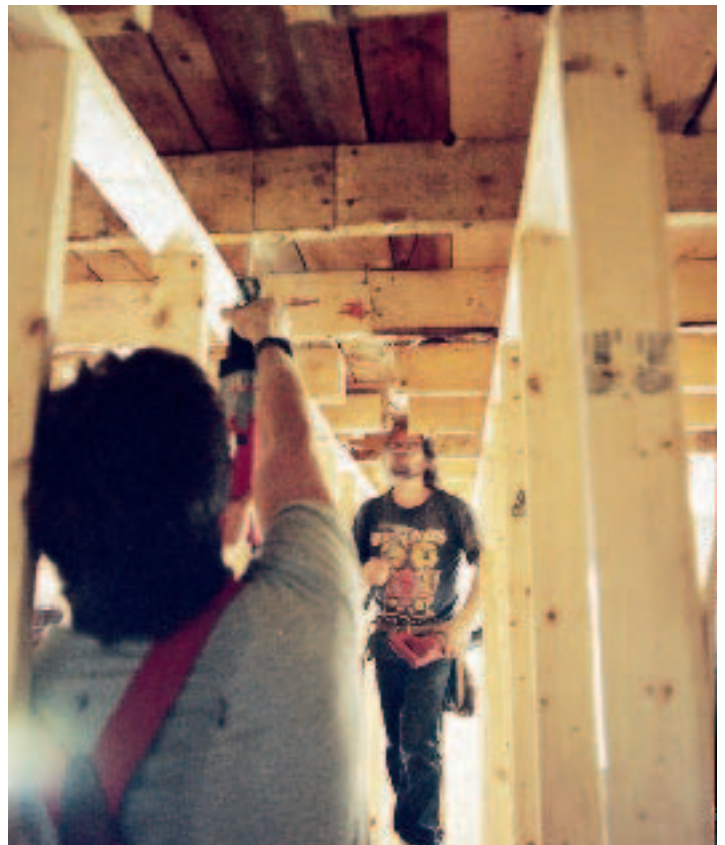
**Figure 2.** The old beams were first jacked to within  $\frac{3}{8}$  inch of level (left), then a temporary 2x4 bearing wall was built on either side, with each stud aligned directly under a second-floor joist (right). To maximize headroom, a section of each existing joist was cut out to make room for an inset  $5\frac{1}{4}$ -inch-wide by 14-inch-deep LVL beam.

Since there was quite a bit of sag in the existing wood beams, we used screw jacks to raise them to near level before installing the temporary bracing system (Figure 2). To temporarily support the second floor framing, we built a makeshift 2x4 bearing wall, placing each stud directly under each joist and bracing the studs diagonally. No additional shoring was needed below the first-floor joists because the walls were nearly aligned over bearing walls in the basement. With the second-floor joists securely supported, we took away the screw jacks, and used a metal-cutting blade in a recip saw to cut off the nails that held the ceiling joists to the old beams. Since the beams were spliced, the 8x8s dropped right out when we knocked out the old posts.

much deeper than the 8x8s that supported the ceiling joists. To reinstall them as “dropped” beams would have left too little headroom, so we decided to cut out a portion of each joist and install the new beams flush with the underside of the second-floor subflooring. We snapped full-length chalk lines on the bottom of the joists to mark the position of both sides of each new beam, then used a reciprocating saw to cut out the joist material between the marks. We allowed an extra 1/2 inch in width for clearance to make it easier to slide the LVLs into place.

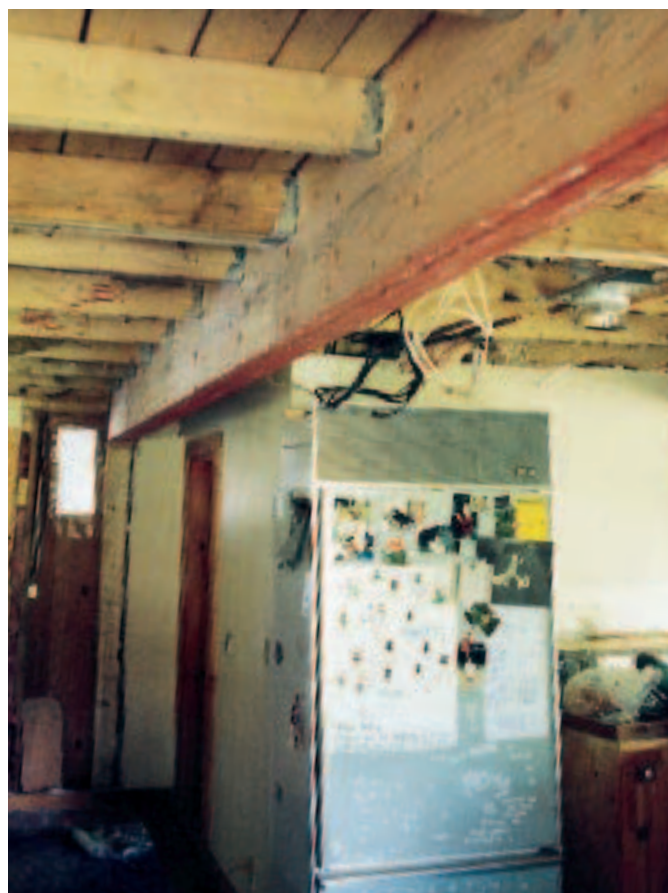
**Figure 3.** The LVLs were cut to length outside, slid through an access hole cut in the exterior wall, and nailed together in place. The steel hangers used to fasten the existing joists to the new beams made for a sleek appearance when the beams were wrapped in drywall.

We cut the LVLs to length outside, then slid them one at a time into position through the access hole in the exterior wall, nailing them off in place. The nailing was a little difficult because the temporary support system was in our way; next time, we’ll keep it farther back from the beam pocket to provide more room to work. When the new beams were completely nailed together, we jacked them tight against the subfloor above, and shimmed each end with hardwood wedges.

new beams, but opted instead for metal hangers (Figure 3). Since the beams were eventually boxed with drywall, using hangers produced a cleaner final appearance. Otherwise, we would have had to rock around the cleat or fur out the LVLs  $1\frac{1}{2}$  inches on each side; either way, the beams would have looked too bulky.
