Seismic Support for Old Foundations

by John Scoggins

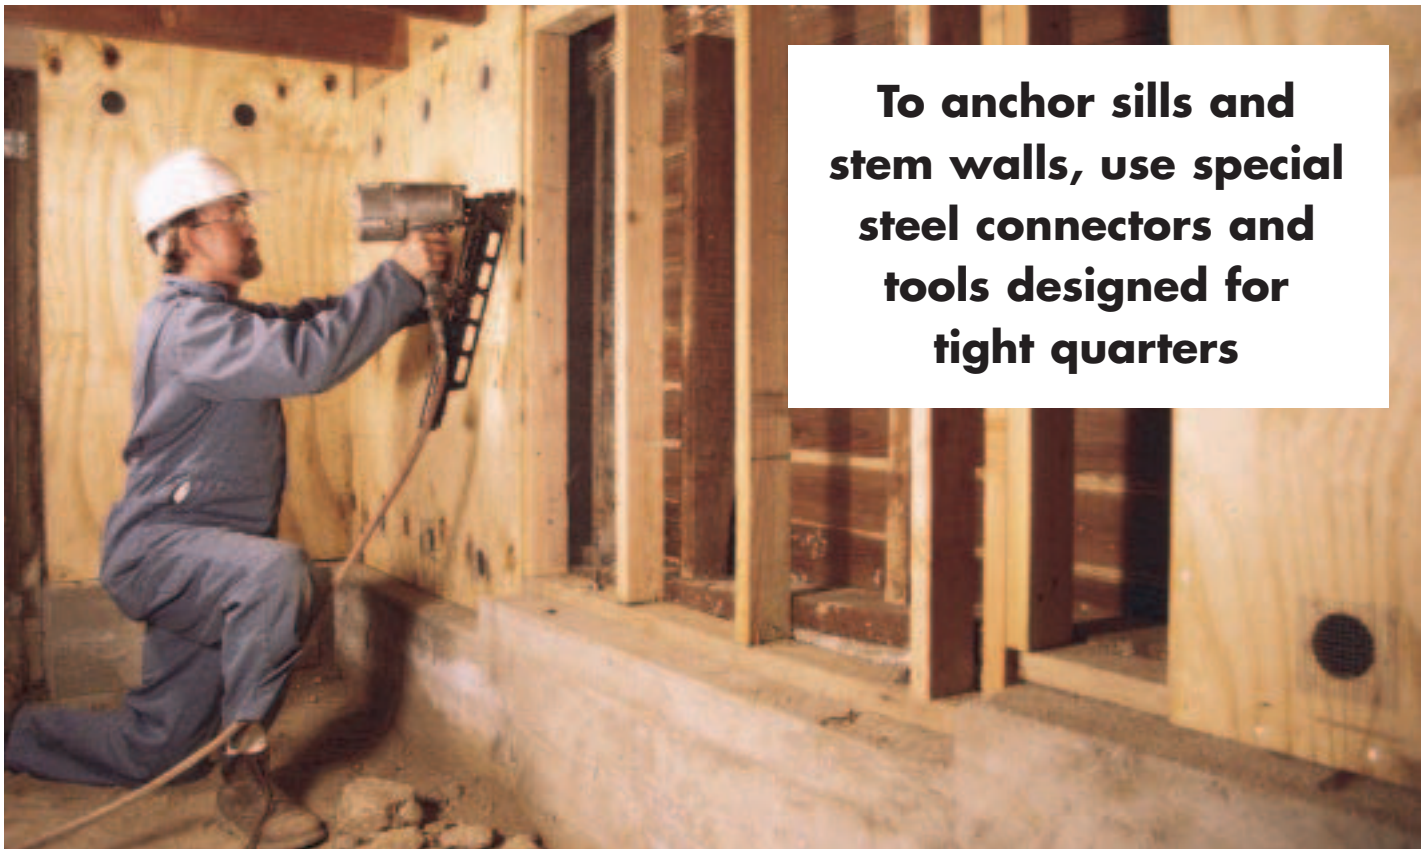
To anchor sills and stem walls, use special steel connectors and tools designed for tight quarters

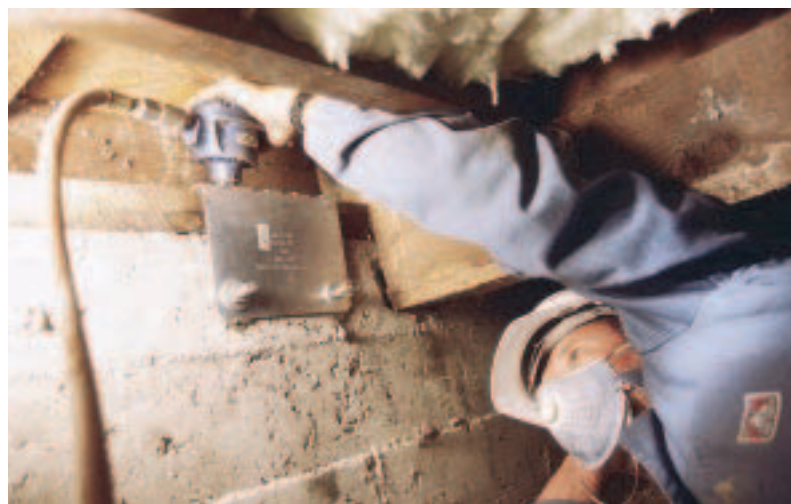
Figure 2. The Simpson FA series anchors are useful in tight quarters for anchoring the mudsill to the foundation wall. The side plate bolts to the foundation wall with epoxied threaded rod; the top can be nailed with a palm nailer.

Occasionally, we get lucky and find that the floor is framed with 2x12 joists. This gives us enough room to use our Hilti TE15 right-angle hammer drill in the restricted area between floor and plate. Then we can drop in an epoxied threaded-rod anchor or a Simpson RFB retrofit bolt. More often, however, the joists are smaller, so we have to use a Simpson FA6 or FA8, an L-shaped 12-gauge steel connector that rests on top of the plate and laps over the side of the stem wall (Figure 2). This configuration allows us to drill into the concrete horizontally, instead of having to position the drill upright. The top of the FA anchor can be nailed to the plate with a pneumatic palm nailer.

These FA anchors aren't cheap; they cost around \$6 to \$8 each, so we try to limit the number we use. Plus, they require us to drill two holes, whereas dropping in threaded rod requires only one hole. But in tight quarters, there's no better choice.

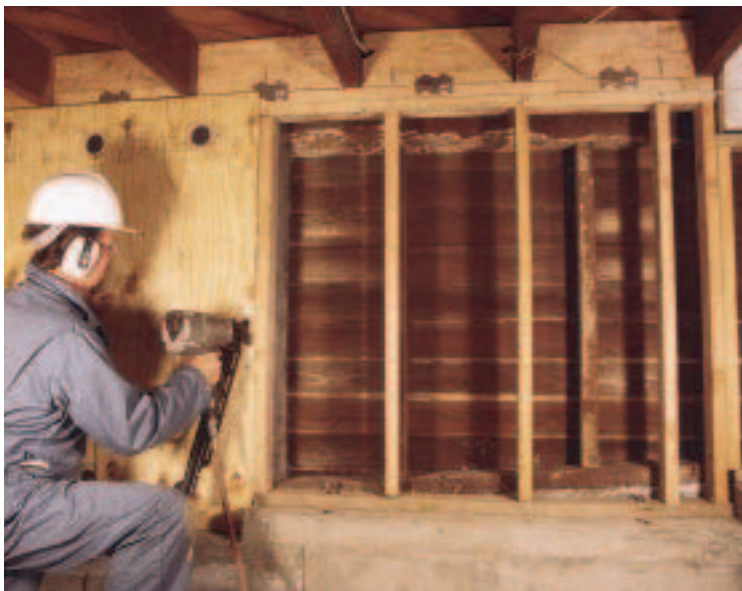
Pouring a New Stem Wall

Figure 3. In cases where the old foundation is too weak to hold anchors, it's necessary to pour a new wall. In the case shown here, a new stepped stem wall was poured tight to the existing one, with new cripple walls built on top. Simpson A35F clips secure the cripple wall to solid blocking between the floor joists above (see photo).

One alternative was to raise the house on large steel I-beams, remove the existing foundation, then form and pour a new one — an expensive proposition. But once we determined that the existing floor was level, we decided instead to pour a new stepped foundation tight to the inside of the existing one (Figure 3).

We first excavated for a new footing, slightly “undermining” the existing footing. Then we drilled and placed #4 rebar dowels in the old stem wall on 4-foot centers. In the new footing trench, we installed continuous #4 rebar around the perimeter, and attached it to the dowels with short vertical pieces of rebar.

After pouring the new foundation, we plated and framed new cripple walls around the perimeter. These were bolted to the new foundation with standard 5/8-inch J-bolts. To connect the floor to the new cripple wall, we blocked between the existing floor joists directly over the cripple wall and used Simpson A35F metal brackets to connect the blocking to the double top plates. We covered the cripple wall with 1/2-inch structural-1 plywood edge-nailed 6 inches on-center, with 12-inch centers in the field.

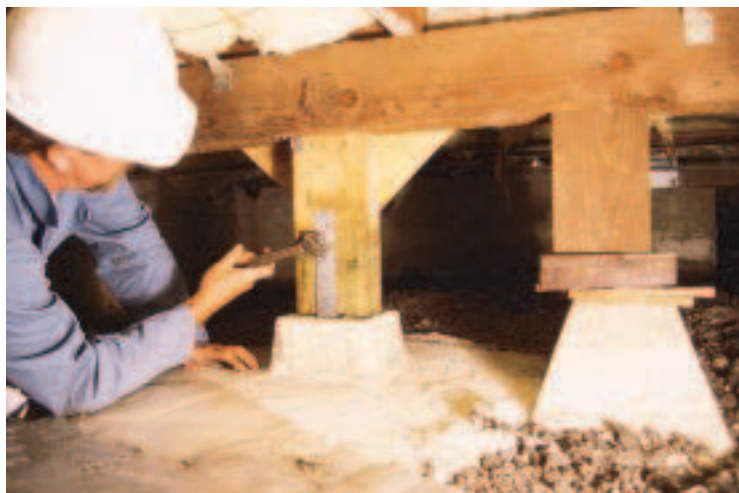
Reinforced Post Footing

Figure 4. New post-and-pier supports are built in place using precast pier blocks set in a 2-foot-square concrete footing. Note how the original post, at right in the photo, has no mechanical anchorage.

Many of the houses we work on have a center girder supported by a series of posts and piers. The posts are typically resting on the piers with no mechanical anchor and are attached to the girders above with nails only. In that case, we install new 2-foot-square by 1-foot-deep pier footings between existing posts. We also replace any posts located under girder splices.

#4 rebar pieces beneath a precast block that comes with embedded straps for attaching to the post (Figure 4). After pouring the new piers, we install new posts, strapped at the bottom and connected at the top with a plywood gusset. Finally, we use Simpson H-series clips to tie the floor joists to the girders. ■
