Troubleshooting Roof Leaks

Careful
flashing at
penetrations
and edges
can prevent
most roof
leaks

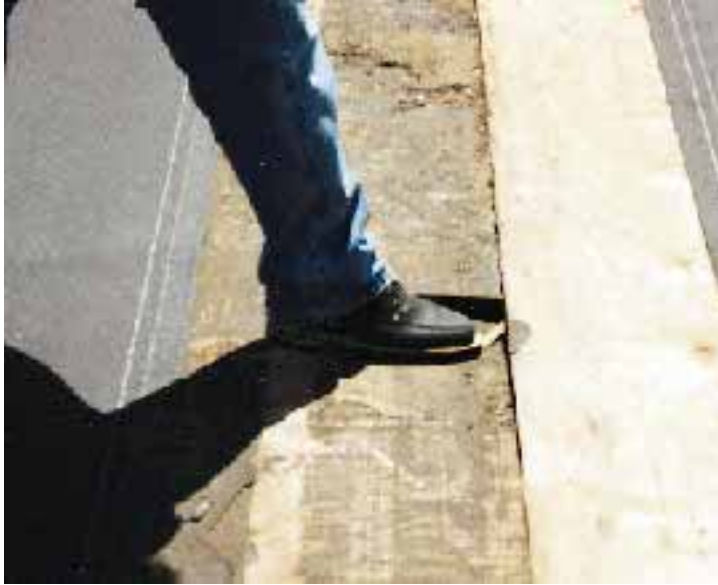
Problem: *No support at sheathing edges.* The plywood sheathing on this flat roof was installed without blocking under the edges. If someone walks on the roof, the roofing may crack when the sheathing flexes at the plywood joints.

Solution: *Use H-clips or solid blocking* at plywood edges, or use tongue-and-groove plywood roof sheathing.

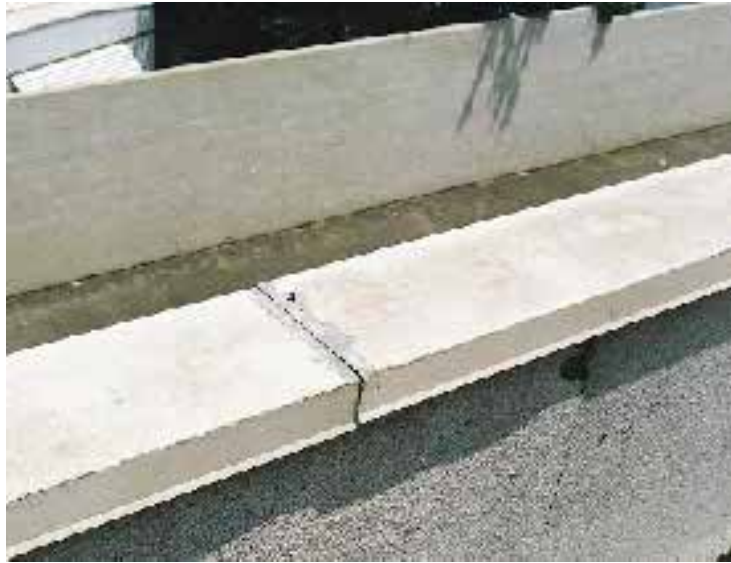
Problem: *Flashing is incorrectly fastened.* There are three problems with the coping flashing on this parapet wall:

- The flashing has been fastened on the horizontal face, instead of the vertical.
- The flashing has been nailed instead of screwed.
- No allowance has been made for expansion and contraction of the metal flashing, nor for differential movement between the metal flashing and the wood nailer, which expand at different rates.

An exposed fastener on the horizontal surface of the flashing is a potential leakage point. If flashing is attached with nails instead of screws, the last hammer blow can leave a concave dimple in the flashing, encouraging ponding around the nail hole.

If long runs of flashing are installed without allowing for expansion and contraction, the moving flashing can work nails back and forth until they loosen.

Attach flashing on a vertical surface rather than a horizontal surface.

Use hex-head screws with neoprene washers rather than nails if it is necessary to use exposed fasteners.

Install fasteners in slotted holes, which allow the flashing to move with changes in temperature.

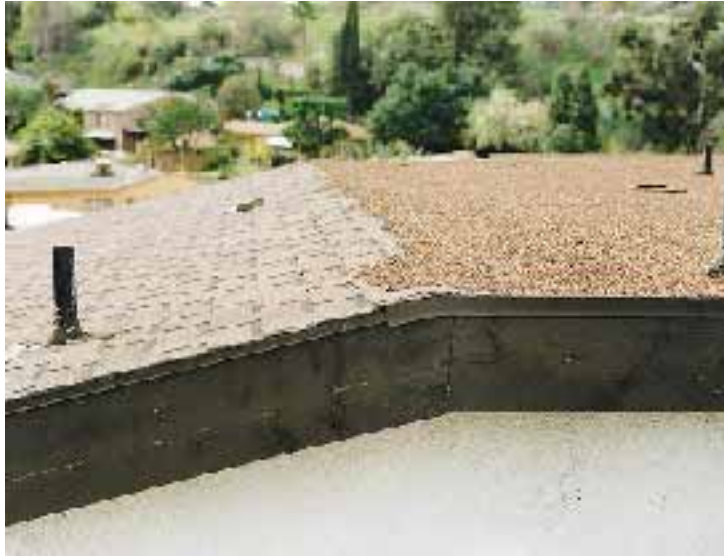
Problem: Because no gravel stop was installed, the asphalt flood coat and the roofing gravel are migrating down the face of the shingle roof.

Solution: Install a $\frac{3}{4}$ -inch-high sheet-metal gravel stop, with a flange at least 4 inches wide, under the edge of the built-up roofing. The stop should also include a bottom flange, extending at least 4 inches over the top course of asphalt shingles.

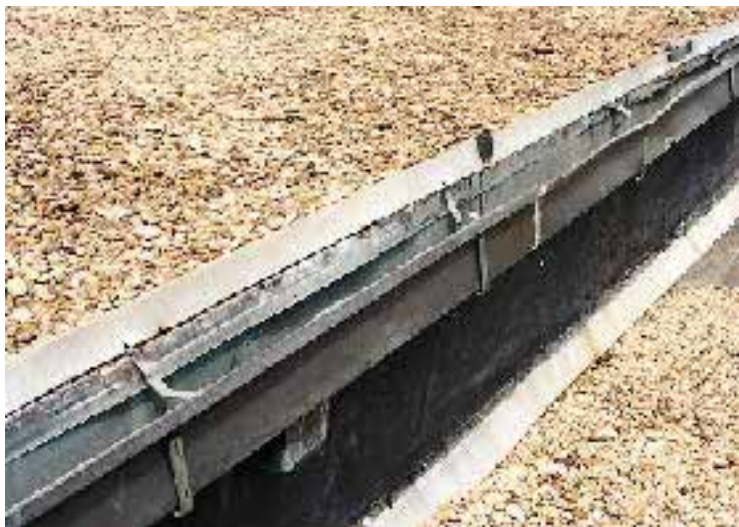
Problem: Edge flashing was **not nailed**. The installer forgot to attach the edge flashing to the roof before the built-up roofing was installed. When the roofing material later contracted, it pulled the entire flashing away from the edge of the roof.

Solution: Don't forget to **fasten the flashing** to the sheathing or nailer with nails or screws.

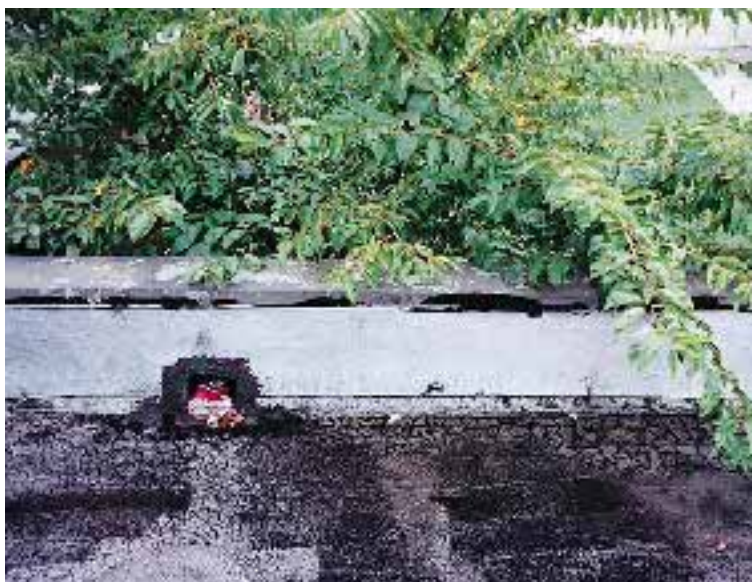
Problem: *No overflow scupper.* The parapet wall around this roof has only one scupper on each side, with no overflow scupper. If the primary scupper becomes blocked — by a tennis ball, for example, or in this case, a soda can — then not only are leaks likely to occur, but ponding water on the roof could get heavy enough to threaten the structural integrity of the roof framing.

Solution: *Install a secondary scupper 2 inches higher than the primary scupper to drain excess water in case the primary scupper becomes blocked.*

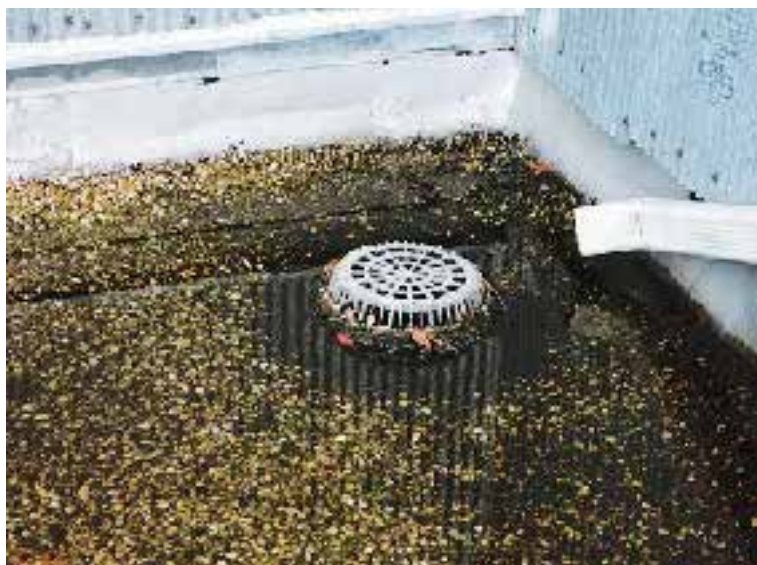
Problem: *Clogged roof drain.* Failure to clear away leaves from a drain strainer can cause ponding.

Solution: *Remind homeowners to check roof drains and scuppers regularly, and to clean them at least once a year — preferably more often. An overflow scupper is needed here, as well — no roof should ever depend upon a single drain.*

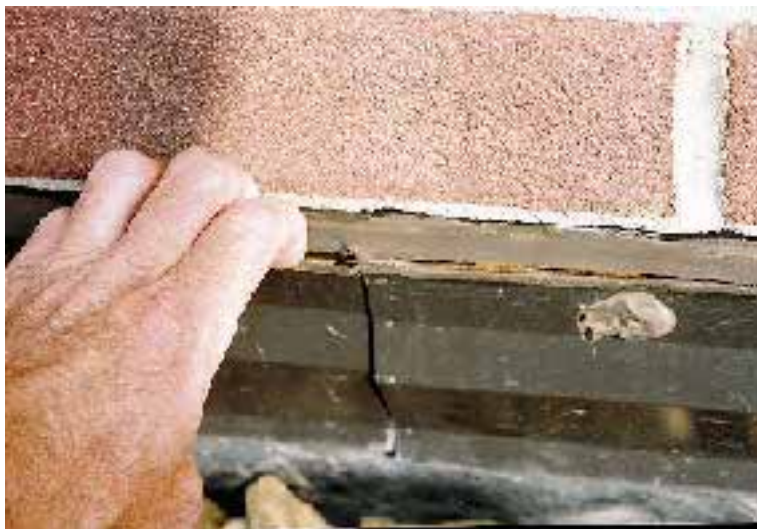
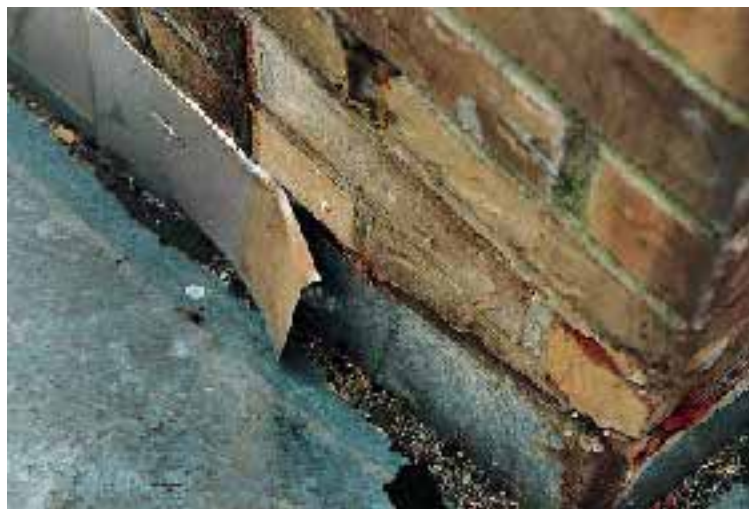
Problem: Counterflashing is pulling away from the chimney. In the top photo, expansion and contraction have caused a failure of the caulk used to seal the surface-mounted counterflashing to the chimney. In the bottom photo, a too-shallow flange in the counterflashing has allowed water to get behind the flashing when the brick gets saturated in a heavy rain.

Solution: Install the counterflashing between courses of brick as the chimney is being laid up. The minimum width flange for counterflashing inserted into a brick chimney is 1 1/4 inches.

For existing masonry, cut a 1 1/2-inch-deep kerf into a mortar joint with an abrasive blade. Run a bead of caulk along a 1/4-inch hem turned up on the back edge of the flange, then slide the flange into the kerf. The hem will compress slightly, holding the flange in place. Finally, caulk the top of the flange where it enters the kerf to keep excess water out.

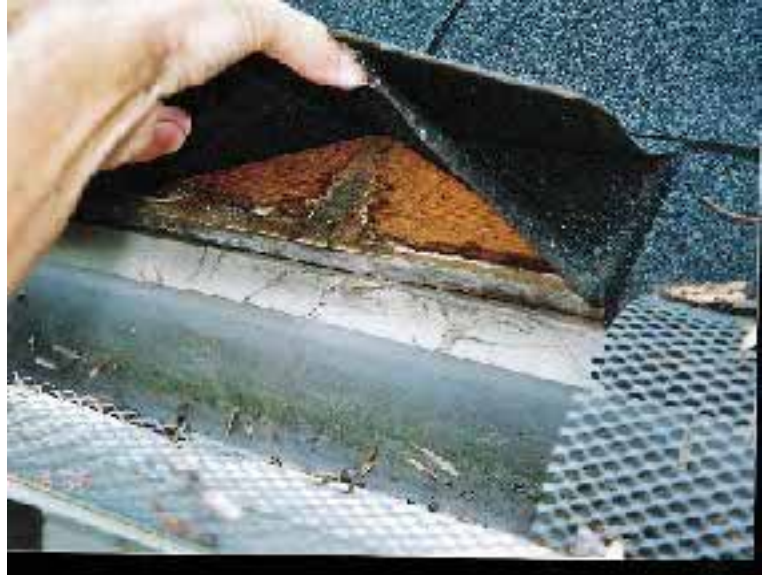
Problem: *Felt underlayment incorrectly lapped* under (instead of over) the metal drip edge. Any water that may get under the shingles — for instance, from wind-driven rain — should be carried by the felt underlayment over the top of the drip edge.

Solution: *Lap the felt underlayment over the drip edge.*

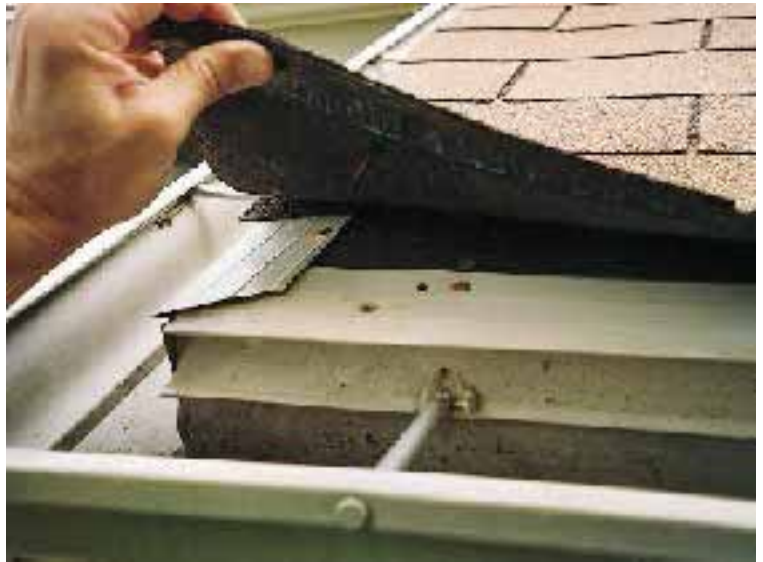
Problem: Valley shingles were not tabbed or spotted with roofing cement. The large volume of water that collects in a valley can back up under uncemented shingles.

Solution: In a closed valley, embed valley shingles in roofing cement. Always clip the top corner of the valley shingles at a 45-degree angle. This prevents debris from getting caught in the shingles and accumulating in the valley, and it also directs water toward the valley centerline. For extra protection, install a self-adhering eaves membrane under valleys.

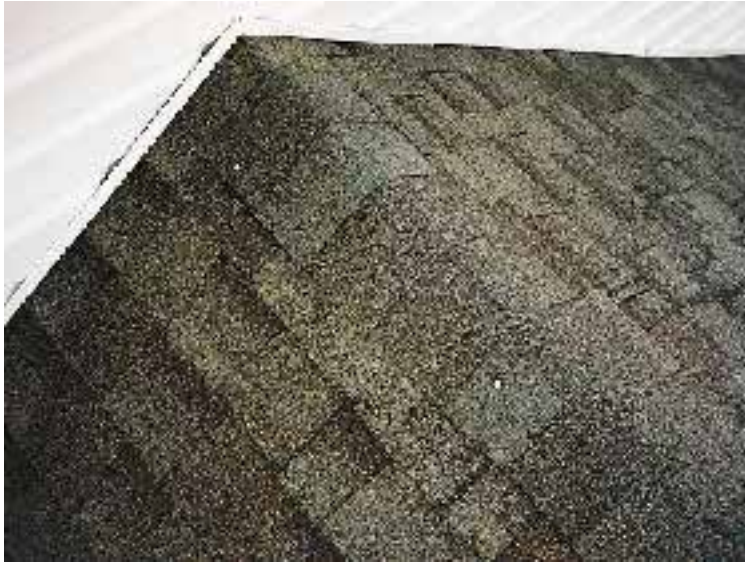
Problem: *Exposed roofing nails.* Exposed roofing nails are sometimes a source of leaks.

Solution: *Cover exposed nail heads with a dab of roofing cement,* when exposed nails can't be avoided — as on cap shingles.

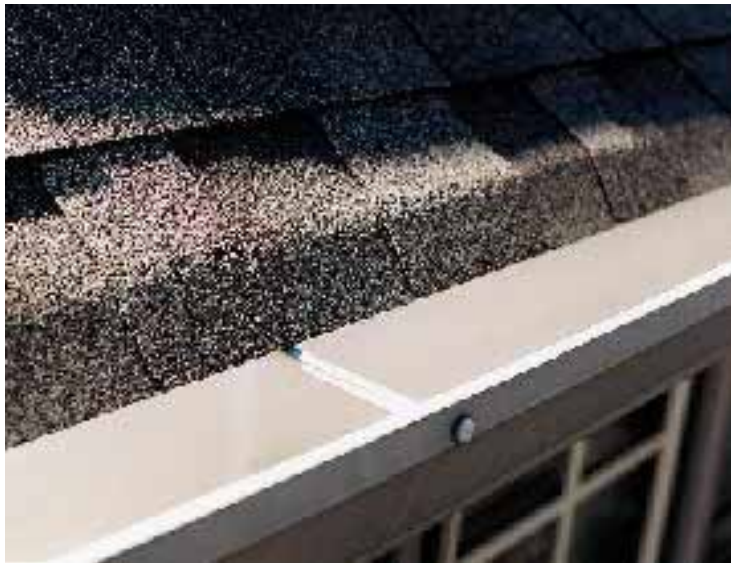
Problem: *Excessive shingle overhang.* This installer apparently believed that increasing the overhang on the first course of shingles would help direct the water into the gutter, and would substitute for metal drip edge. Eventually, however, the shingles crease under their own weight and break off, exposing the edge of the sheathing beneath.

Solution: *Shingles should overhang 1/2 inch to 3/4 inch* beyond the metal drip, according to recommendations from the Asphalt Roof Manufacturers Association.

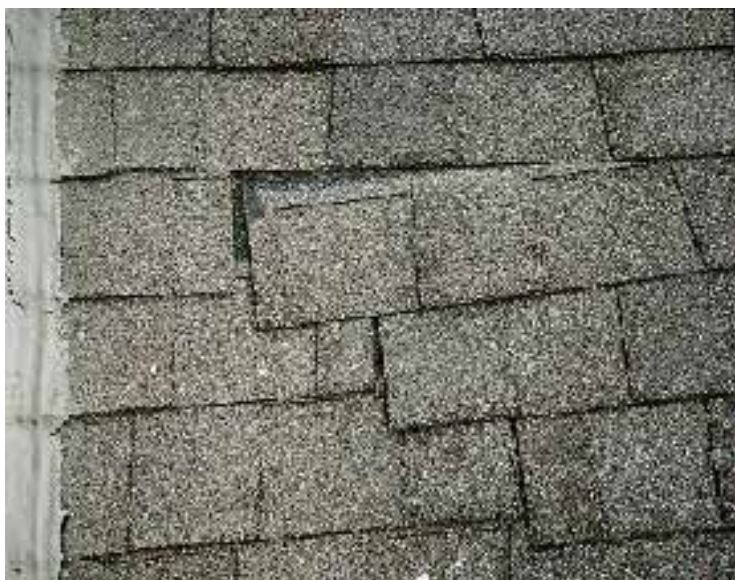
Problem: *Slipping shingles.*

Shingles can slip when the manufacturer's fastening instructions are not followed. Improper practices include using too few fasteners, and overdriving and underdriving the fasteners.

Solution: *Follow the shingle manufacturer's fastening instructions* as printed on the bundle wrappers.
