# REPAIRING A Stone Foundation

by David Rippe

**A poured exterior foundation provides a smooth surface for waterproofing membrane, leaving a leaky old foundation as tight and dry as a new one**

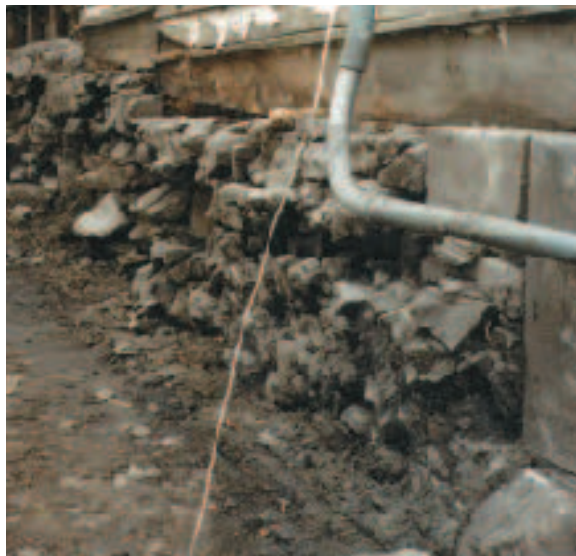
**Figure 1.** The existing rubble foundation was sitting on well-drained soil and supported the building adequately, but it was far too rough to accept the waterproofing membrane needed to deflect heavy spring runoff.

Unlike the school foundation, which was smooth on the outside, the below-grade portion of this one had a lot of uneven and protruding stones that would quickly puncture a liner (see Figure 1). The low-quality concrete was deteriorated and crumbling, and although the foundation was supporting the building adequately, we knew we'd have to stabilize it and provide a smooth backing for the liner before we could proceed. After some thought, we worked out a plan to form and pour an external reinforcing wall directly against the existing walls. Regular concrete subs wouldn't touch the job ("You want to do what, now?"), so we decided to go ahead and do it ourselves.

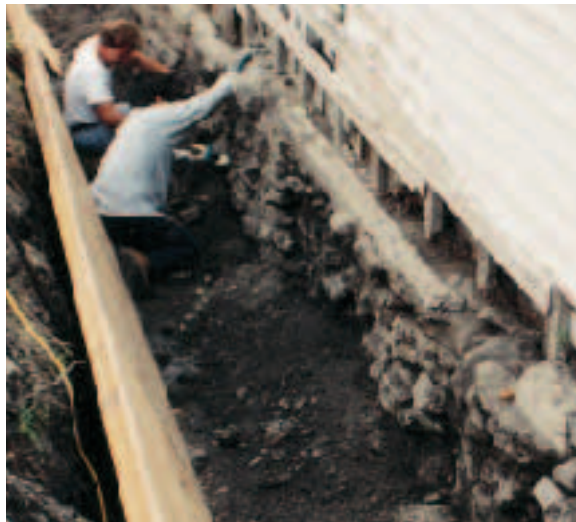
**Figure 2.** Wall forms were made from 2x4s and full sheets of  $\frac{3}{4}$ -inch plywood. Before they were secured to the wall in preparation for the concrete pour, the forms were leaned back against the side of the trench to help keep dirt out of the excavation while the existing walls were being cleaned.

After digging and carefully leveling the bottoms of the trenches, we'd prepared some simple forms by placing full sheets of plywood end to end and connecting them with 16-foot 2x4s scabbed together where they butted. These were temporarily left leaning back against the bank, where they helped prevent soil from spilling into the trench while we gave the stones their final cleaning (Figure 2, previous page).

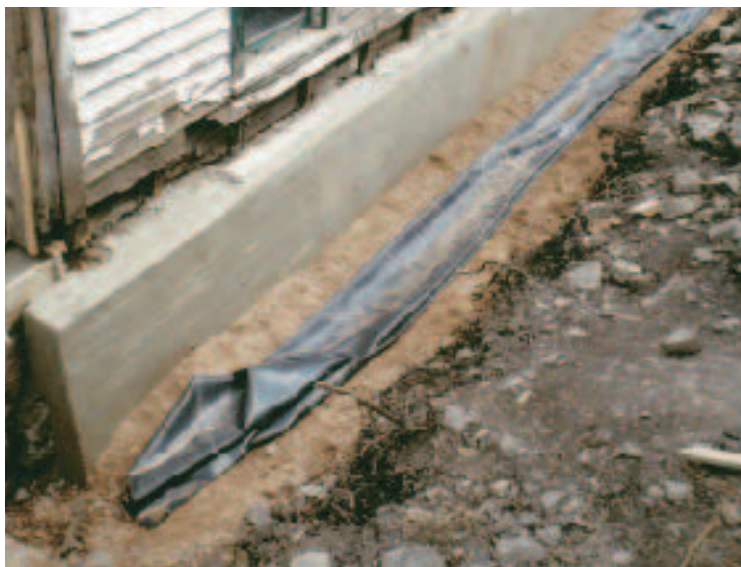
**Figure 4.** The new poured wall locked the rubble in place and provided a smooth surface for a waterproofing membrane. A smooth layer of roadbed material in the bottom of the trench helps protect the membrane from punctures.

Because spring snowmelt exposes the repaired foundation to very heavy runoff, we waterproofed it with a 40-mil EPDM membrane made by Carlisle (800/527-7092, [www.carlisle-ccw.com](http://www.carlisle-ccw.com)). To prevent the membrane from being damaged by sharp stones, we started by lining the trenches with a smooth layer of what's locally called roadbed material — a mixture of dirt, sand, and fine gravel — sloped gently to the front for drainage (Figure 4, previous page).

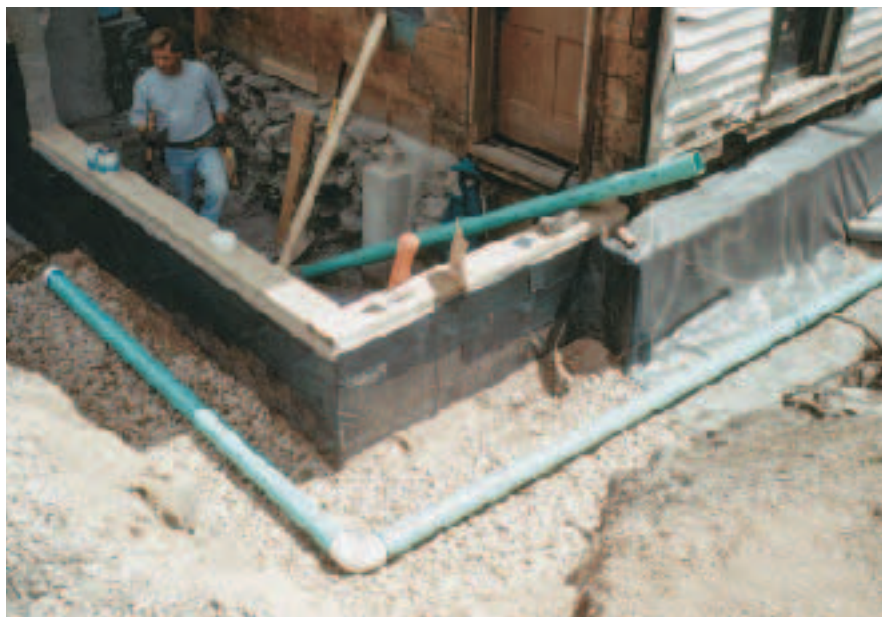
**Figure 5.** The 40-mil EPDM membrane extends to the top edge of the new shed foundation but overlaps the reinforcing wall, which lies outside the footprint of the building.

After rolling out the 6-foot-wide material, we tacked it temporarily to the siding at the top before cutting, fitting, and cementing it where it joined the poured addition at the back (Figure 5, previous page). Finally, we put down crushed stone, drainage pipe, and filter cloth, topped by dirt from the site.

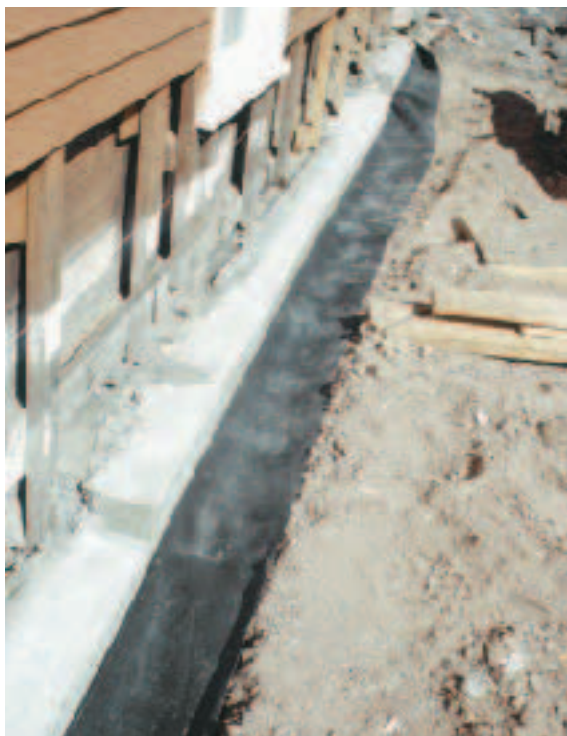
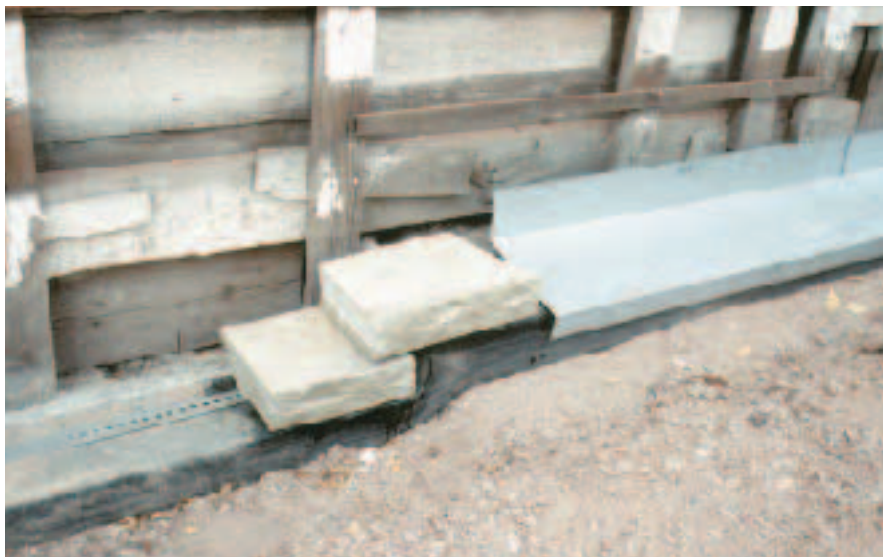
**Figure 6.** The topmost edge of the membrane was left loose for two months to allow the backfill to settle (right). After being cut and fitted over stepped sections of the foundation, it was covered by galvanized flashing that was later tucked beneath the siding (below).

**Flashing.** Backfill tends to pull waterproofing membrane down slightly as it settles, so I waited two months before I cut and cemented the flap that covers the top of the new reinforcing wall (Figure 6). I'd originally hoped to cap the foundation with blocks of cut sandstone known locally as farmer stone. In the end, though, the budget couldn't be stretched that far, so we finished up with a cap of 24-gauge galvanized flashing, which was later tucked under the siding.
