by Robert Hayden

"Move it or lose it" is a call to action when an antique home outlives its prime location

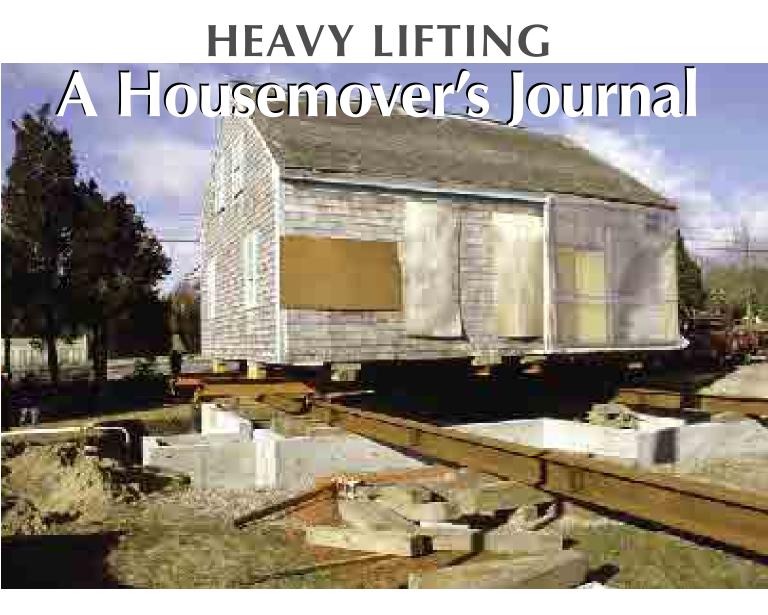
Figure 1. The house originally stood only inches above grade on a low brick perimeter, with intermediate wood posts at key framing junctions in the floor system. With the exception of a circular root cellar under the ell (above), there was virtually no clearance below the joists. In spite of this, the wood was in remarkably good condition (right).

One of the first steps in evaluating a building for lifting is to check the condition of the building's underpinnings — the perimeter sill and floor joists. In this case, that meant handdigging a few exploratory holes to inspect the framing over the marginal crawlspace foundation. The foundation was a double-wide course of locally made brick, laid about six high directly on grade. The stable, free-draining sandy soil on the site has to be credited with the exceptional condition of the oak sill and floor joists, which had only inches of clearance above the roughly leveled grade (see Figure 1). This was an unexpected piece of luck, as the rotfree framing would allow us to proceed conventionally by lifting from underneath the sills and floor system. Otherwise, contrary to preservation efforts, we'd have to destructively alter areas of the antique structure in order to lift the building by its walls (see "Extreme Lifting," page 8).

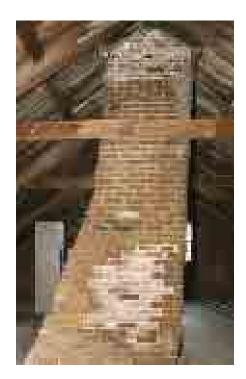
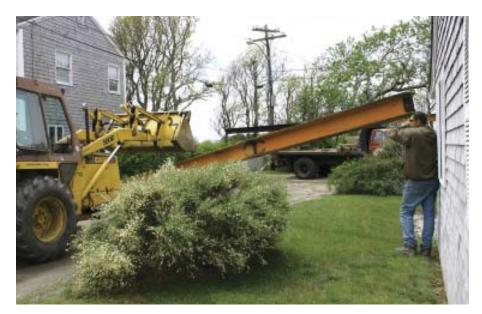
Figure 2. A parge-coat of masonry cement held the bricks steady for lifting and transportation (above). Restoration efforts included making a temporary access hole (shown patched in the photo at right) to send a small mason inside the chimney to repair and reline the three throats and flues.

To prevent the bricks from shaking apart during the move, we applied a sticky "skin" of rich masonry cement, reinforced with embedded chicken wire, to the fireboxes and brick above the lintels (Figure 2). Simultaneously, we selectively removed field stones and earth from the sub-hearth area. With the foundations of all three fireplaces now somewhat exposed, we beamed a laser level from one firebox to the next

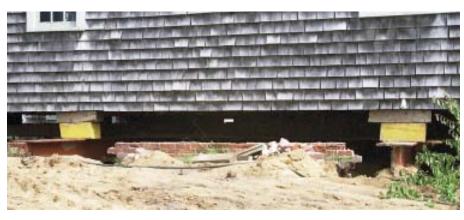
Figure 5. After carefully removing every other stone supporting the three chimneys and pouring a unifying reinforced concrete slab between them, the author slipped two needle beams beneath the masonry, initially jacking them just enough to transfer the load.

Pre-loading the chimney. On this job, we inserted the center needles under the chimney mass first (Figure 5). We slid the first one in and jacked it snug

against the modified chimney base, so that it began to shoulder, but not raise, some of the masonry load. Then we inserted the second needle and snugged it up, too, effectively transferring the full weight of the chimneys onto the needles. Usually, you'd place the main beams, then set the needles; but then, this wasn't a usual case. Despite the overall bearing capacity of the H-beam needles, there is still considerable midspan deflection under a masonry load, which moves independently of the wood structure. We accounted for that deflection by transferring the chimney weight first. Lifting the building was then a matter of placing 40-foot-long 12x12-inch main beams under the center needles, installing the outer needles, then shimming as needed.

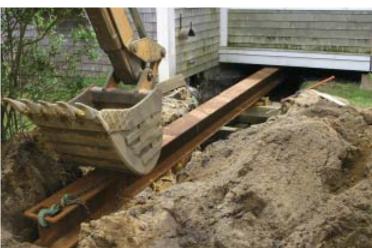
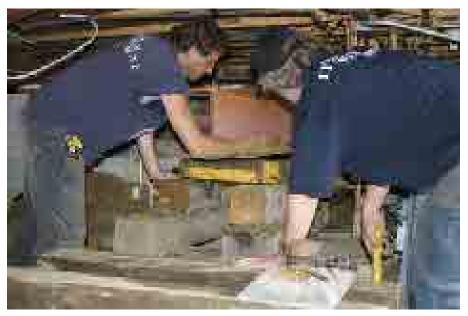
Figure 6. Rollers facilitate beam placement under the structure. The beam is chained to the backhoe bucket to keep it from launching itself forward like a battering ram.

We chute the beams in on rollers set on low cribbing stacked just outside and just beyond midway inside the foundation (Figure 6, previous page). My derrick usually does the heavy work — a 40-foot H-beam weighs 3,600 pounds — and also pivots the far end of the beam up or down to clear the floor by using the outside roller as a fulcrum. There's always a man under the house keeping an eye on the blind end of the beam and shouting directions.

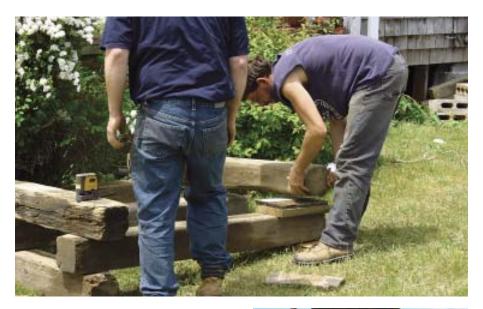
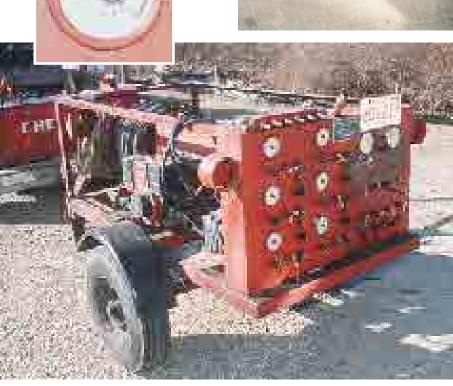
Figure 7. Four-foot lengths of 6x7-inch timbers are stacked to support the main steel H-beams. To ensure stability, the cribbing must be shimmed or shoveled dead level (above). One layer is blocked solid to support the jack (right). The unified jacking system manifold also provides an instant readout on the weight each jack lifts (below).

Cribbing supports the four ends of the two main beams and must be installed completely level for stability. It's retrofitted under the beams, crossing 6x7 members two on two in a box configuration (Figure 7). The remotely controlled, unified system jacks are placed on a solid layer of timbers placed within the cribbing. Once the cribbing is built as high as possible under the beams, the jacks are individually activated at the central manifold while lookouts call out local conditions at the jacking stations. Any telltale creak or shifting is cause for a halt and possible correction before proceeding. The jacks raise the building in 14-inch lifts, allowing the cribbing to be stacked progressively higher, up to the point where the building can be rolled

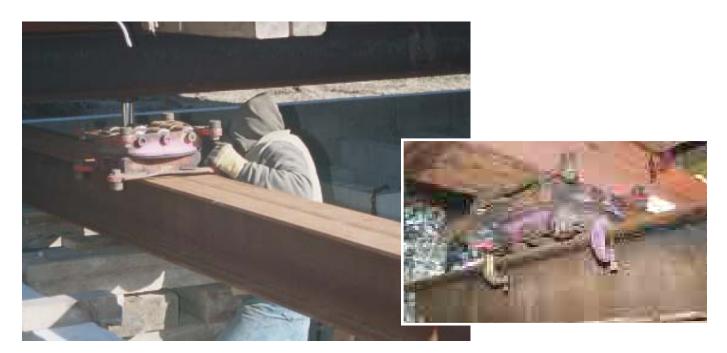
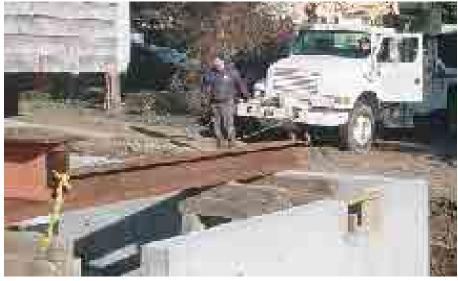
Figure 8. Two-way Hevi-Haul skates (top), are used to roll a building on or off the foundation as well as for alignment above a new foundation before lowering the house into place. Here, the house is winched forward on one axis (above) and nudged into position with a derrick arm on the other axis (left).

To roll the building off (or on) the foundation requires another set of track beams, set perpendicular to the main beams and supported at intervals on cribbing and the foundation itself. The main beams ride on the track beams on heavy-duty bidirectional "skates" (Figure 8).

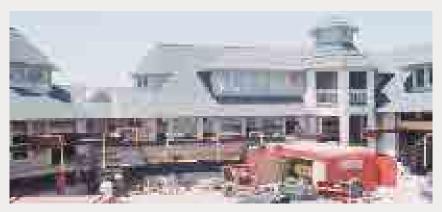
Ledgers nailed across studs (right) provided lifting points for steel beams, which were fed in through window openings (below, left). Because coastal regs prohibited digging around the perimeter of the house, cribbing had to be stacked through the floor joists with the subflooring removed (below, right).

We were forbidden to dig access holes around the foundation to insert the large steel I-beams needed for lifting under the sills. That meant that we had to work from inside the foundation instead, break through the floor at strategic locations, and lift the house by its walls using temporary, nailed-on ledger boards. It also meant that the I-beams would have to be fed in through existing door and window openings. The house measured 135 feet along its delta-shaped length, was
