## Deck Collapse Injures Scores

Ledger splits from faulty lag screw installation

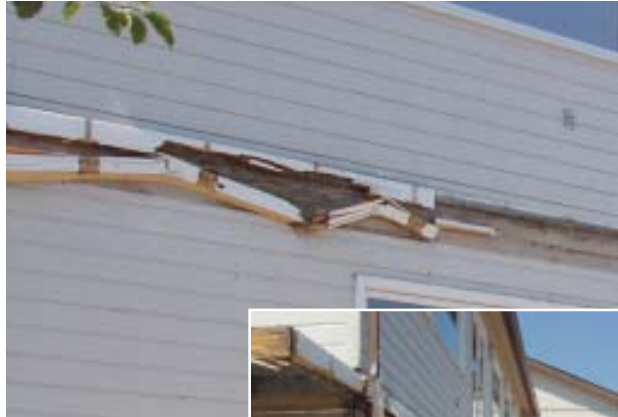
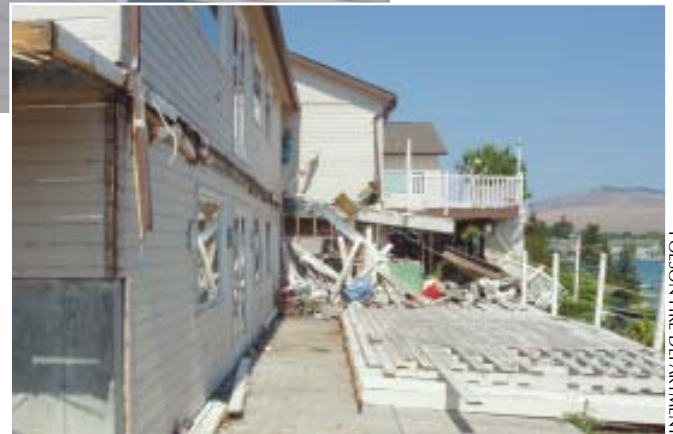
Lag screws and fragments of the split ledger board remain attached to the building, and the mostly intact deck lies on the ground below, in these photos taken the morning after the structure's sudden collapse sent dozens of injured to the hospital.

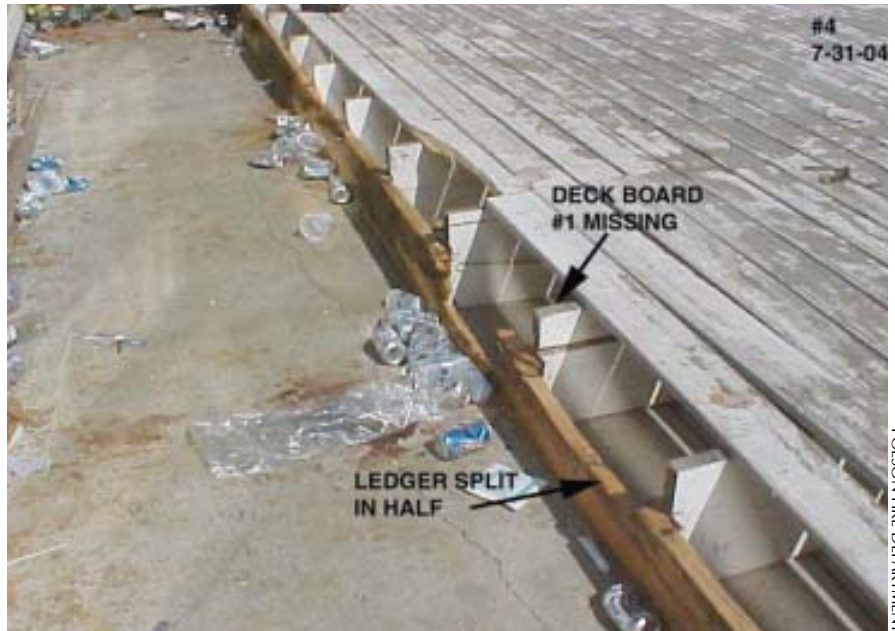
A morning-after photo shows the bottom half of the split ledger board still attached to the otherwise intact deck assembly.

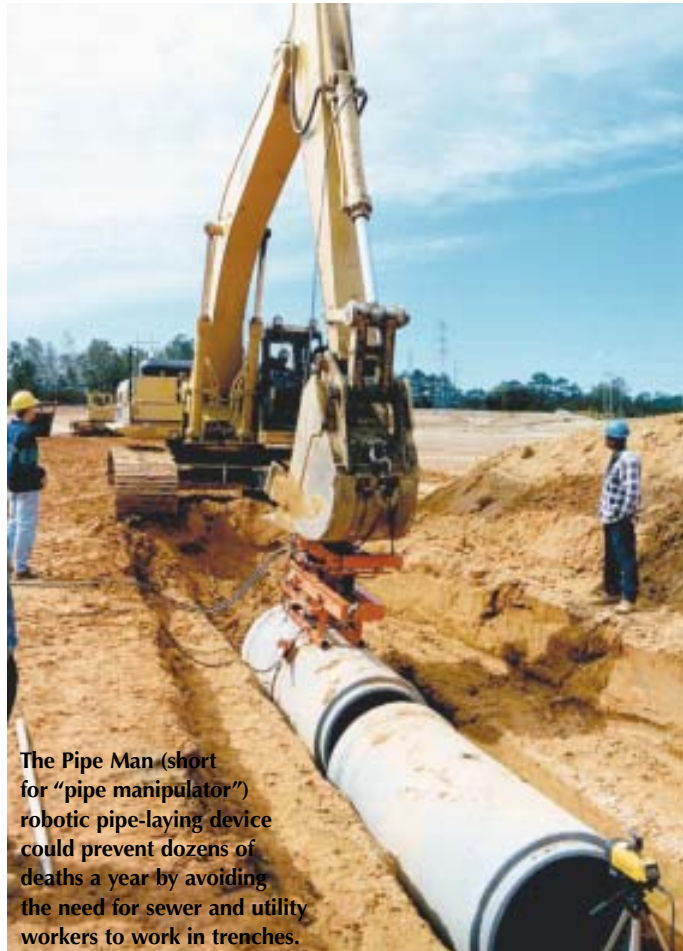
The Pipe Man (short for "pipe manipulator") robotic pipe-laying device could prevent dozens of deaths a year by avoiding the need for sewer and utility workers to work in trenches.

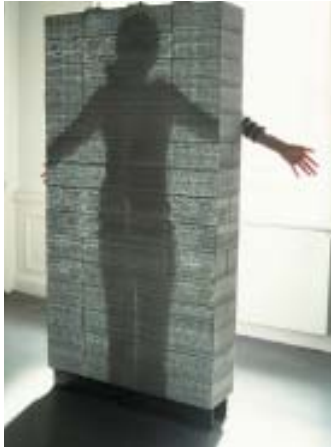
Glass fibers in the mix let LiTraCon concrete blocks achieve translucency, opening up a new set of options for daylighting and nighttime illumination in concrete construction.

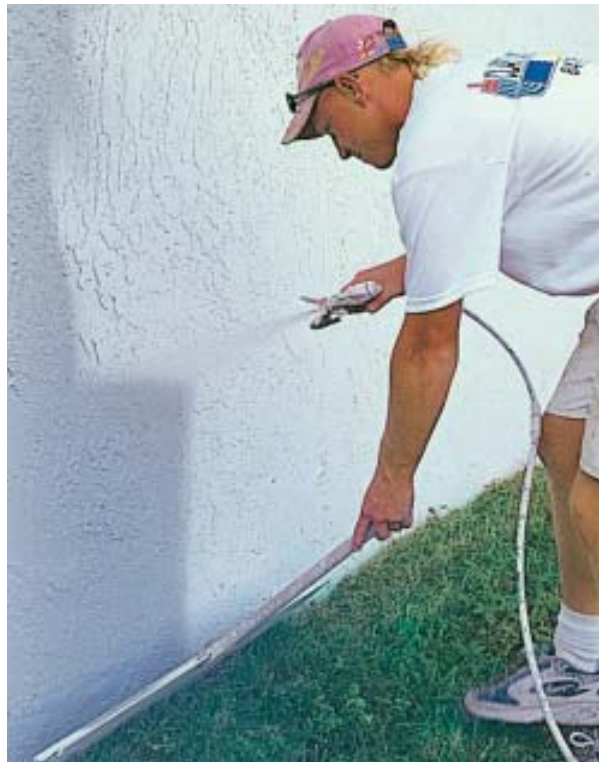
Painted stucco has replaced pigmented applications in some Southwest markets, but suppliers worry that builders aren’t allowing the cladding to cure properly and possibly causing latent moisture problems.

prior to painting with two coats of a high-quality exterior latex or elastomeric coating, the latter of which helps bridge cracks. Walls with a high pH level need an exterior acrylic masonry primer that is high in alkali and resistant to efflorescence prior to the finish application. “Moisture leaks and high pH are typically the reasons for stucco failures,” says Steve Revnew, director of architectural marketing at The Sherwin-Williams Company in Columbus, Ohio.
