A builder examines how well the materials on one of his houses have weathered more than a decade at the beach

Ten Years After

After 14 years building waterfront homes, architect/builder Andrew DiGiammo took an inspection tour of one of his early homes to see how the materials he had chosen were holding up.

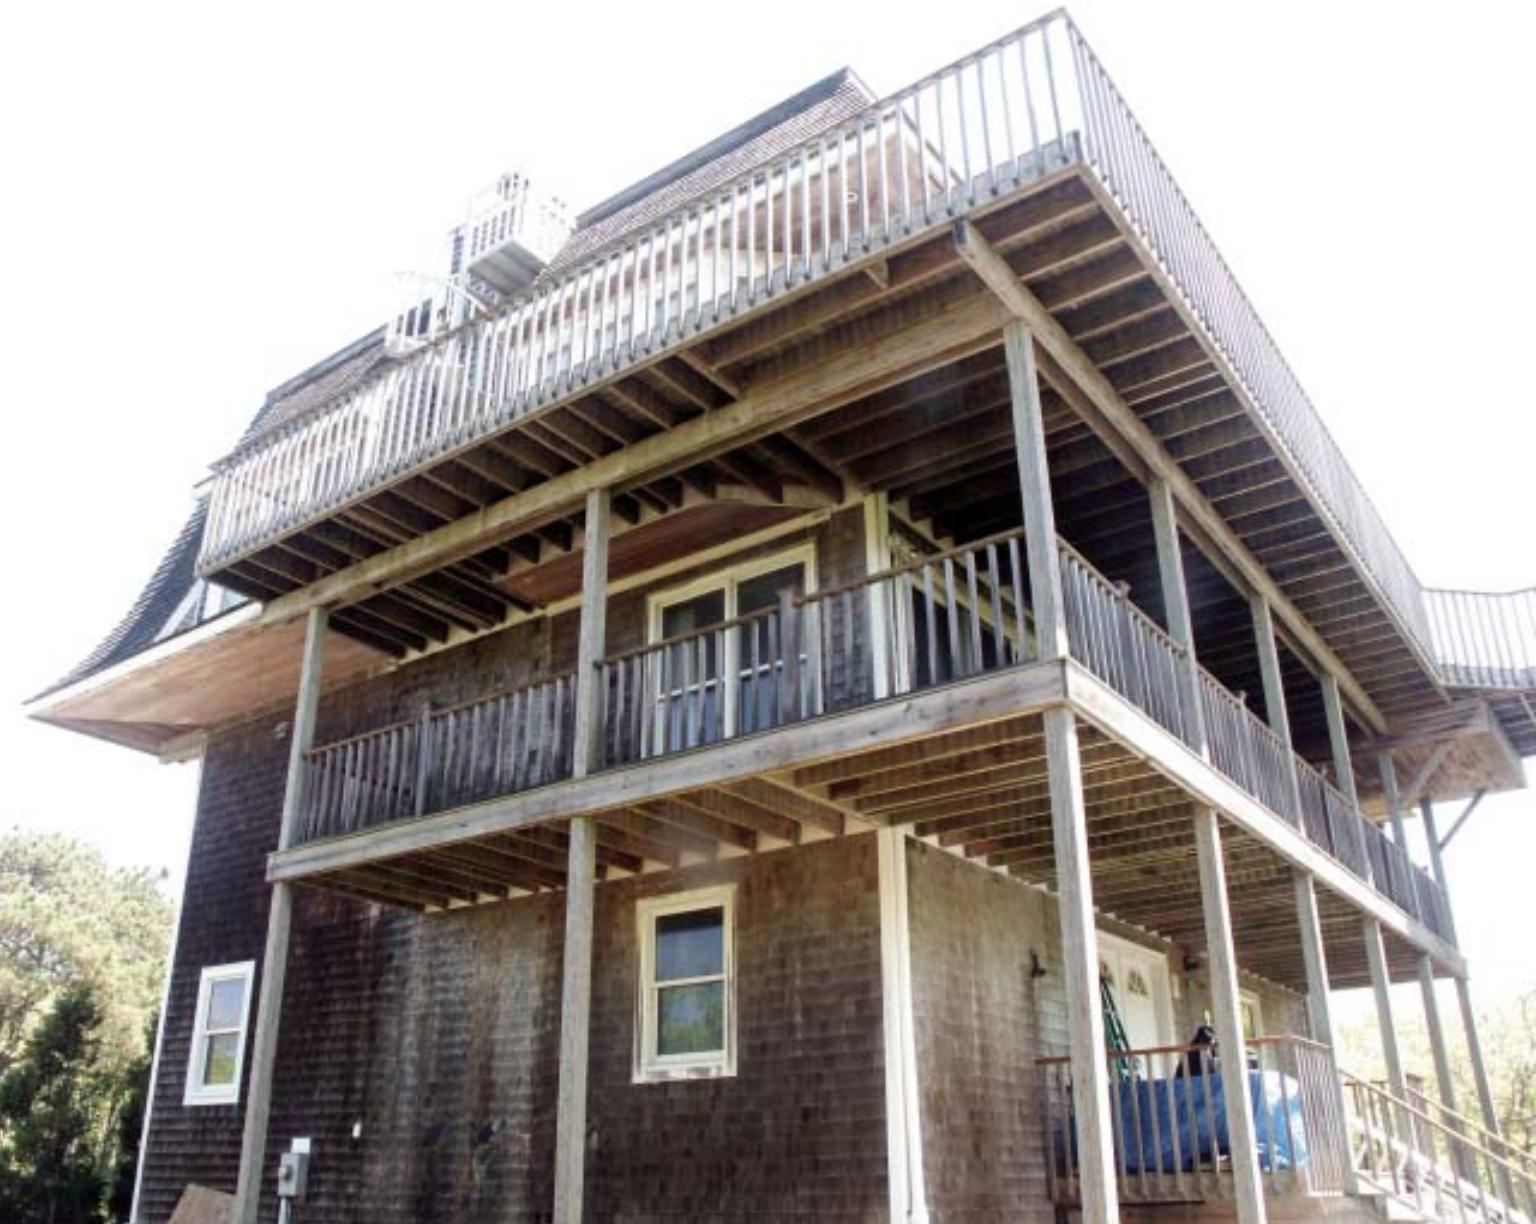
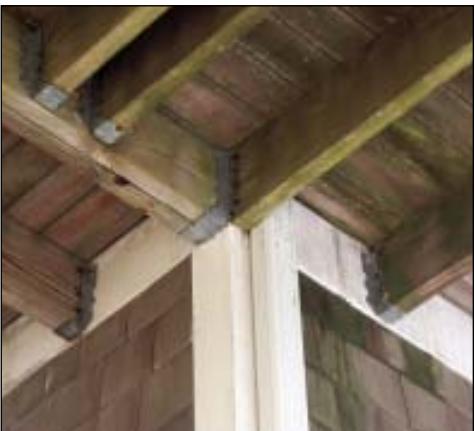
FIGURE 1. The author was happy with the performance of preservative-treated Parallam girders and posts, connected to concrete piers with custom-fabricated galvanized steel anchors (left). But he noticed accelerated corrosion on some of the nails used to fasten joist hangers in the treated sawn-lumber deck structure (above).

This house was one of the first buildings in which I used treated engineered wood (**Figure 1**, page 3). The entire house is built on a framework of preservative-treated Parallam girders (www.trusjoist.com), supported by concrete piers resting on isolated pad footings. Posts for the second- and third-story decks are also treated Parallam (continuous 6x6s that run the full height). After more than 10 years in the weather, all the Parallam timbers are in prime condition — they look as good as new.

I used custom-fabricated steel anchors to connect the Parallam girders and posts to their concrete piers. The anchors were specially ordered from a steel fabricator (any good steel shop can supply this type of thing). They are made of 1/4-inch steel plate bent into a U shape; the steel was bent and holes for carriage bolts were drilled before the pieces were sent to be hot-dip galvanized.

We embedded the anchors into the wet concrete when the piers were poured, then we drilled the wood members and bolted them in place. Posts and girders are suspended above the concrete pier, provid-

ing an air gap to keep the wood dry (we set a Simpson Strong-Tie standoff post base under each post, to act as a spacer). When the bolts are torqued tight, the contact area between the U-shaped anchor and the wood member develops a significant amount of friction, which combines with the bolts themselves to support the post or girder. More than a decade later, not one of those joints has budged, and the galvanized anchors don't show any sign of deterioration. I'm very happy with the performance of this design element.

I'm not quite as happy, however, with the condition I noticed in some of the

hangers and fasteners we used to assemble the treated southern yellow pine deck framing. In a few cases, the crew apparently used nails that were not compatible with the galvanized joist hangers. When dissimilar metals are brought into contact in a moist environment, one metal can attack the other — a process known as *bimetallic galvanic corrosion* (Figure 2, page 3). This phenomenon is worse in a saltwater exposure than in conditions of regular rain or dew. Using regular roofing nails or common framing nails for hangers is a common practice but not a good idea. Not only is the connection weaker, but the nails rust

more quickly and will eventually need to be replaced. Whenever you use framing connectors or hangers in an exposed coastal environment, it's important to be especially careful with fastener choice. In the case of decks, I'd advise builders to ask the manufacturer of the hangers to specify and supply the appropriate nails — and the crew on site, in turn, has to understand why it's important not to substitute something else.

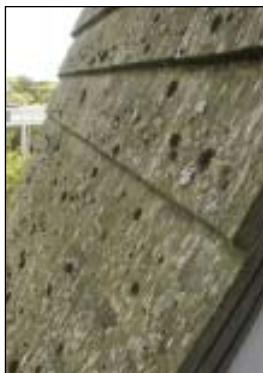
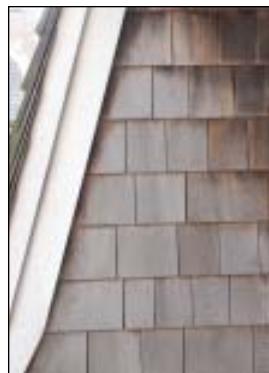
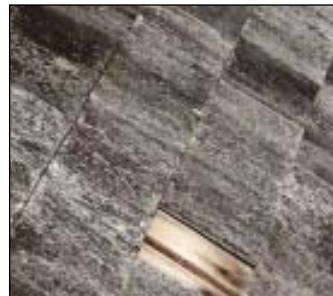
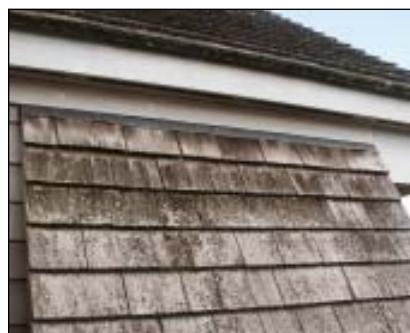
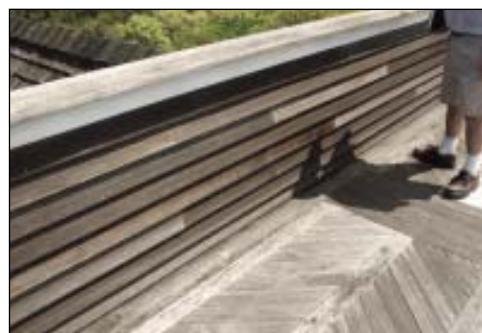
FIGURE 3. Red cedar roof shingles have collected dirt, algae, lichens, and moss over the years (above left). Vertically applied white cedar shingles on the wall look cleaner and newer (above center); both types should be cleaned periodically. Galvanized nails used to attach the roof shingles have been attacked by the corrosive chemistry of the wood (above right) — the author now uses stainless-steel nails for all cedar applications, as he did on the parapet clapboards (bottom right). Lead flashing has had a partial protective effect on the top course of red cedar roof shingles (bottom left).

I used cedar wood without any paint or coating for this home's siding and roofing (Figure 3, page 4). The roof is shingled with western red cedar, and the walls are shingled with white cedar (which grows in the Northeast). The rooftop deck's parapet walls are sided with red cedar clapboards.

The white cedar wall shingles, in general, are doing fine. They've weathered to varying shades of gray, but they're still doing their job and will last for a long time.

Red cedar is a more durable species than white cedar, and the shingles on this roof are also bigger and heavier than the ones on the walls. However, the roof shingles have a rougher exposure than the wall shingles — they're in a more horizontal position, where they get direct rain and sun and can accumulate debris. They're now supporting growths of algae, lichens,

and moss, particularly in the lower-slope and more shaded areas.

We're also starting to see some fastener failure on the red cedar roof. We used galvanized nails to attach the shingles, and the same natural chemistry that makes red cedar resist rot is mildly corrosive to galvanized nails (and much more to ordinary steel). One photo in Figure 3 shows a missing roof shingle, and you can see how the fasteners in the newly exposed area are rust-

ing. Code in my area now requires stainless-steel fasteners for red cedar roofing applications, but even before that code change, I switched to using stainless-steel nails for fastening all naturally rot-resistant wood. In fact, we now use stainless-steel fasteners for all exterior siding or trim, as well. (You can see why if you look at the stainless-steel nail heads in the parapet clapboards in Figure 3 — the cedar is gray and weathered, but the nail heads are still shiny.)

Generally, an owner will get better performance out of a wood shingle roof if the roof is cleaned every two years with water and a cleanser that kills algae and fungi. If owners don't want to take that on, you might want to steer them toward metal or composition roofing.

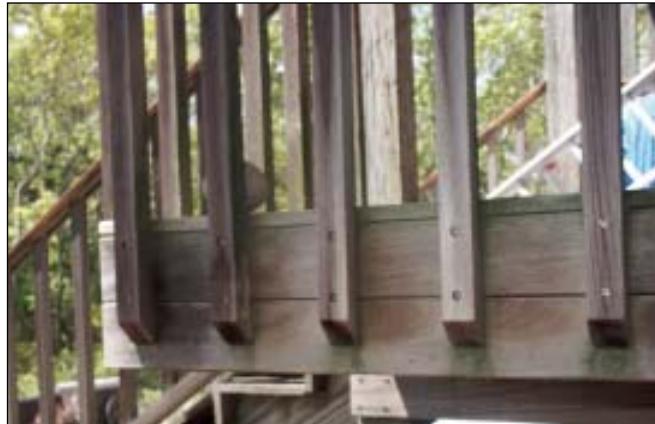
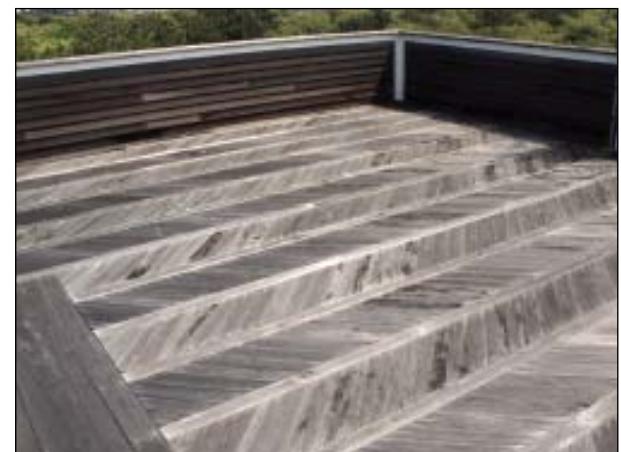
FIGURE 4. Naturally rot-resistant cedar rails (above) and mahogany decking (right) have performed well, but the author notes mahogany can be inconsistent, depending on the variety and on the presence of sapwood rather than heartwood boards in the shipment.

I used a mahogany decking on all the decks, and red cedar for rails and balusters (Figure 4). All that wood is still in good shape, but the mahogany was not my first choice. As I recall, we used it at the time because the owner had gotten a good deal on this lumber and asked us to use it. I prefer to use ipe (sometimes called Brazilian walnut) for natural wood decks. In my market at least, ipe seems to be a more consistent product, and very weather resistant.

Not that some mahogany isn't durable — if it's the right kind of mahogany, and if it's all heartwood rather than sapwood. The problem is that there are hundreds of species and subspecies of mahogany and no real grading system for them, so you don't know for sure what you've got until you break open the bundle. In my experience, the heavy pieces are heartwood, but lighter boards may be sawn from less durable sapwood. On this deck, I noticed that a few pieces of exposed decking here and there were darker than the others, apparently because they were holding water — maybe because they're sapwood, or maybe just because of the grain pattern.

from sawing. Down the road, some boards in this deck may need to be replaced.

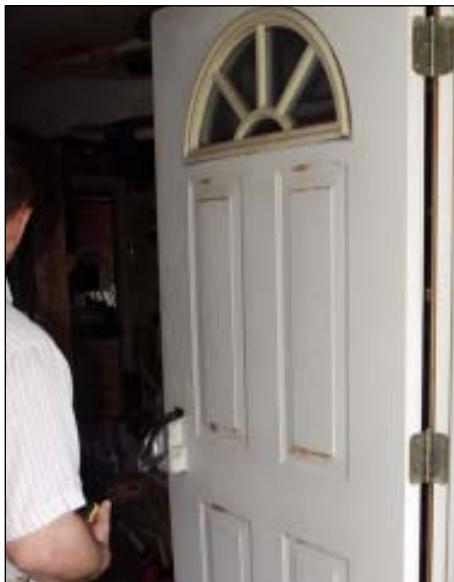
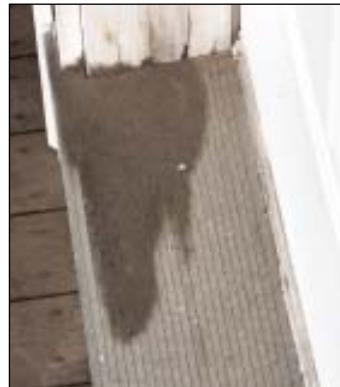
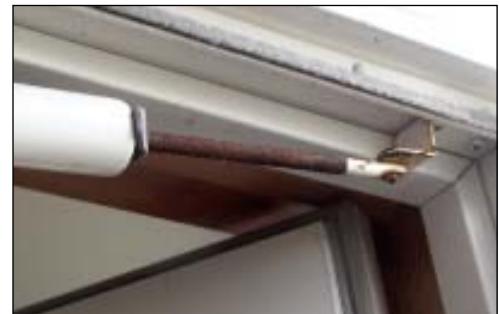
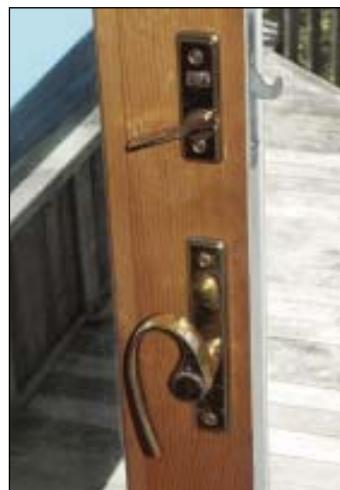
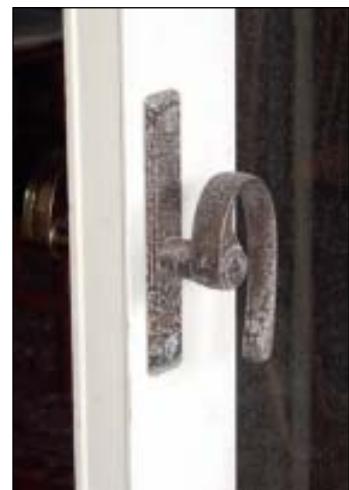
FIGURE 7. Doors and hardware take a beating on the beach. A steel door shows rust (below) and its pine jamb has deteriorated (near right), while a hardware-store storm-door closer is rusting badly (far right). Standard brass door hardware is tarnished and pitted (bottom center and right). For beach construction, the author recommends ordering special hardware designed for extreme exposures.

On the ground level of this house in the back, I used a standard steel entry door with a push-button combination lock (Figure 7). The door shows some rust, and the lock is tarnishing. Fiberglass doors are clearly more durable in the coastal environment.

Brass hardware on some French doors upstairs is tarnishing badly, especially the exterior levers. The entry latch set in Figure 7 is standard door hardware and, as you can see, isn't designed for the beach environment. Andersen and some other door makers supply upgraded hardware for severe exposures; these days I always order the tougher hardware and go with the white-coated variety. I haven't found any brass hardware that keeps looking good on a beach house over time.

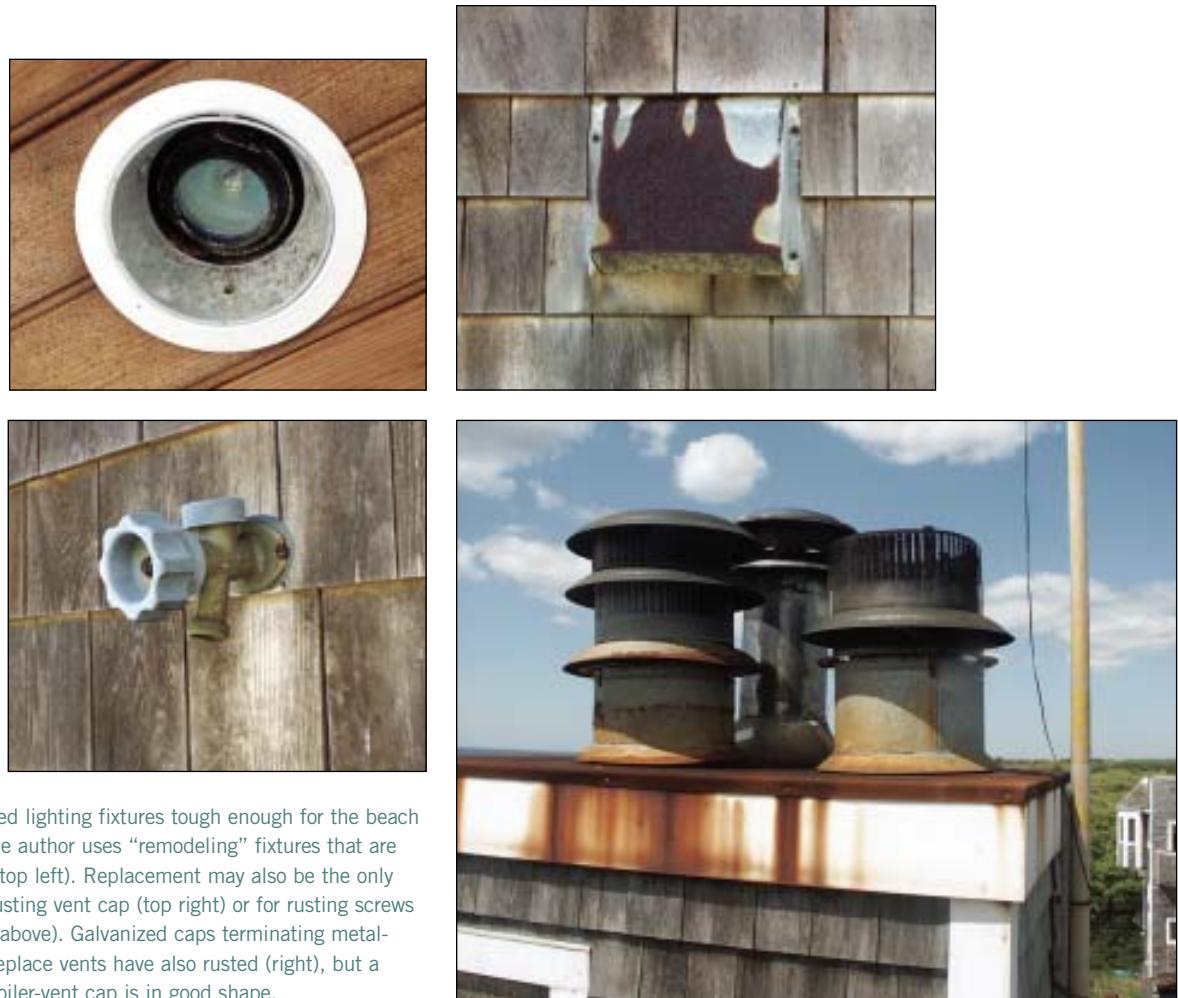
FIGURE 8. Recessed lighting fixtures tough enough for the beach are scarce, so the author uses “remodeling” fixtures that are easily replaced (top left). Replacement may also be the only option for this rusting vent cap (top right) or for rusting screws on a hose bibb (above). Galvanized caps terminating metal-and-asbestos fireplace vents have also rusted (right), but a stainless-steel boiler-vent cap is in good shape.

Exterior accessories like light fixtures, vent caps, hose bibbs, and the like have not had an easy time of it on this house (Figure 8, page 7). The low-voltage down-lighting fixtures in the soffits, for instance, are corroded. Lighting suppliers don't have many products

rugged enough for this environment, but plastic fixtures hold up much better. In general, I like to use “remodeling fixtures” designed to be snapped in and out rather than fastened to the building structure. When they deteriorate, the fixtures can be easily replaced. I also try to use plastic fixtures whenever I can, to eliminate the metal altogether.

The hose bibb in Figure 8 is in good shape, but the screws holding it have rusted. This may be another case of bimetallic galvanic corrosion; by experimenting with different screws, we might find one that holds up better here. Two exhaust vent caps are also rusting badly; those just have to be replaced.

On the rooftop I found an interesting contrast in the performance of vent terminations. Galvanized caps for the metal vents for two zero-clearance fireplaces were rusting badly, while a stainless-steel vent for a gas burner was in good shape. Evidently, galvanized metal

isn’t sufficiently protected for this environment — wherever possible, you have to use stainless.
