ADDING A

Supporting the home's brick veneer while cutting through the concrete foundation required careful planning and good temporary support

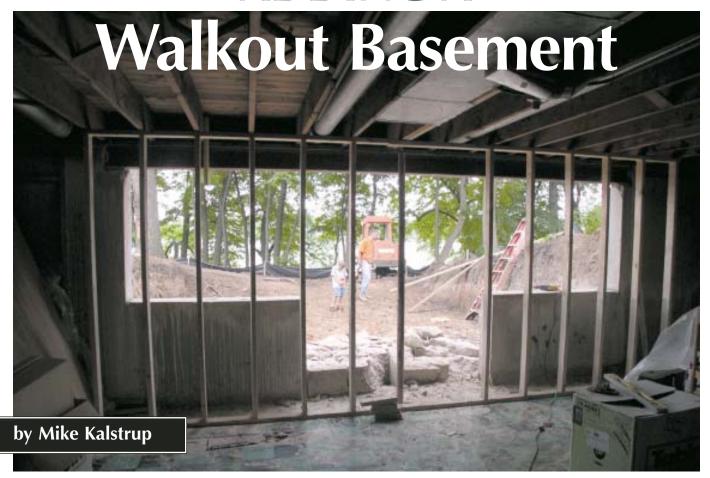
Figure 1. Although there was plenty of room for expansion in the basement area of this ranch, the small windows let in scant natural light and there was no means of egress (above). By adding the patio door and windows, the author made the interior space more livable and provided convenient access to the backyard and the lake beyond (right).

Given the lot's natural slope and the great view of the lake, we figured a walkout basement would be a big improvement. Part of the downstairs space was finished, including a fireplace and a three-quarter bath, but there was no door to the outside and the tiny windows didn't offer much light or ventilation. So, we

decided to add a patio door with windows on both sides (see Figure 1).

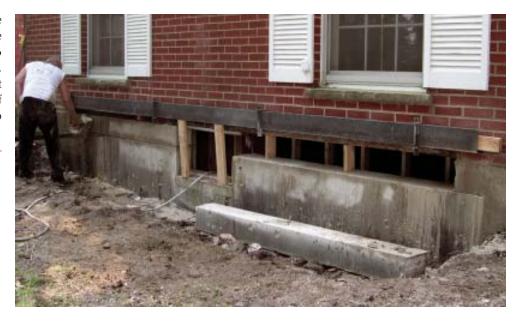
Figure 2. After sawing part of the way through a mortar joint, the author slid in this 18-foot-long 4x6 steel lintel to support the veneer. He clamped it to the band joist using threaded rod and lengths of angle iron so that it wouldn't slip out of place.

I inserted a 2x4 to take up the remaining space between the brick and the lintel, drilled pairs of holes in four locations through the masonry and band joist, then used threaded rod and pieces of angle iron to clamp the lintel to the band so it wouldn't slide out (Figure 2, page 4). With everything secure, I removed the course of brick below the lintel. Nothing budged.

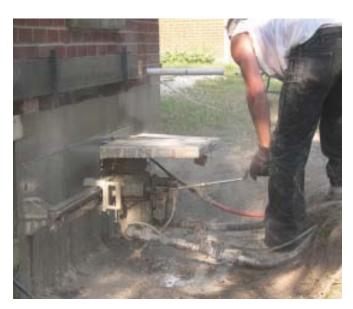
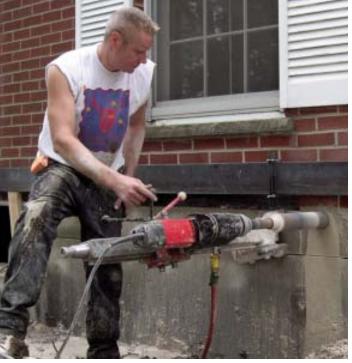
Figure 3. Cutting the beam pocket before excavating the walk-out made setting the beam much easier. A steel rail bolted to the foundation guides the horizontal cut (above). The vertical end cuts were made by stitch-drilling with a coring bit (right).

with the saw, the concrete cutter made the vertical end cuts by stitch-drilling with a core bit (Figure 3). This method avoided the vertical overcuts that the concrete saw would have made in the brick veneer above.

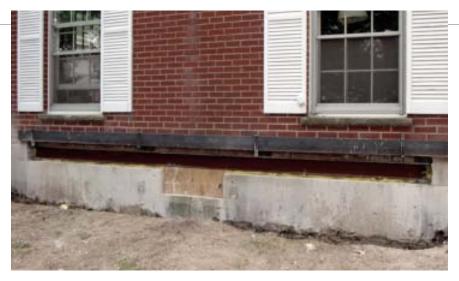
Figure 4. After slipping the I-beam into its slightly oversized pocket (above), the author shimmed it tight to the floor framing above (right). Before removing the temporary lintel, the missing course of brick was relaid.

Placing the steel. When the steel beam was delivered, I had it craned over the house as far as possible, then we dragged it the remaining 20 feet or so. It took four of us to place it in the slot, but I was pleased with how smoothly everything went when we were working at grade level. We slid the beam into position across some 2x6s and shimmed it level on the existing sill plate without much trouble (Figure 4).

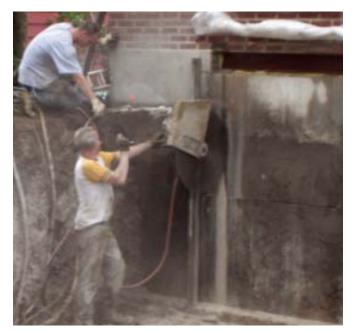
Figure 5. A day of excavating and grading left a flat, accessible site for the concrete-cutting subs. Once the opening was cut, the crew broke the concrete slabs into manageable pieces.

the next day, they were pleased: Besides providing them with a level work area, I had marked out all the cuts. They assured me that the prep work would make the sawing go much faster — good news, since they were charging me by the hour. Everything went smoothly, and they finished more quickly than expected (Figure 5, previous page).

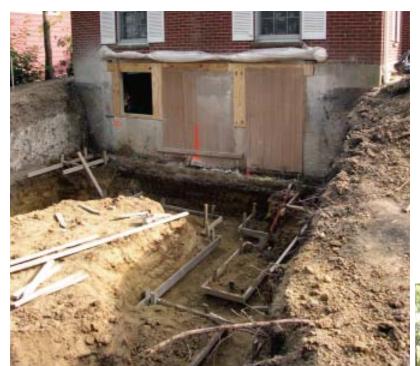
Figure 6. The footing below the patio door was dropped almost 4 feet to reach below the frost line; a one-sided form was used to pour that section of the foundation. Access was limited, so the crew used a bucket on a skid-steer loader to place the concrete for the footings; the walls were pumped.

The next morning, after clearing the cut-out chunks of concrete with a skid-steer loader, we used a compact excavator to dig down about 4 feet below the door opening to deepen the section of foundation left vulnerable by the walk-out. At the bottom of the hole, we dug a 24-inch-wide by 12-inch-deep trench for the footing. The following day we poured all the footings, using a bucket attachment on the skid-steer loader to move the concrete (Figure 6).
