# Replacing a Beach-House Foundation

A modified mat saved this cottage from the sea

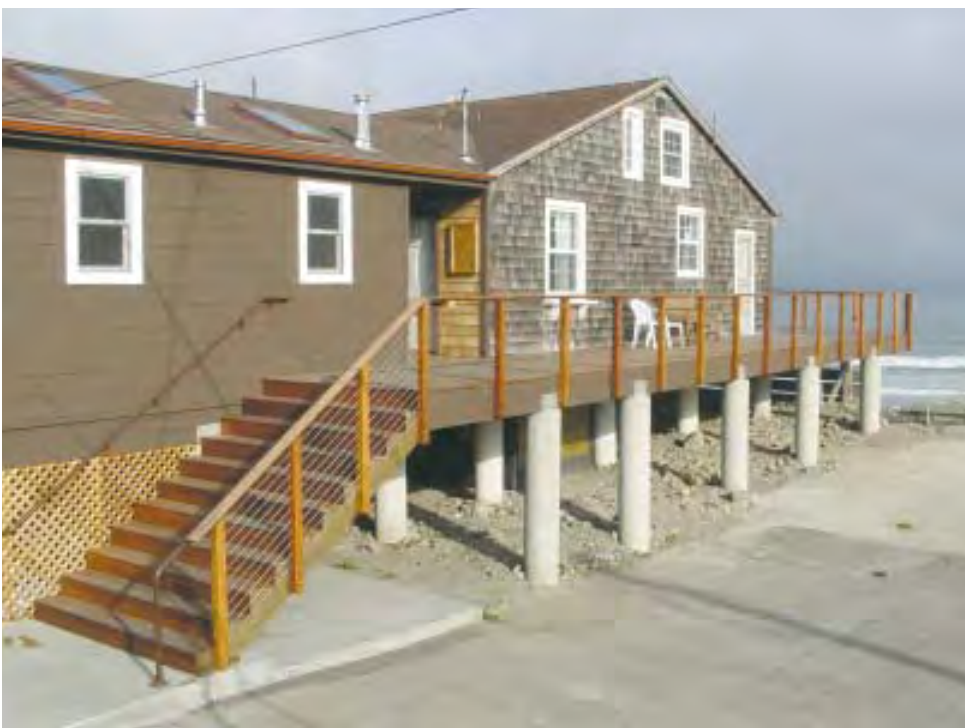
Recently, our company was hired to remodel a 1950s beach cottage just south of San Francisco. The job included repairing the house's seriously damaged foundation (see Figure 1, next page).

Our original plan was to shore up the building, replace the support beams, and reuse the existing wood piles. But once we got the house supported by cribbing and temporary steel beams (Figure 2, page 3) and started excavating around the piles, we found that they extended only 4 or 5 feet below grade rather than the 15 to 20 feet we'd been expecting.

Since the existing foundation could not be saved, we had to design, gain approval for, and build a new one from scratch.

Instead, we decided to remove the piles and support the cottage with concrete columns extending up from a modified version of a mat foundation, which was designed for us by Joshua B. Kardon, a structural engineer in Berkeley, Calif. A mat foundation is a thick and heavily reinforced concrete "slab" stiff enough to span weak areas of soil. The mat is usually continuous, but this one would be grid-shaped, because we planned to leave the house where it was and form around the

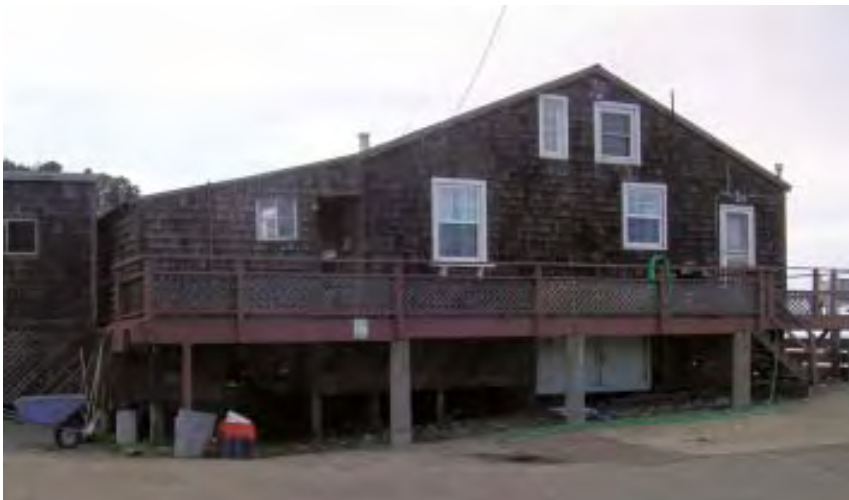
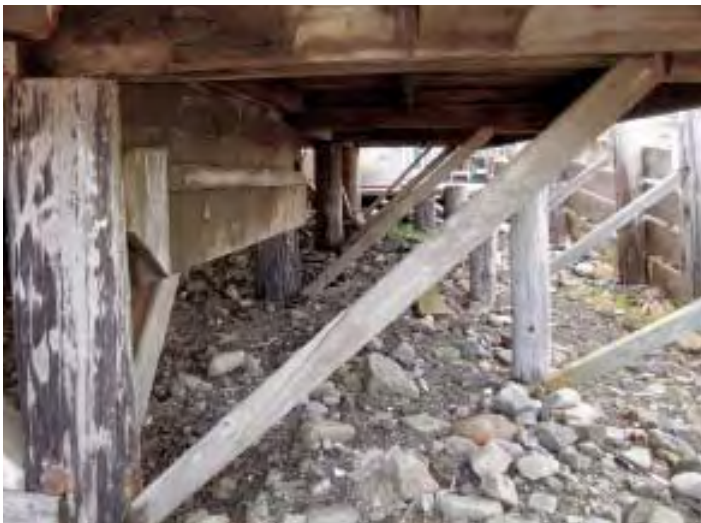
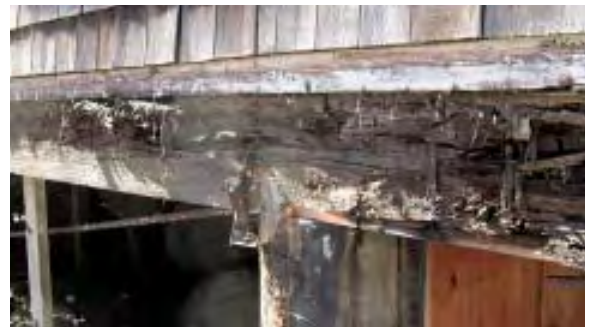
**Figure 1.** Creosote-treated wood piles supported the cottage 5 feet above the beach, so storm surge could flow under it. The decks were carried by shallow concrete piers (above left). About half of the piles showed signs of rot (left), as did most of the beams that carried the floor system and decks (above).

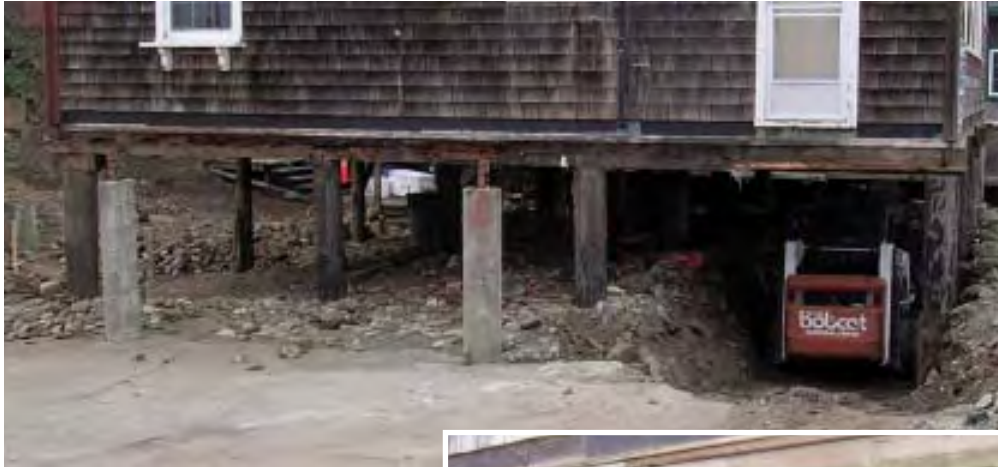
**Figure 2.** The crew members did not want to undermine the shoring when they dug down to repair damaged piles, so they excavated the areas where the cribbing would go, then built “forms” around the cribs to protect them from being buried if waves came under the house (below).

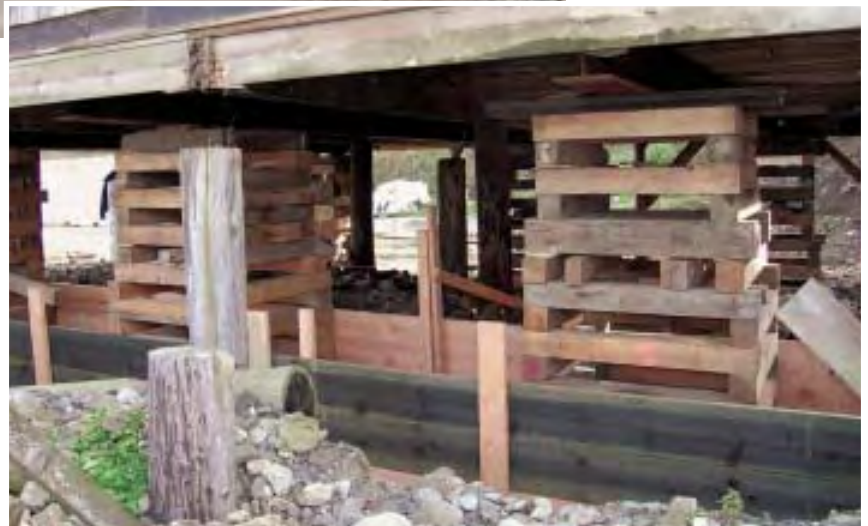
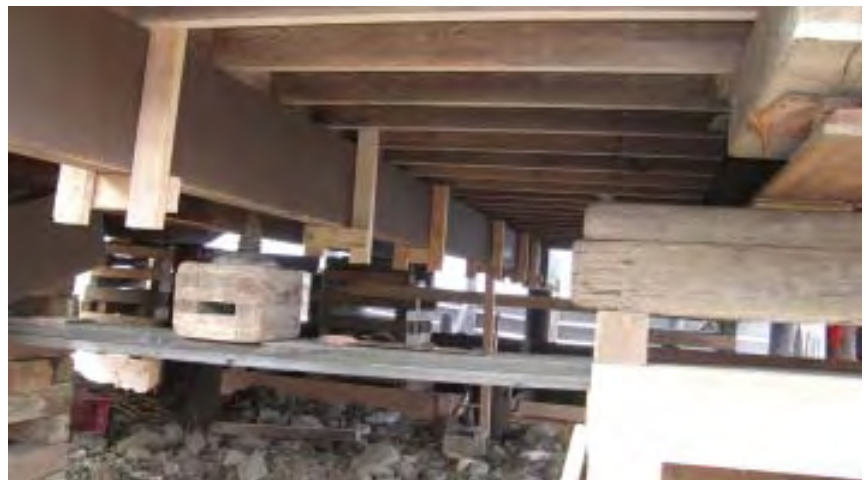
**Figure 3.** It was easier to install the beams before bringing the supports up from below. Here, the beam is hung from the joists before installation of the support columns.

The design called for new Port Orford cedar glulam support beams, which we decided to install before forming the mat and columns. That way, there would be fewer things in the way. We could hang the beams from the joists, install the column caps, and then form and pour up to the caps (Figure 3, next page). Since the house was so close to the ocean, we opted to use only stainless steel fasteners and hardware for extra resistance to corrosion.

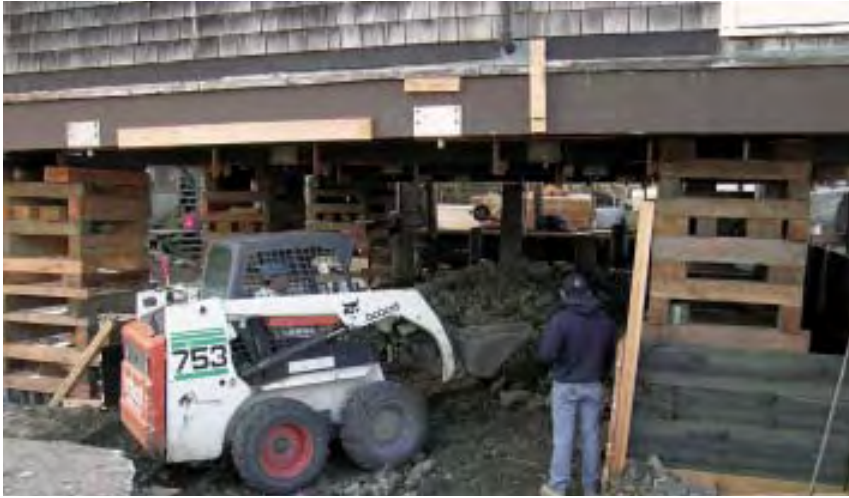
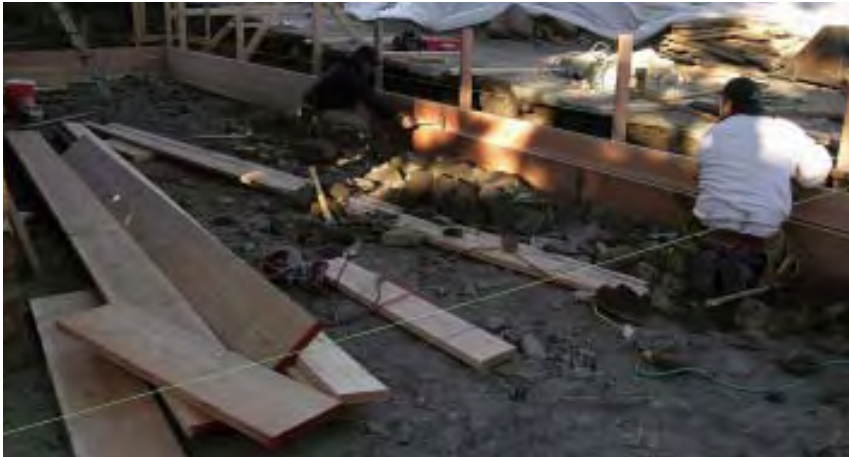
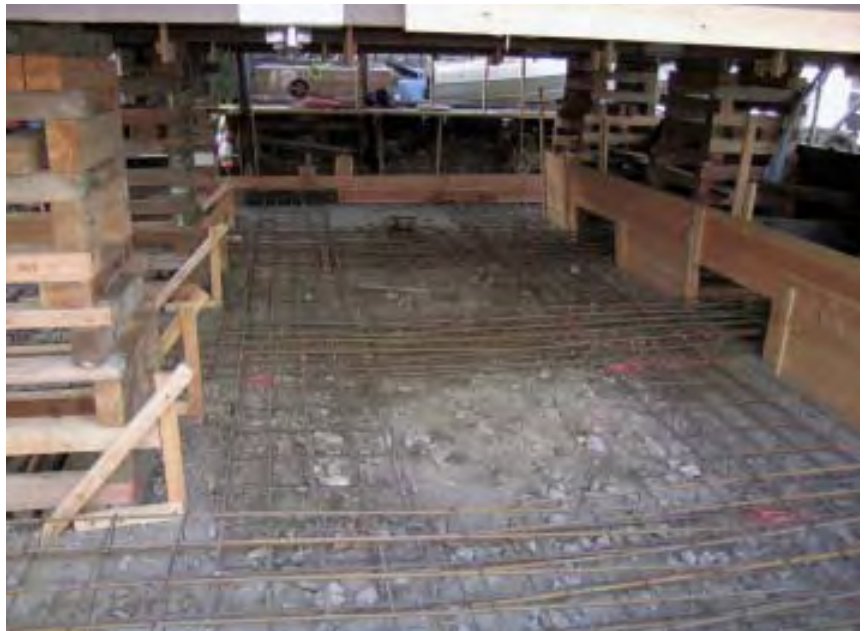
**Figure 4.** The concrete sub used a skid steer to excavate a flat surface for the grid to sit on (top). Next, his crew formed the perimeter (above), then laid and tied all the steel before forming the inner parts of the grid (right).

**Steel reinforcing.** The grid was heavily reinforced, with each grade beam containing 10 #6 bars, five on top and five on the bottom (Figure 4, next page). The crew connected them with #3 ties every 14 inches on-center and spaced them off the ground with small precast blocks called dobies.

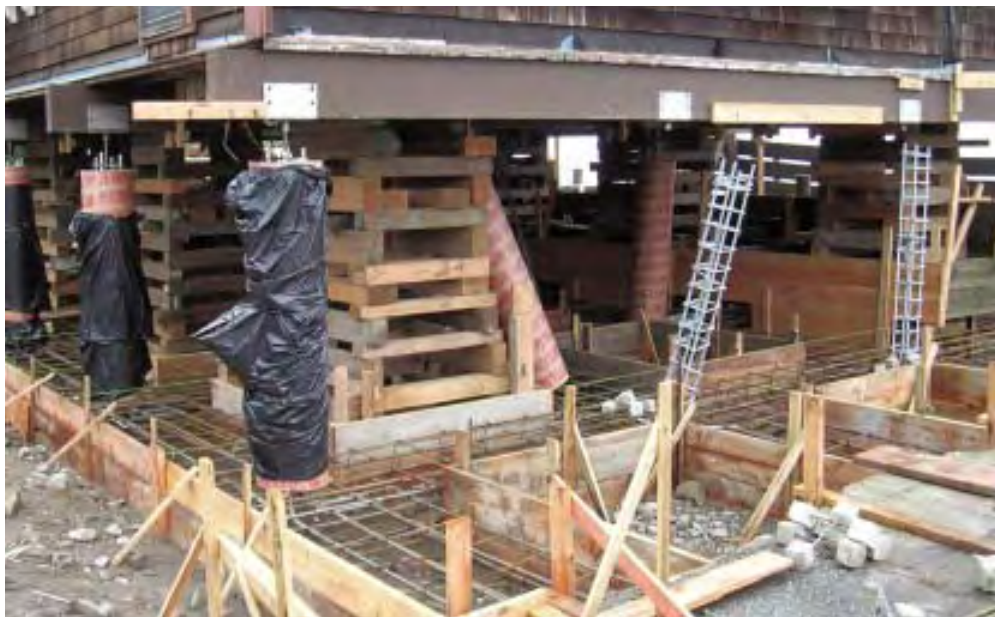
**Figure 5.** Once the steel was tied, crew members finished the formwork by boxing out the grid openings with 2-by-lumber, then installed the rebar cages for the columns. They wrapped the Sonotubes with plastic to protect them from exposure to heavy rain.

The columns projecting up from the footings contained cages of four #7 bars with #3 ties 6 inches on-center. We had the cages tied off site and sent out to be hot-dip galvanized. Before tying the cages into the grid, the crew slipped 16-inch-diameter Sonotubes over them (Figure 5, page 5). Fourteen-inch columns would have been strong enough, but with all that salt water around, we upsized them to get an extra inch of coverage over the steel.

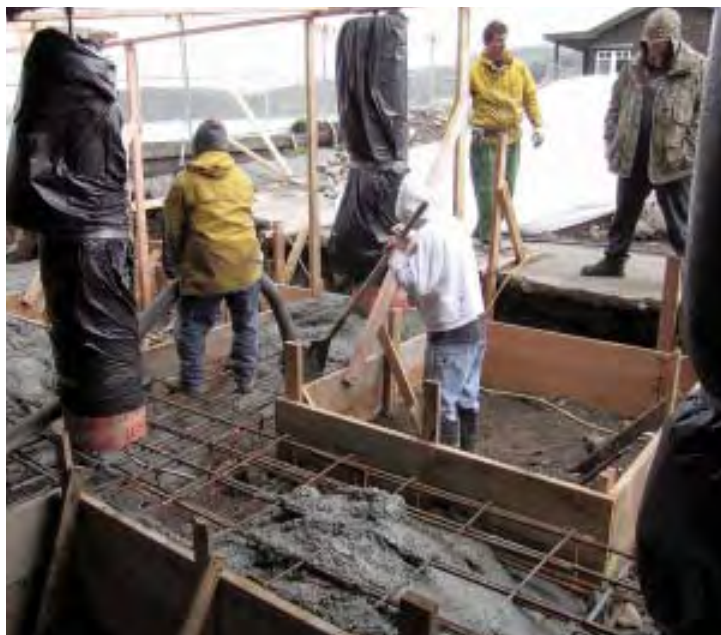
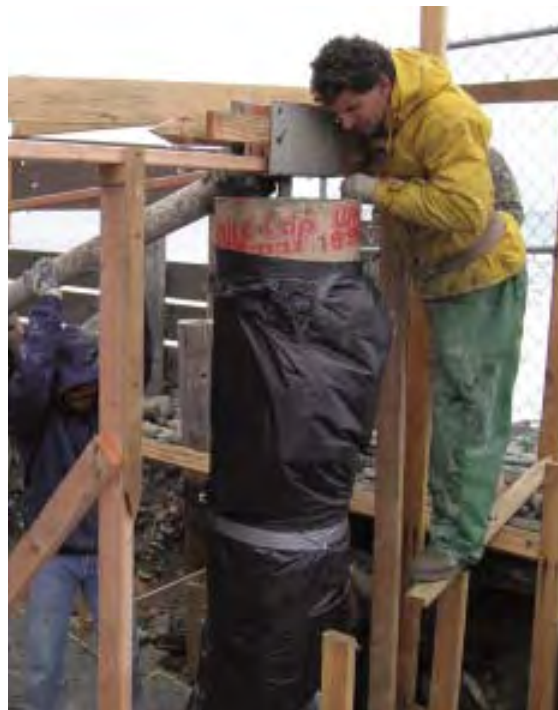
**Figure 6.** Access was poor, so the crew used a pump to place concrete for the grid (above) and columns (right).

It took eight trucks all morning to deliver the 77 yards of concrete needed to pour the grid and house columns (Figure 6, previous page). The design strength of the mix was 3,000 psi, but when the cylinders were tested at 28 days, we found that the concrete was already at 6,000 psi and would likely continue to gain strength for years.

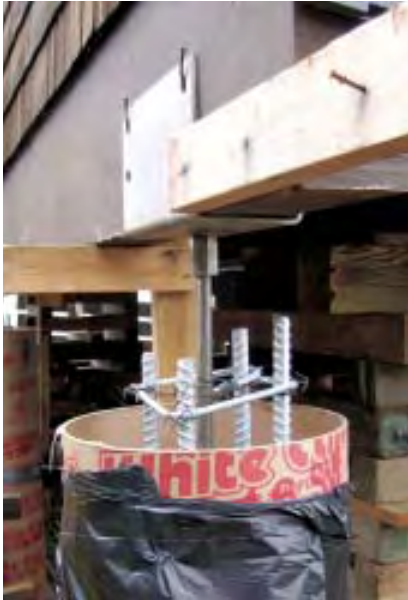
**Figure 7.** The threaded rod coming down from this column cap (above) is attached to a large nut and washer that will be embedded in the concrete. The Sonotube was lifted to within an inch or two of the beam before the concrete was poured, and the gap was later packed with grout. Because the column received a stuccolike waterproof coating, it's not possible to see the joint between the concrete and the grout (right).

been practical, because when we vibrated them, the concrete would consolidate and separate from the caps. So we poured the columns an inch or so short, then grouted them tight to the bottom of the brackets with high-strength grout once the concrete had set (Figure 7, page 6).

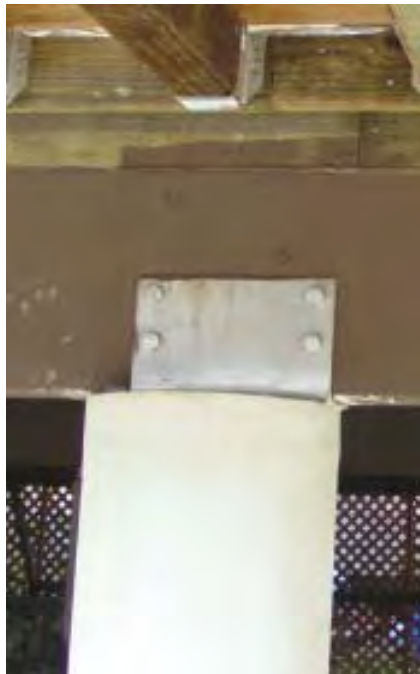
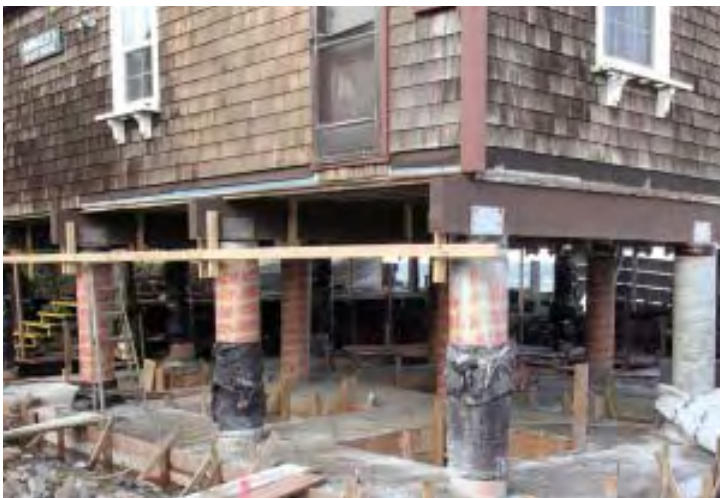
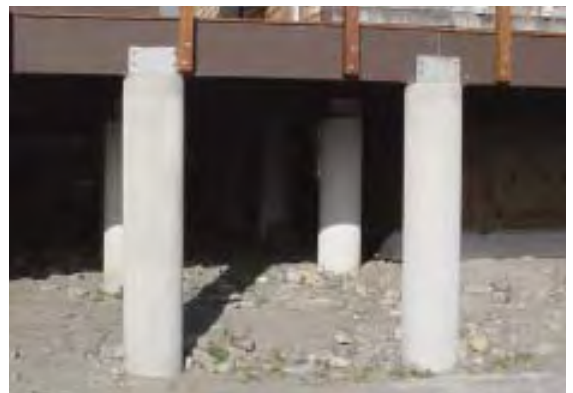
**Figure 8.** In the photo at left, the grid and columns are both visible. Once the foundation was backfilled, only the columns could be seen (above).

After about a week of cure time, the foundation was strong enough to support the cottage, so the house mover came back and removed the cribbing. We all breathed a sigh of relief once the cottage was firmly bolted to the new foundation. With the cribbing out of the way, we were able to bury the grid with the excavated material and begin working on the individual piers that would support the decks (Figure 8, page 6).

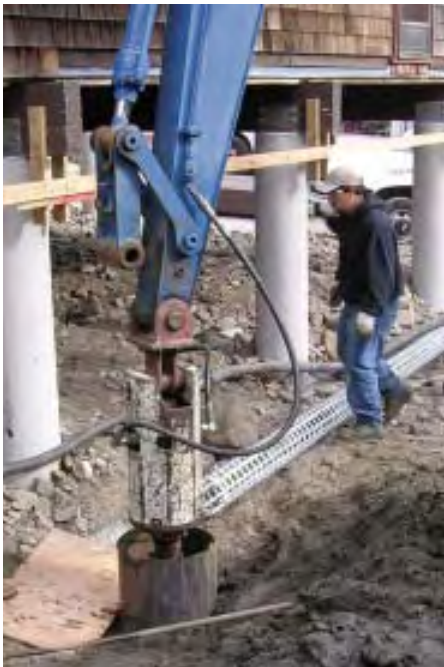
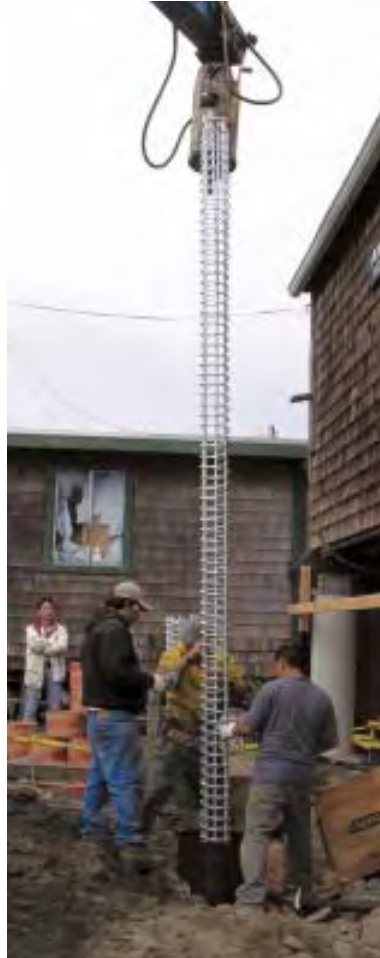
**Figure 10.** Before pouring a pier, the drilling contractor redrilled the bottom of the hole to make sure it hadn't filled up with silt (above). Like the columns, the piers were heavily reinforced with galvanized rebar cages (right).

drilling contractor redrilled the bottom of each hole to clean it out, placed the rebar cage, and began filling the hole with concrete (Figure 10, previous page). Because the holes were half filled with water, he put a tremie pipe on the concrete pump hose, inserted it into the hole, and pumped from the bottom up, making sure to keep the nozzle below

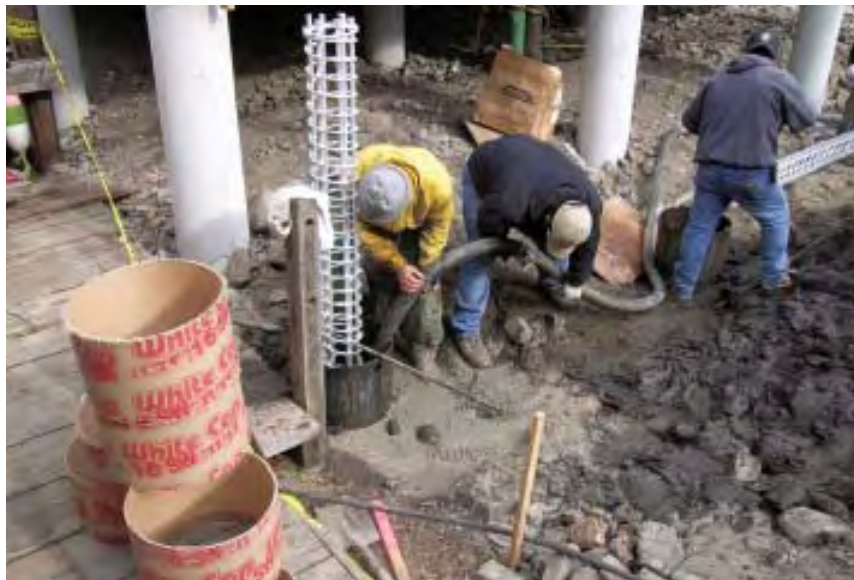
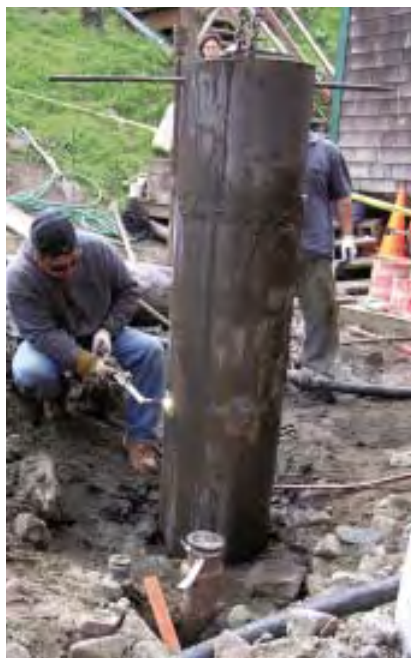
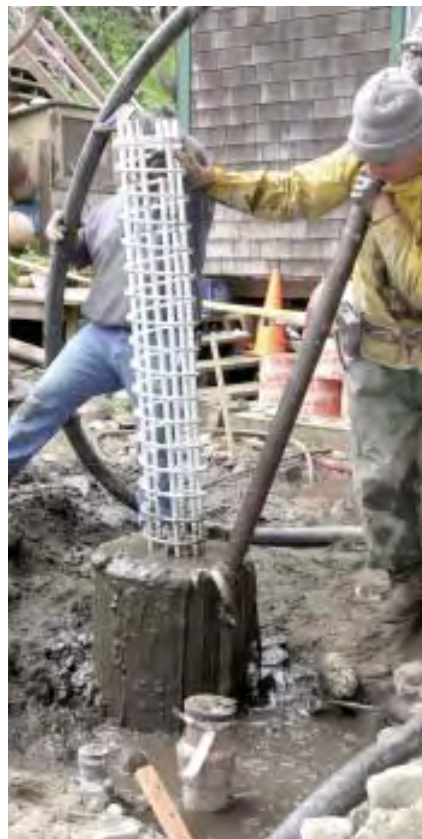
**Figure 11.** The crew pumped from the bottom up to prevent concrete from mixing with the water in the hole (left). The casing was pulled out as the concrete was poured. Below left, a welder cuts off a section that had just come out of the ground. The silt pouring out of the top indicates that this hole was nearly filled with concrete (below right).

Since concrete is denser than water, it forced the water and silt up and out of the hole without diluting or mixing with the concrete. As each hole was being filled, the drilling contractor vibrated the concrete and pulled out the casing, one section at a time (Figure 11, previous page). When the process was complete, the rebar cages projected several feet into the air and were encased in concrete up to grade.

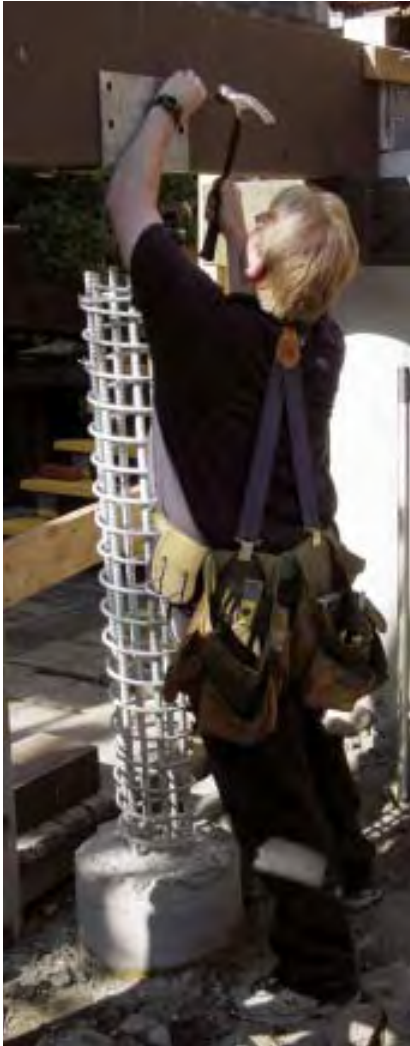
**Figure 12.** Once the piers were up to grade, members of the crew braced the deck support beams into position and installed the column caps (above). Then they formed up to the beam with Sonotubes and poured the rest of the way (right).

After the lower sections had set, our crew braced the deck beams into position and tacked stainless steel column caps onto them (Figure 12). Then all the drill-

ing contractor had to do was apply a bonding agent, Rezi-Weld 1000 (W.R. Meadows, 800/342-5976, [www.wrmeadows.com](http://www.wrmeadows.com)), to the top of the pier, flex the rebar off to one side, slide a Sonotube over it, and finish the pier by pumping the Sonotube full of concrete. That way, there was no possibility the piers would not line up with the beams or that the mounting brackets would be set at the wrong height.
