Replacing a Leaking Chimney Cap

by John Carroll

Built with concrete rather than mortar and detailed to shed water, this chimney cap should outlast the chimney beneath it

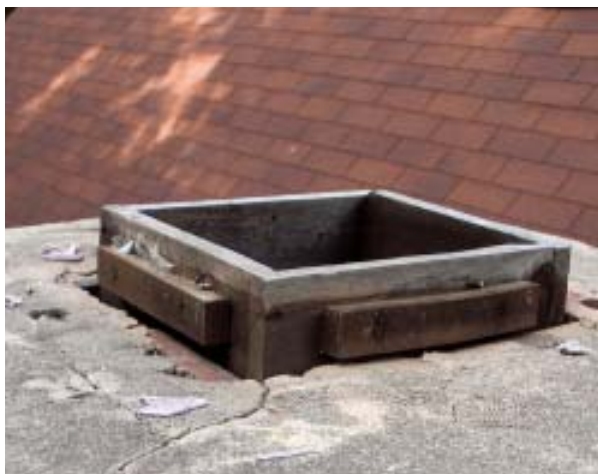
tar around the perimeter of the cap had weathered away, and cracks had formed in the rest of the cap. These cracks probably started the day the mason slathered on wet mortar to form the cap (see Figure 1, next page). As the mortar dried, the cap undoubtedly developed shrinkage cracks, allowing small amounts of water to

Figure 1. Though fast and easy to build, a mortared chimney cap soon develops shrinkage cracks that allow water to penetrate into the chimney, leading to leaks and deterioration.

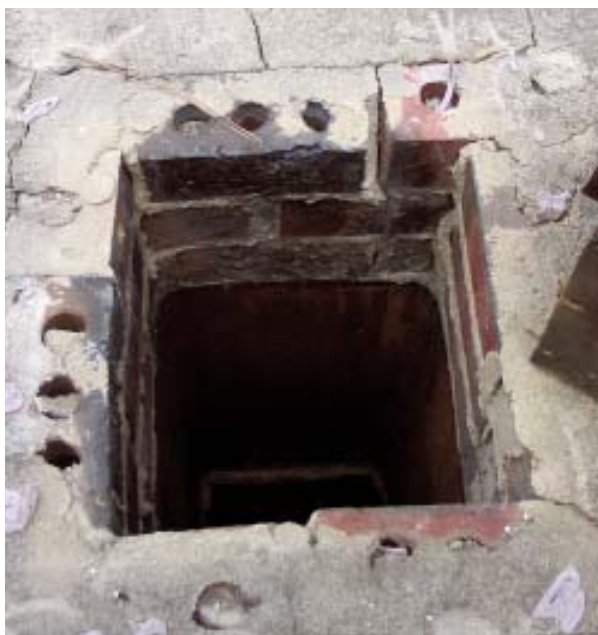
Figure 2. Instead of ending with a clay tile extending above the chimney cap, this flue was finished with brick, a code violation.

Also, this particular chimney was missing one section of flue liner. Apparently, the original mason ran short when he was building the chimney, because he used brick to finish the last 8 inches of the flue. In addition to being a code violation, this created a flat area on top of the bricks where water could pool (Figure 2). And, without a flue liner projecting above the cap, there was nothing upon which to clamp a metal flue cap and screen. These components aren’t always needed, but in this case, birds or squirrels had at some point taken up residence in the chimney; in an effort to keep them out, a previous owner had inserted a wooden bracket so that he could install a metal flue cap and screen. Because the present homeowner was unaware of the wooden bracket, this modification turned out to be a pretty serious fire hazard. The fact that the masonry cap leaked, therefore, may have been a blessing in disguise (Figure 3).

creating a safe and comfortable working height. Working from the scaffold, I used a grinder, hammer, and chisel to remove the three brick courses that made up the final 8 inches of the flue. I also ground away the featheredge around the perimeter of the existing cap. With a flashlight, I carefully inspected the rest of the flue liner, finding it to be in very good shape (Figure 5).

Next, I cut and installed a flue liner to replace the brick I had removed. Using a 4 1/2-inch grinder equipped with a dry-cutting diamond blade, I cut the flue liner down so that about 9 inches of the flue would extend above the top course of bricks on the chimney. The concrete cap would be 2 1/2 inches thick around its perimeter and slope up toward the flue, with a rise of about 3 1/2 inches, leaving roughly 3 inches of flue extending above the finished cap.

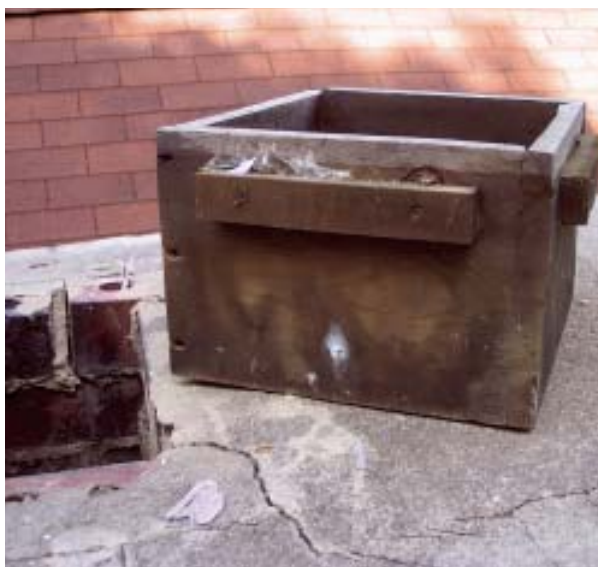
Figure 3. A previous owner had inserted a wood bracket into the top of the original chimney, creating a potential fire hazard.

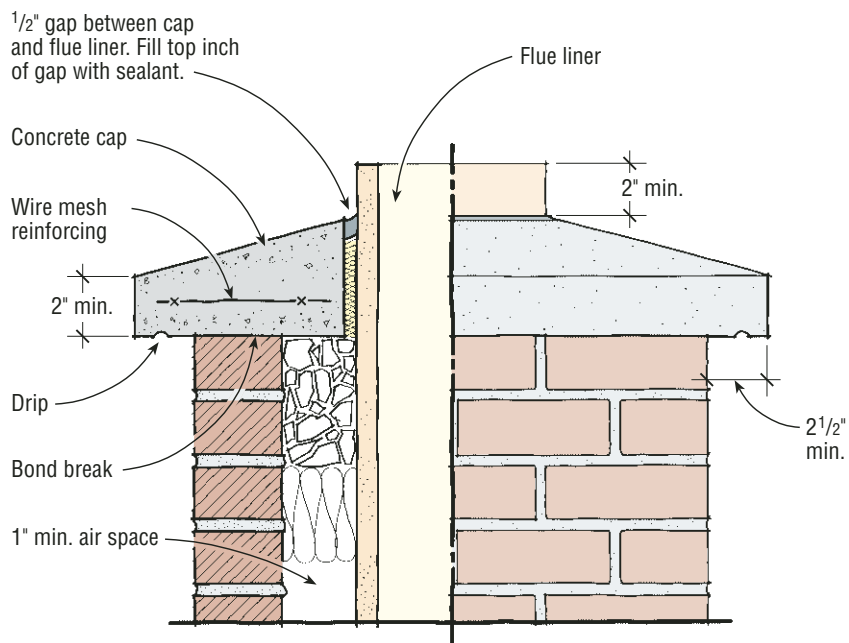
Section/Elevation

Figure 4. Built of concrete rather than mortar for durability, this industry-recommended chimney-cap design features a small gap around the flue that allows it to move independently of the cap when it heats up and expands.

Building a cap to Masonry Institute of America (MIA) and Brick Industry Association (BIA) standards adds several hundred dollars to the cost of a chimney and ties up a mason’s scaffolding for several days (Figure 4, next page). It’s faster and cheaper to simply apply a 2-inch-thick layer of mortar around the flue liner and taper it down to a feather-edge at the outside of the chimney. That way, the mason not only uses up his mortar and finishes the chimney in one step, but he can begin taking down his scaffolding an hour or so after laying his final brick. There is an undeniable short-term economy to this method, but over the long haul such a cap is bound to fail. Properly built, the cap should last the life of the chimney, not just a decade or two.

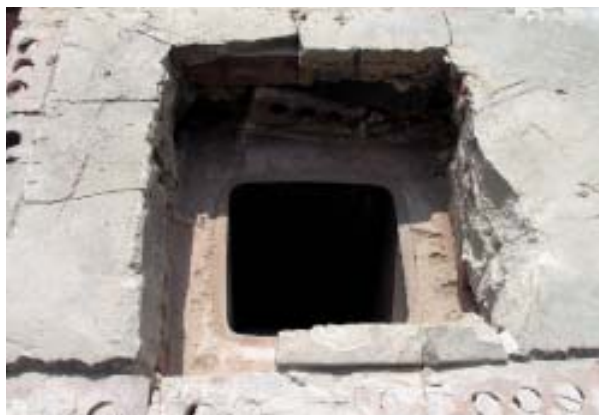
Figure 5. To prepare the chimney for a new cap, the author removed enough bricks to expose the top of the last clay tile and ground away the remnants of the old chimney cap.

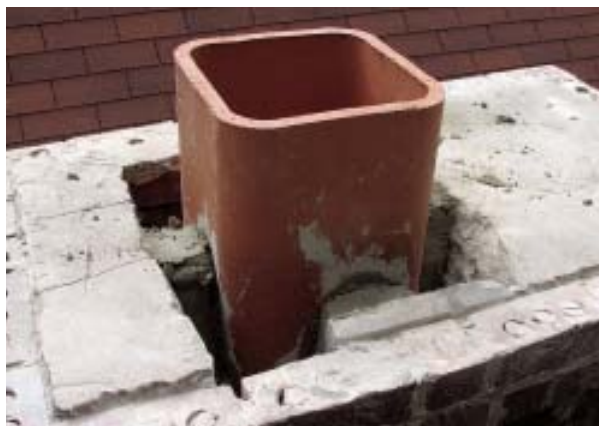
Figure 6. Supported by columns of mortar, the new clay tile extends 9 inches above the level of the chimney, leaving plenty of room to accommodate the thickness of the new concrete cap.

I used refractory mortar to join the new flue liner to the old. To hold the liner in place, I used columns of mortar. Industry literature calls for a 1-inch air space between the flue liner and the structure of the chimney, but most codes also require that the flue lining be supported on all sides. To achieve this contradictory goal, the IRC states that "only enough mortar shall be used to make the joint and hold the liners in position." The columns of mortar were what I deemed sufficient to hold the liner in place (Figure 6).

After letting the mortar columns set overnight, I filled the spaces around the flue liner with sand. Since the entire flue liner was already thoroughly encased in the masonry structure below this final piece of the liner, I was not terribly worried about the air space for the last 8 inches below the cap. I filled it with sand to keep the concrete from the cap from filling the space around the flue. This allowed me to hold the flue in place while accommodating any slight upward movement of the flue liner through the cap. If the chimney had had a functional air space surrounding the flue, I could have used sheet metal or tile backerboard to cover the gap on top.

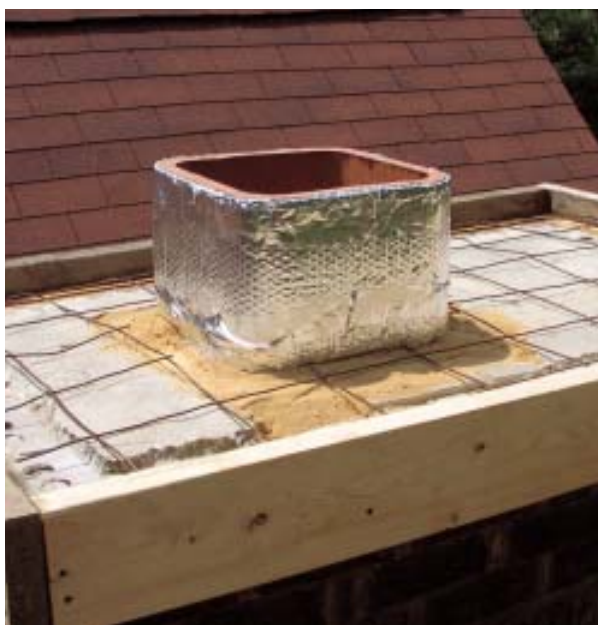
Figure 7. A double layer of 2-by material was used to build a tightfitting form around the chimney. To create a bond break between the flue and the concrete cap, the author wrapped the clay tile with thin insulation. Sand fills the gap around the flue while allowing for differential movement.

The form for the concrete cap consisted of two layers. The first, made of 2x4s, created a ledge that would cause the concrete to extend 1 1/2 inches past the top course of bricks. I installed this layer of the form so that it was even with the top outside edge of the final course of bricks. Because I was working alone, I used bar clamps to position and hold the pieces initially, then tied them together with 3-inch deck screws.

The second layer of the form, made of scrap 2x6s and 2x8s, formed the outside edge of the cap. To give the cap a substantial 2 1/2-inch thickness around its perimeter, I set the top of this layer 2 1/2 inches above the top of the inner layer of the form. Once again, I used clamps to hold the pieces in place while I secured them with screws. Because I was careful to cut and fit the pieces of the form tightly, it held fast to the chimney by friction alone when I was finished. If I had not been satisfied that the form would stay put, I could have used my bar clamps to hold it in place.

A bond break is important. My next step was to wrap the flue with foil-faced bubble-pack insulation. Approximately 1/4 inch thick, inflammable, and easy to wrap around the flue liner, this product is the best I've found for isolating the concrete cap from the flue. It has enough body to hold back the concrete during the pour, yet contains air spaces that allow for differential movement between the cap and the flue (Figure 7).

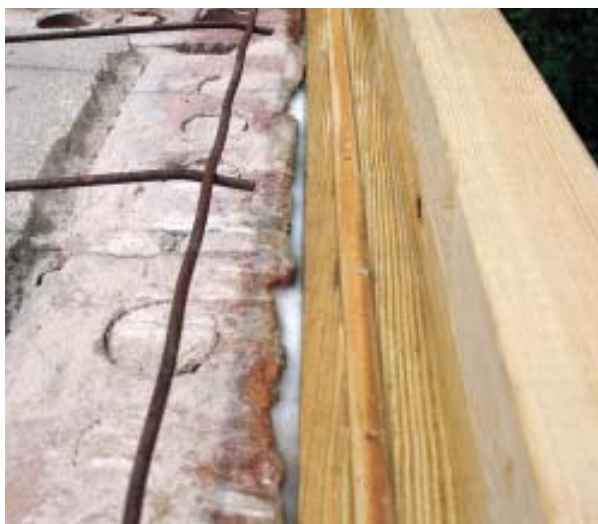
Figure 8. Wire mesh was used to reinforce the concrete; small 3/8-inch-square strips of wood placed in the bottom of the form created a drip edge in the concrete cap after the form was removed.

Because the surface of the brick was irregular, I was concerned about the form leaking when I filled it with concrete. I didn't like the idea of wet concrete running down the outside face of the chimney, so I caulked this seam with clear silicone caulk. To reinforce the concrete, I cut and installed 6-by-6 welded wire. I also installed 3/8-inch-by-3/8-inch strips of wood on top of the inner layer of the form to create a drip channel on the bottom of the cap overhang (Figure 8). To make it easier to remove these strips after the concrete cured, I rubbed paraffin wax on them.

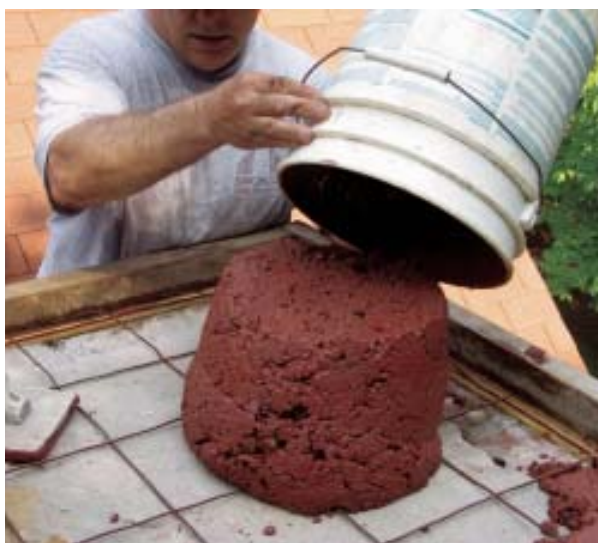
Figure 9. Dyed to match the color of the roof shingles, the concrete used to form the cap had virtually no slump, which minimized shrinkage during curing and made it possible to push the concrete into shape.

next day, I poured the concrete cap. Because I wanted the concrete to blend in with the chimney and the roof, I mixed in a reddish brown dye while adding just enough water to thoroughly hydrate the concrete, so that it had almost no slump (Figure 9, previous page). The concrete was, in fact, so stiff that it had to be pushed and pounded into place. But the stiffness prevented it from running over or through the form, and allowed me to form, stack, and shape the cap by hand. Also, because the mixture was so dry, there was very little shrinkage; as a result, no shrinkage cracks developed as the concrete cured.

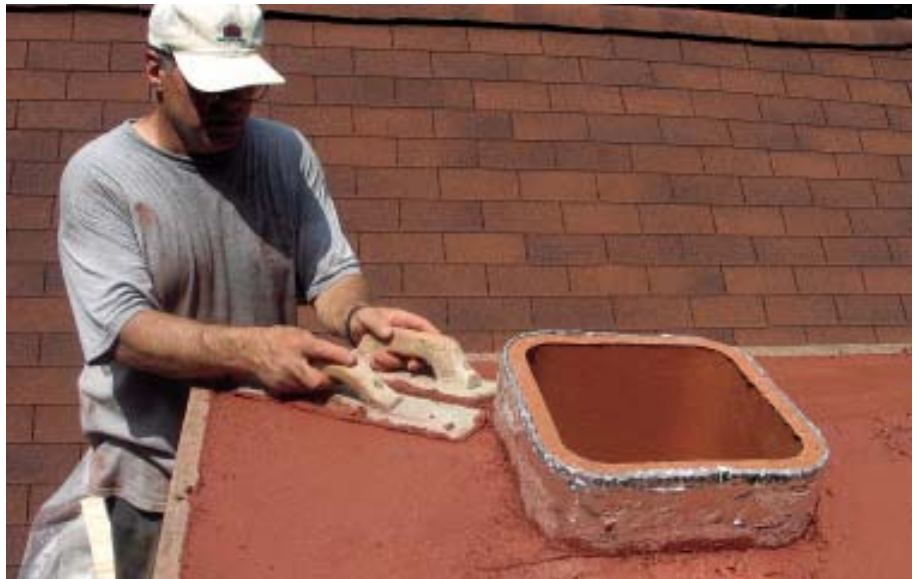
Figure 10. To create the hips of the chimney cap, the author used two floats. He pushed the concrete into position and smoothed out high and low spots so that the cap would easily drain water away from the flue.

My goal in forming the cap was to create straight, flat planes that rose from each side of the form to a point about 3 inches below the top of the flue liner. I wanted the intersection of these planes to form straight lines, much like the hips on a hip roof. I used hand floats to push the material into place; by lightly rubbing the surface in a circular motion, I was able to knock down the high points and fill in the low points. I used two floats at once to get a crisp line along the hips. At this point, my objective was to get the shape right. I wanted the surfaces to be flat and straight, but because I wasn't trying to make it perfect I did everything by eye (Figure 10).

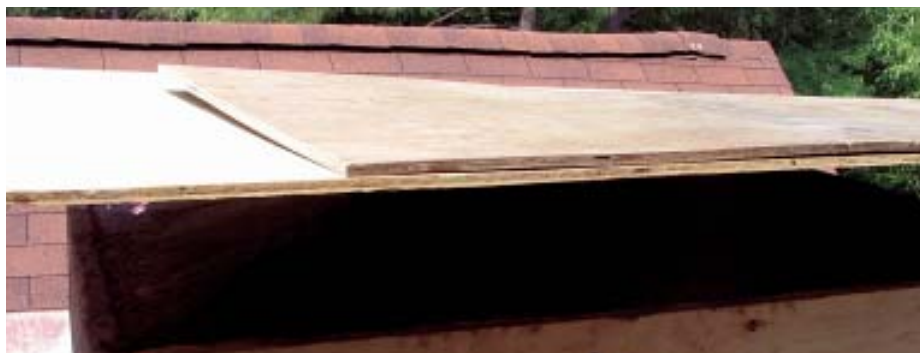
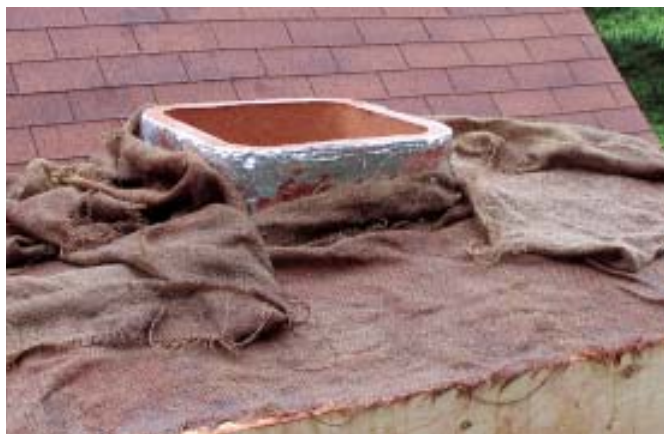
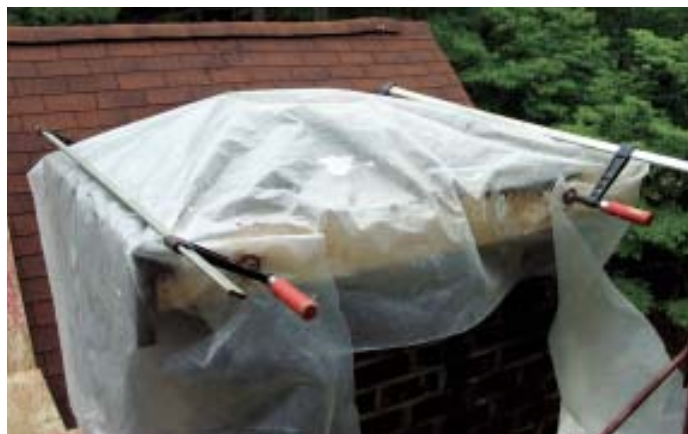
Figure 11. Plywood placed on top of the flue prevented the hot sun from accelerating the cure of the newly poured concrete cap (left). After the initial set, the author covered the cap with wet burlap (below left), then wrapped the top with plastic held in place with bar clamps (below), a procedure repeated for three successive nights to promote proper curing of the concrete.

Cure slowly for best results. When I finished shaping the cap, I turned my attention to the proper curing of the concrete. Hydration — the chemical reaction that takes place when concrete cures — requires water, and it's essential to keep concrete from drying out prematurely. Therefore, I began by setting a couple of sheets of plywood on the top of the flue to get the concrete out of the sun. The temperature was in the 90s and the sun was shining brightly, but this measure kept the concrete in the shade for the rest of the afternoon. That evening, after the initial set of the concrete, I covered the cap with wet burlap. Then I covered the wet burlap with plastic and used two bar clamps to hold the plastic in place. The next night,

I removed the plastic, soaked the burlap with water, then replaced the plastic. I repeated this routine each day for three days to make sure the concrete stayed damp for 72 hours (Figure 11).

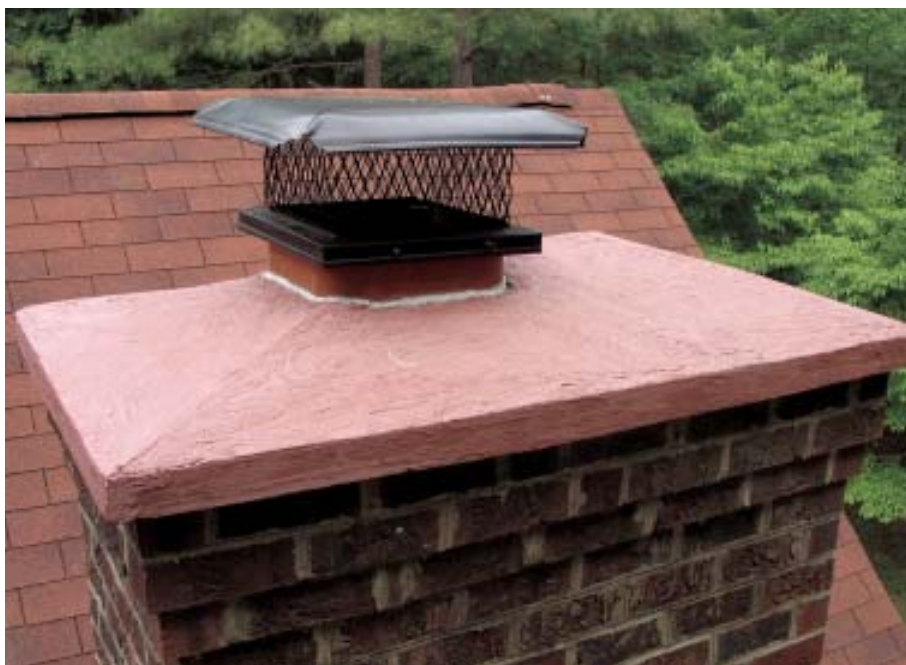
Figure 12. Rubbed with a colored cement-and-sand slurry that was applied with an abrasive stone, the finished chimney cap has a textured finish. It should last as long as the chimney it protects.

After the concrete cured, I removed the forms and did some final work on the surface of the concrete. I began by mixing up a rich slurry made of 50 percent portland cement and 50 percent sand, using enough water to make it the consistency of wet grits. I also added dye to make this concoction the same color as the concrete, then rubbed it into the surface of the concrete with a Carborundum rubbing stone. In this way, I filled in the honeycombs and knocked down rough edges and high spots (Figure 12).

The next day, I cut the aluminum insulation so that it was even with the top of the cap and pushed the top edge of it down into the crevice between the flue and the cap. Then I filled the joint with a gray silicone sealant to complete the job.
