## One Day at a Time

## Katrina Reports Offer Expert View of Wind Damage to Wood-Frame Buildings

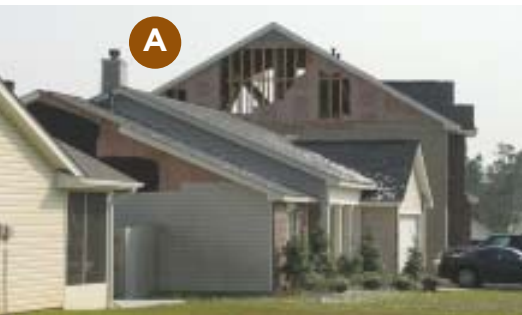
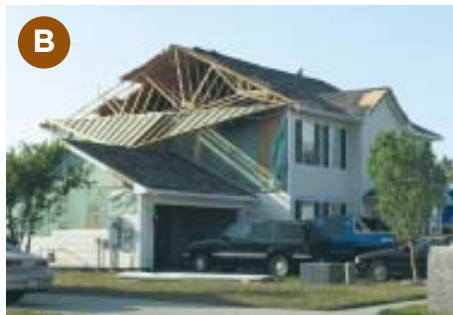
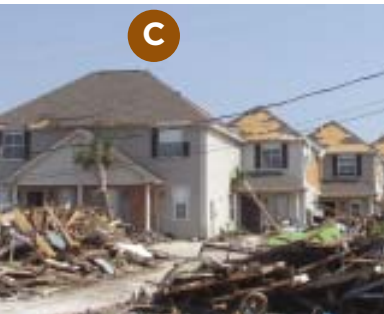
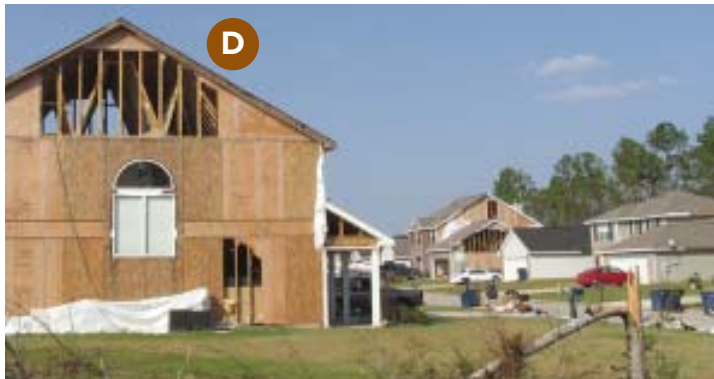
Gable roofs (A,B) typically sustain greater damage from high winds than hip roofs (C). Note the intact hip roof (D) in a neighborhood where gabled homes are stripped of siding and have lost sheathing.

The damage they found was similar to that seen in earlier hurricanes. Exposed gable ends fared poorly compared with hip roofs (see photos, page 2. Roof edges typically experienced greater damage than the field of the roof, suggesting that perimeter sheathing should be nailed more closely and shingles should be both nailed and glued down in vulnerable areas (photos, left).

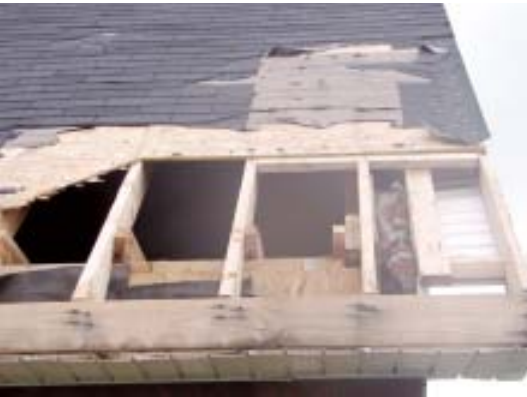
Wind forces are greatest at roof edges (above and right). Perimeter sheathing should be nailed at a closer spacing in high-wind regions.

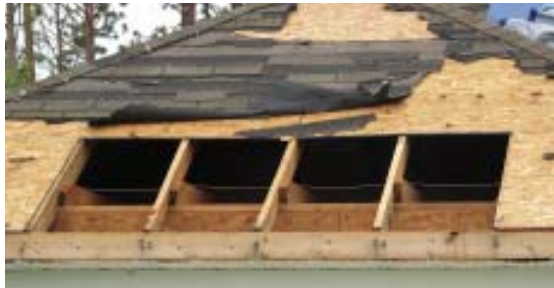
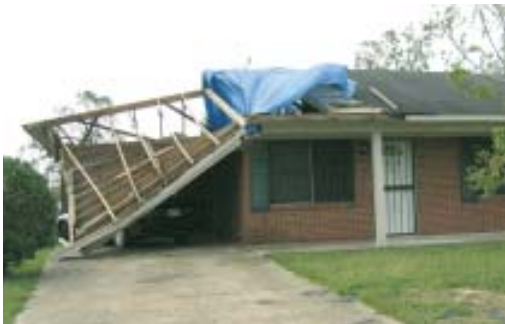
On this home (far left), the roof over the carport was framed as a continuation of the main roof, but the posts supporting it were not anchored. When the wind lifted the carport, the roof of the house was also breached. Nearby, a properly anchored porch post (left) held fast, losing only some of its vinyl trim.

The lack of hold-downs and metal connectors also contributed to the destruction, as did shoddy nailing of roof sheathing (photos, next page).

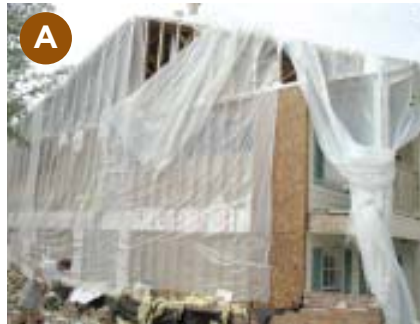
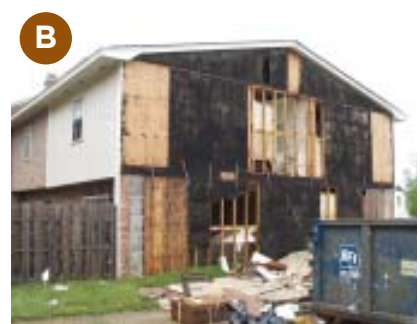
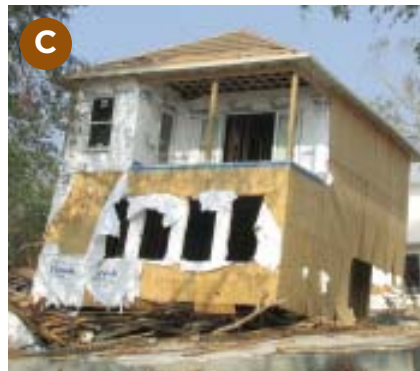
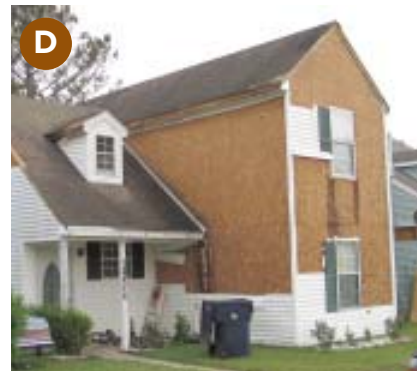
While it is not uncommon for hurricanes to pull off siding, what's underneath often determines the extent of the building's damage. This building (A) lost its brick veneer, which was inadequately tied to the foam sheathing beneath. Once the siding was gone, the foam panels blew off, exposing the interior. Note the intact OSB panels at the front corner. In a similar case (B), plywood panels held while fiberboard sheathing came loose. Though this home (C) next to the Gulf was swept from its foundation, its frame was remarkably preserved because of the plywood sheathing. A home sheathed with OSB (D) fared well despite loss of its vinyl siding. However, the omission of building paper beneath the siding contributed to water intrusion; note the stains beneath the gable window.

Many homes in the region were built with a mixture of sheathing types — enough structural panels to meet code, infilled with nonstructural panels, which cost less than plywood or OSB (photos, page 4). One of the most striking and repeated observations in the reports is that nonstructural sheathings — fiberboard or rigid foam — often blew right off, leaving the house wide open to the rain. While the intact structural panels — mostly OSB — may have protected the frames from complete destruction, water damage from the breaches was severe and costly.
