Installing a Twenty-Foot Header

Retrofitting a half-ton steel I-beam into an existing house calls for careful shoring and lifting As a framing and finish subcontractor working in the suburbs north of New York City, I get my share of interesting remodeling projects. One recent favorite was a two-story addition on the back of a conventional two-story colonial. The first floor of the addition doubled the size of the existing kitchen; upstairs we added a new laundry and a master bath complete with a 6-foot whirlpool tub.

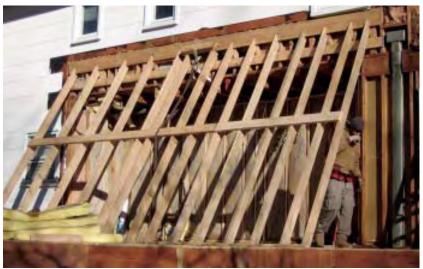
Figure 2. A 2x10 ledger fastened to the studs with ¹/2-inch lag screws serves as an attachment point for the 2x8 diagonal braces (above left). A second ledger beneath the top end of the braces keeps them snugly in place and helps prevent splitting. A sheathed, insulated 2x4 wall on the inside picks up the second-story floor loads (above).

Luckily, the GC took care of removing the asbestos siding from the area where the addition was going; to get started, we just had to pull off the sheathing and remove an existing window and door. Before installing the diagonals, we fastened a temporary 2x10 ledger above the new opening, using 1/2-inch lag screws. We predrilled the studs to prevent splitting, and used plenty of 16d commons as well.

After placing the 2x8 diagonals, we attached a second ledger underneath to prevent them from slipping and to contain the inevitable splits at the notches (Figure 2, page 3). We nailed them off at their bases to a plate secured to the floor framing.

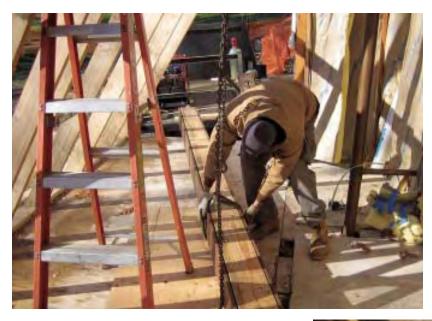
Figure 5. A chain hoist attached to the temporary ledger supplied lift (top photos). After the hoist maxed out, a pair of heavyduty ratchet straps finished the job (above).

At 48 pounds per foot, our 19-foot 8-inch header weighed almost 1,000 pounds. We rolled it off the truck on PVC pipes to get it into position, then used a chain hoist to raise it (Figure 5).

We strapped the chain hoist to the temporary 2x10 ledger, found the balance point on the beam, and carefully lifted, keeping an eye on our ledger and shoring as we went.

When it became obvious that we would max out the chain hoist capacity, we finished the lifting with a couple of 1,000-pound-capacity ratchet straps.

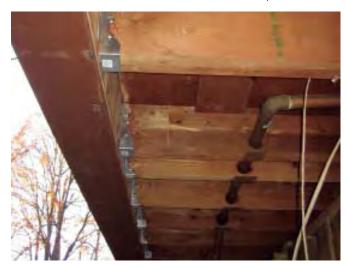
Figure 6. Four-inch steel columns with welded caps and base plates support the beam at each end. Note the ½-inch-drive ratchet's drift handle, used for lining up the predrilled bolt holes (above). The column bottoms (above right) would be secured later with one ½-inch wedge anchor each; the inside hole landed too close to the edge of the concrete for drilling.

Once the beam was in near-final position, we slipped in the 4-inch-square columns and bolted everything together (Figure 6). We'd had the columns made to exact length, which made it a little tough to get the beam into place. We used a post on a bottle jack to lift first one end of the beam (and the house, too) and then the other end, so we could get the column bases seated.

Only then — when the beam had solid bearing — did we remove the ratchet straps. We checked the posts for plumb, then installed a couple of wedge anchors through the base plates into the foundation.

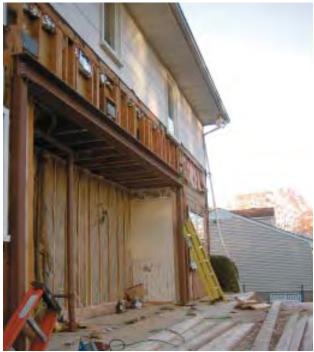
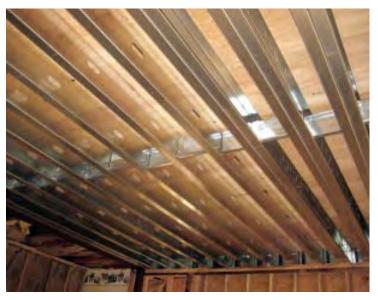
Figure 7. The author used conventional face-mount hangers nailed to the header to support the joist ends on the existing part of the house (above). With the hangers installed and the post bases fastened to the foundation, the ledger and 2x8 supports came down. The temporary wall was left in place to keep the house clean and offer weather protection (right).

Next we attached the existing second-floor joists to the beam. To maintain a consistent ceiling plane, we jacked each joist individually to the proper height, toenailed it snug, and installed the hanger. We used a powder-actuated tool to fasten the exterior wall plate above to the top of the header. Finally, with everything secure, we took down the diagonal bracing so we could frame the rest of the addition (Figure 7, page 6).

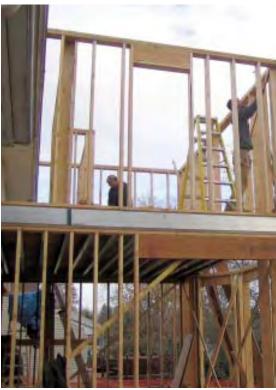
Figure 8. Eight-inch-deep steel joists on 12-inch centers provide a clear-span ceiling in the kitchen. The doubled joists on the right side of the photo at left support the whirlpool tub. The steel band joist is visible between floors (above).

The rest of the framing was a piece of cake — except for the time spent dealing with the steel floor joists (Figure 8).

If you're used to working with wood, steel framing takes a lot more time. You cut with an abrasive cutoff saw, and all the connections have to be made with an impact driver and self-tapping screws. It took a while to align the precut holes for plumbing and electrical rough-in, and we had to install a row of blocking midspan.

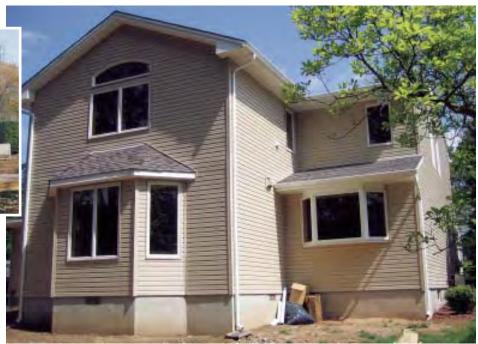
Figure 9. The addition didn't just furnish extra space; it dramatically improved the appearance of the original rear facade. Inside (bottom), the new kitchen.

We hid the steel posts supporting the I-beam in the 2x6 walls of the addition. The addition's roof and overhang details had been designed to match the existing house (Figure 9), and once the entire house was sided with vinyl, the addition looked as if it had been there forever.
