# Common Callbacks

*In the face of wind-blown rain and short drying cycles, coastal exteriors are shown no mercy*

by Steve Easley

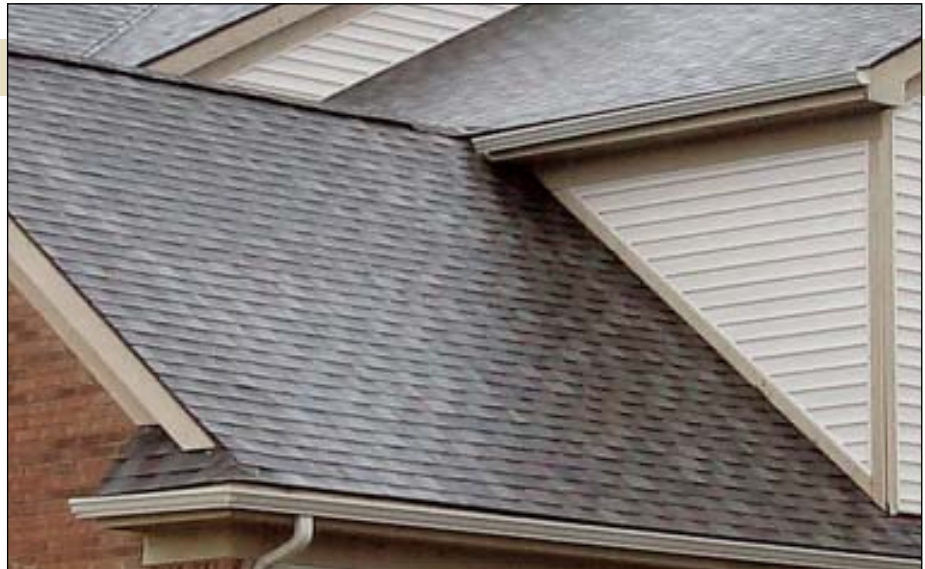
▲ **Ridge intersecting eaves.** The problem with this design is that all the water that runs off the higher roof is collected into the gutter. Note that there is no downspout, so all the water that runs off the higher roof runs toward the poorly flashed ridge cap of the intersecting roof. The solution is to drop the ridge so the eaves and the gutter of the higher roof can run uninterrupted above the lower roof ridge. And, of course, pitch the upper gutter to a downspout at the corner.

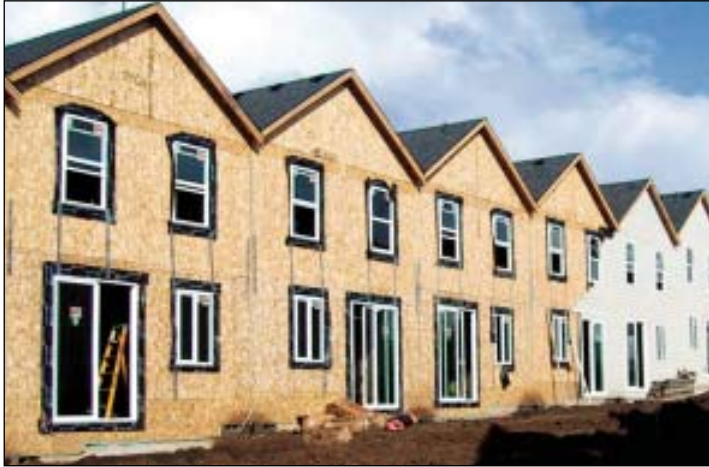
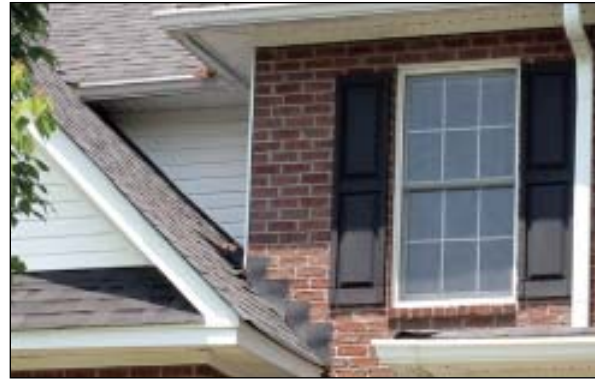
▲ **Horizontal valleys.** Whenever a valley runs into a horizontal plane, the water flowing down that valley will become trapped. If there's enough water at one time (or it turns to snow), it's likely to back up under the shingles and flashing. A whole series of horizontal valleys has been created between these condo units (above left). Such poor-draining roofs means the builder is more likely to face a lawsuit from the homeowner's association. Another common mistake is a roof sloping into a vertical wall (above right), creating a horizontal valley condition that leads to leaks.

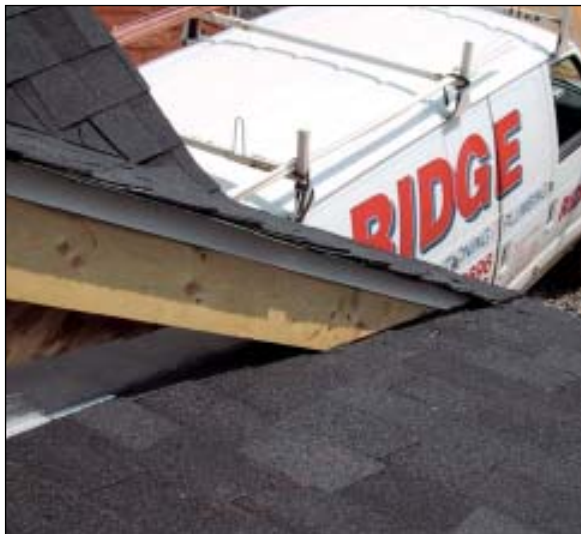
▼ **Poorly conceived roof intersections.** Wherever two roofs of different pitches intersect, it's important to detail the intersection so that water can shed away from the structure. In this example, there's no way for water to drain off the lower roof (in the foreground) without getting funneled into the wall, where the eaves of the second roof blocks its way.

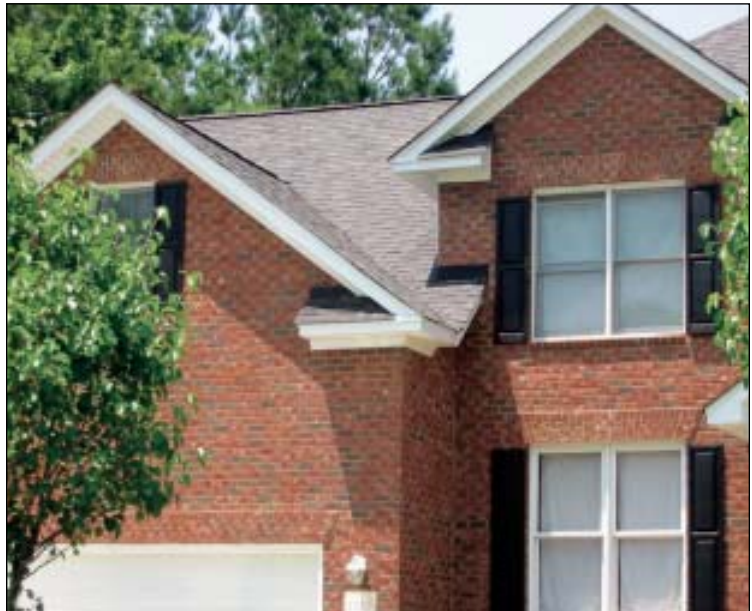
▲ **Design solution.** Here's one example of how to detail intersecting roofs to avoid a horizontal valley. By keeping the gable ends on different planes, the valley is allowed to run unbroken, so water can drain away freely.

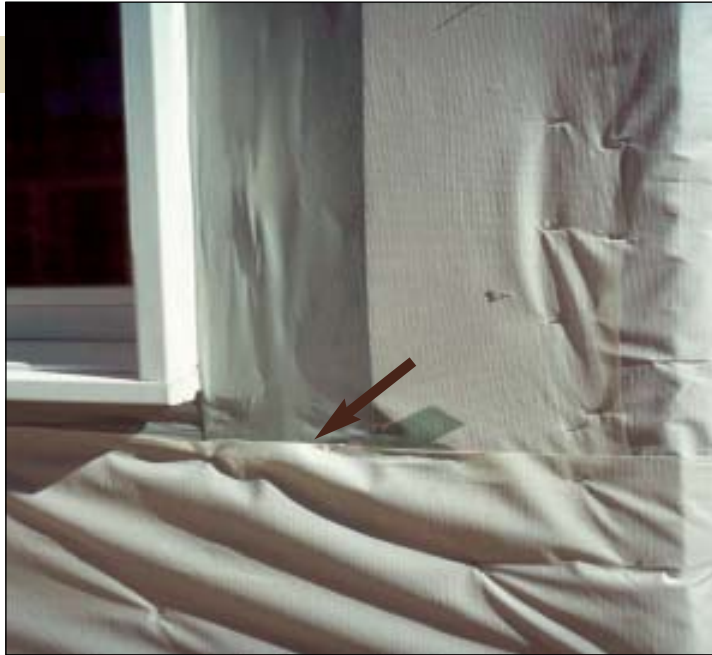
▲ **Reverse-shingled housewrap.** If you follow the arrow above, you can see that the secondary moisture barrier is reversed-shingled — the bottom layer overlaps the top layer, which means that any water that gets in behind the cladding can easily be funneled into the wall rather than draining away from it. When wrapping a wall, always start at the bottom so each successive layer overlaps the layer below.

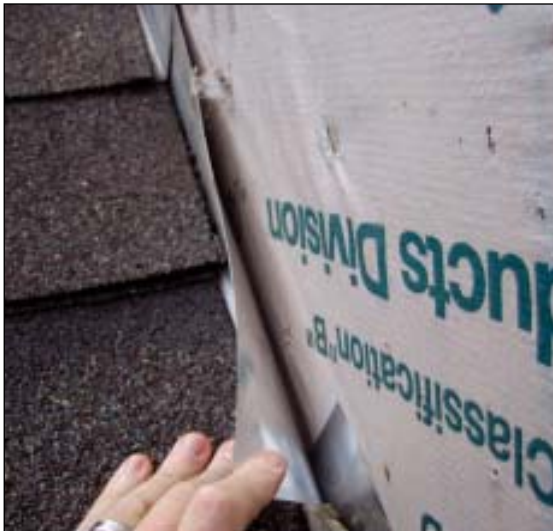
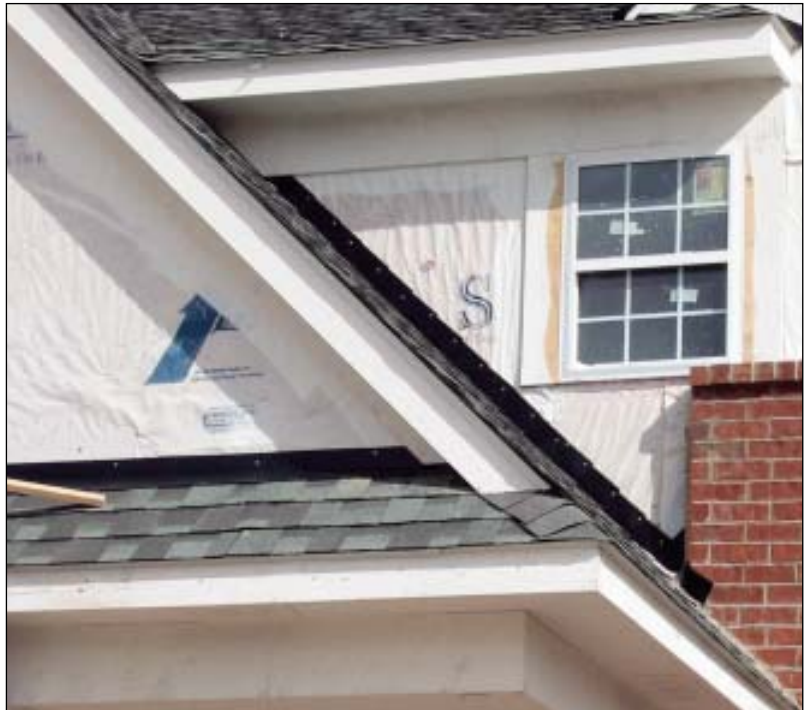
► **Reverse-shingled step flashing.** Each piece of step flashing shown in these two cases (above and right) is applied over the one below it, which is correct. But they are *all* applied over the housewrap. Best practice calls for installing the step flashing over the wall sheathing, followed by a piece of flexible peel-and-stick flashing over this, so that the sheathing itself functions as a tertiary moisture barrier. Housewrap — the secondary barrier — should overlap the peel-and-stick, and then cladding — the primary defense — would overlap the housewrap. The wall shown in the photo on the right has the added problem that water has a chance to become trapped where the roof meets the brick veneer — an example of the drainless design described previously.

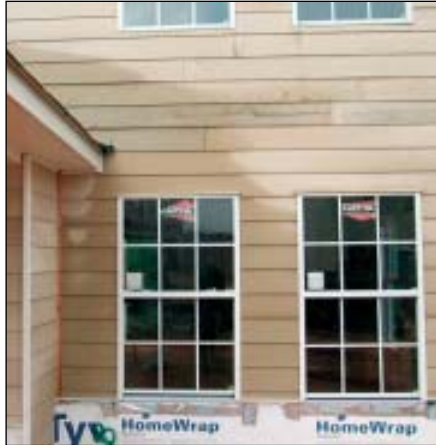
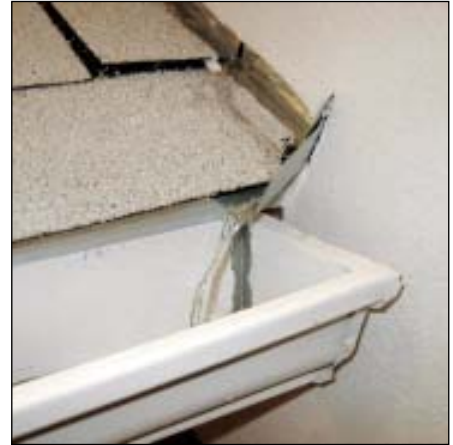
▲ **No kickouts.** The concentrated water flowing off a sloped roof can soak side walls (above left), concentrating the moisture load right at vulnerable window headers (not a great design). The solution is to divert the water away from the wall using kickouts — small pieces of sheet metal placed at the end of the step flashing and sealed to the wall and roof sheathings with some peel-and-stick flexible flashing (above right).

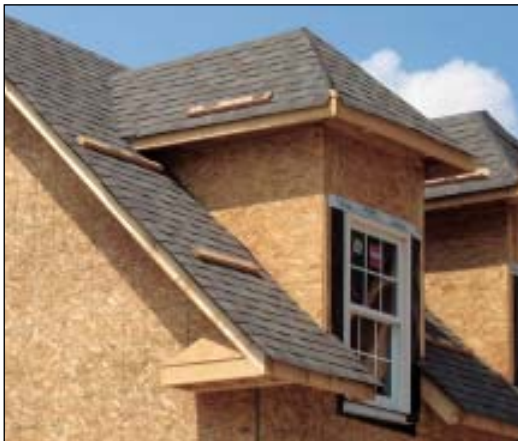
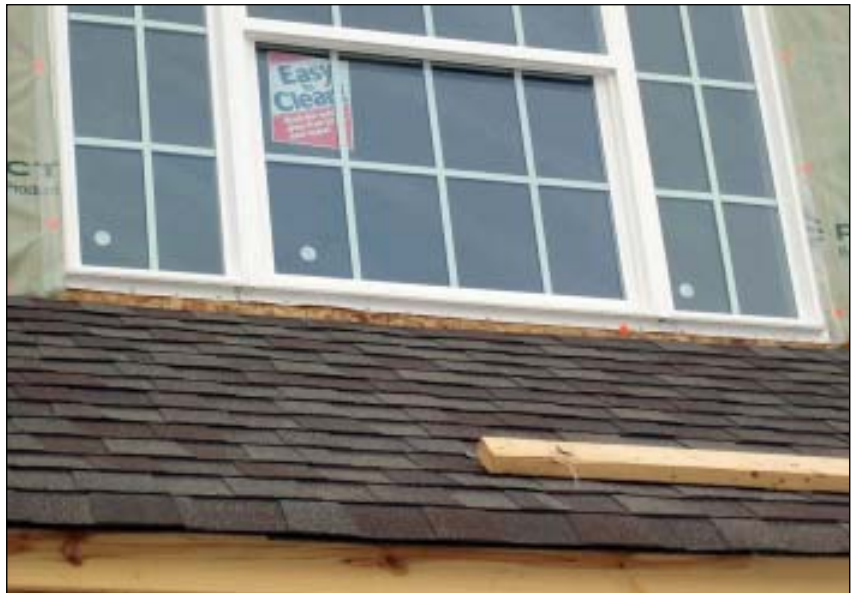
► **Missing flashings.** The window at right has neither sill flashing underneath the windowsill (to direct water that leaks through the window to the exterior) nor step flashing underneath the roofing shingles where it intersects the wall (to protect against splashback). On the dormer below, step flashing should be installed underneath the shingles on the roof and underneath a water-resistive barrier on the wall of any sloped roof that intersects a wall.

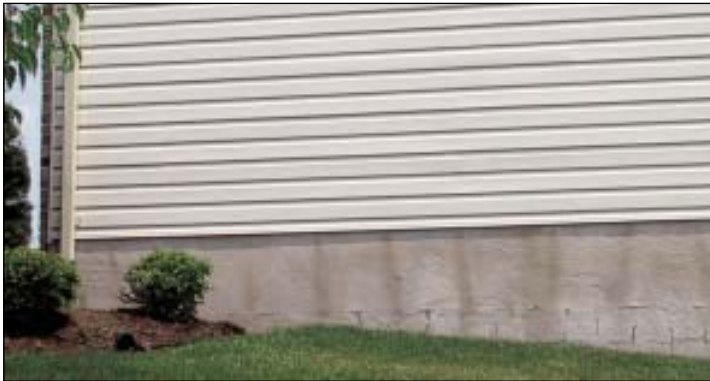
▲ **Like all cladding**, vinyl siding leaks. By design, it is made with weep holes to allow for drainage, but it needs a good drainage plane behind it to protect the wall. In this example, the secondary moisture barrier is doing its job, shedding enough water that wet spots are clearly visible underneath the vinyl siding.

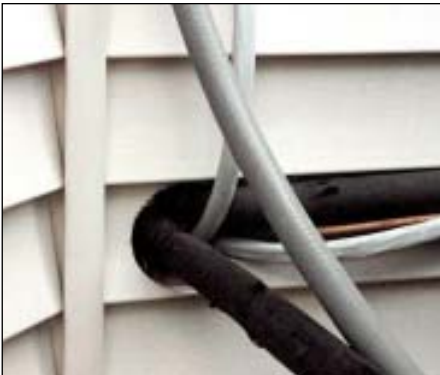
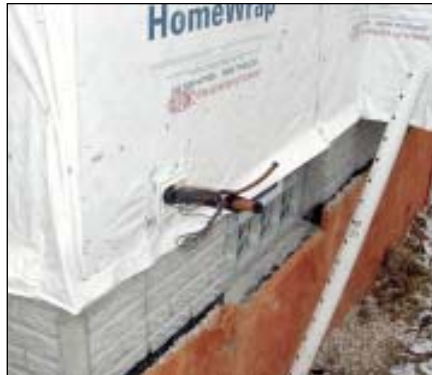
▼ **Unprotected wall penetrations.** It takes only minutes for wall components to get wet, but it takes days weeks or months for them to dry out. If the wetting rate exceeds the drying rate of building materials, mold and decay can occur. Notice that there is no flashing around the air conditioner line set and electrical wires coming through the wall (below left). It would be very easy for water to run down the wires and flow directly into the opening. The proper way to handle this penetration (below right) is to use a flashing boot that is tightly sealed with an acrylic-based tape or flashing materials.

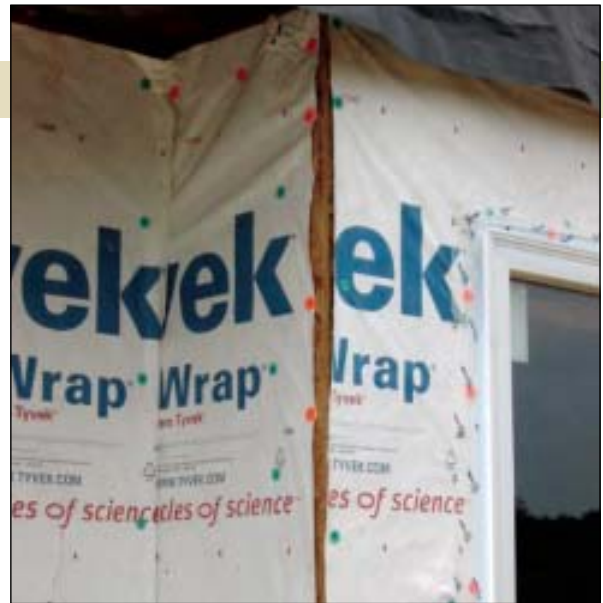
▲ **Incomplete coverage.** Water-resistive barriers must be installed correctly. The rips and gaps in the WRB shown here will allow any water blowing through to leak into the wall at the corners. The housewrap should be overlapped approximately 12 inches at the corners and sealed with an acrylic-backed tape. Note that the tape used for the window flashing is not an approved flashing material. It will probably fail as a result of differential movement.

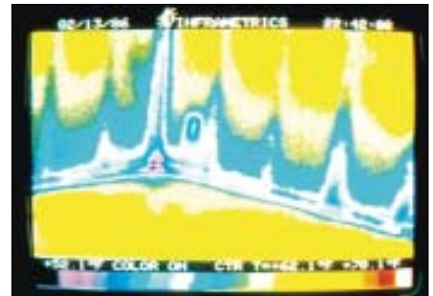
▲ **How to grow mold.** This thermograph looks at the corner of the house from the inside. The fan of a blower door is depressurizing the house (sucking air out the door), so cold outdoor air is being drawn in through cracks in the exterior wall. The blue areas show where cold air is infiltrating underneath the wall plate and around an electrical outlet. This cold air will reduce the surface temperatures, thereby increasing the surface relative humidity and the chance for mold growth. The cure includes a breathable exterior housewrap with the seams taped as well as sill seal and other air-sealing measures — all elements of a good air-barrier system.

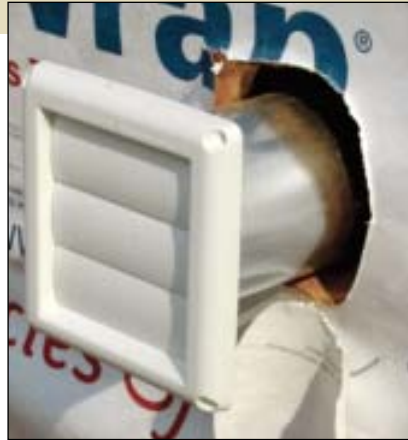
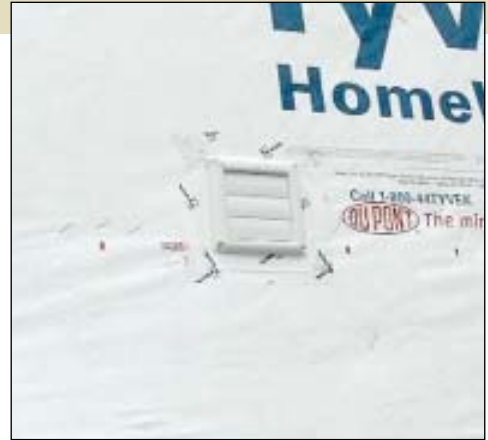
► **Unsealed wall penetration.** Cutting a large round hole in the housewrap (right) defeats its purpose. The solution is to X-cut the housewrap, then slide the vent through the X-cut and seal around the pipe with an acrylic tape before securing the face plate (far right).

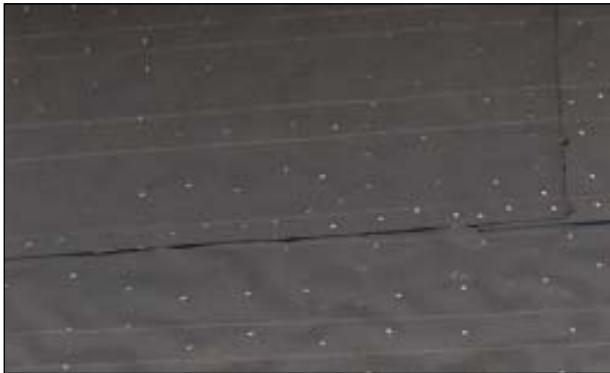
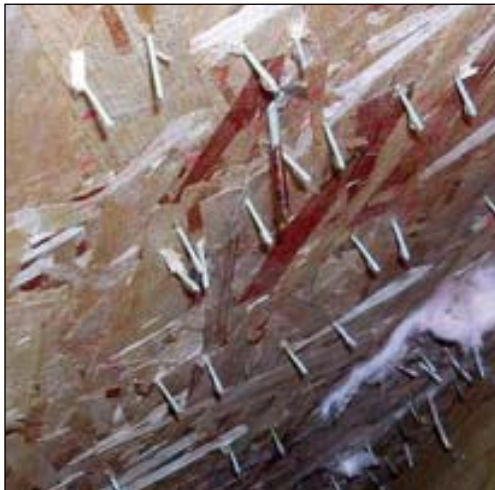
▼ **Overfastening.** Every staple through the water-resistive barrier is a potential water leak, so don't get trigger happy, as this installer did (below). In this case, water can actually be seen dripping off the ends of the staples inside the wall cavities (bottom). Best practice calls for a staple or cap nail every 12 to 18 inches along the vertical stud.

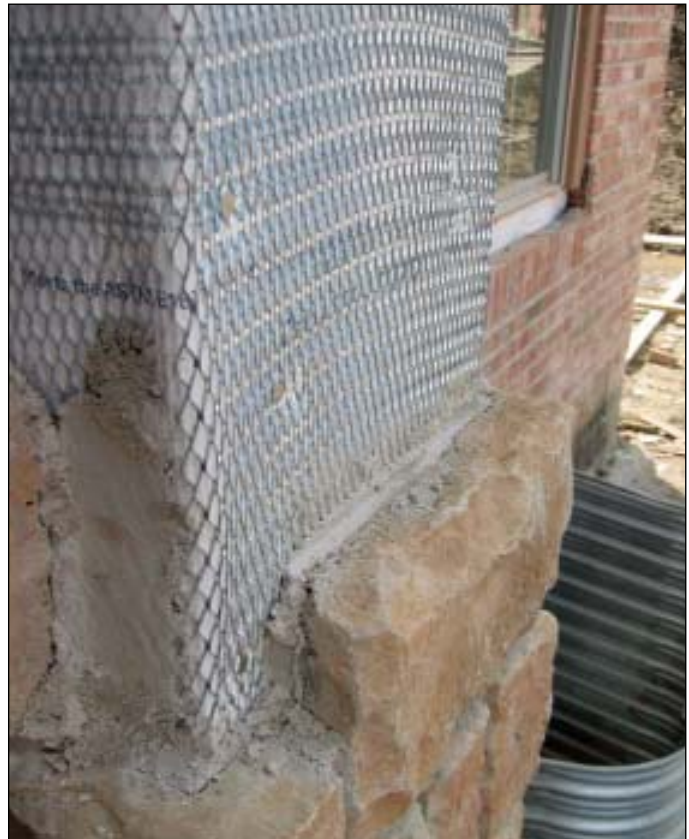
▲ **No capillary break.** Synthetic stone (above) creates a unique challenge: Unlike brick veneer, which is built in front of an air space, synthetic stone is buttered right to the wall and has no air space to promote drainage. Use two layers of housewrap before installing the lath. The outer layer protects the inner layer from bonding to the mortar holding the stone in place, which allows the inner layer to function as the drainage plane. The natural separation between the layers provides a capillary break to reduce the chance for water wicking through.

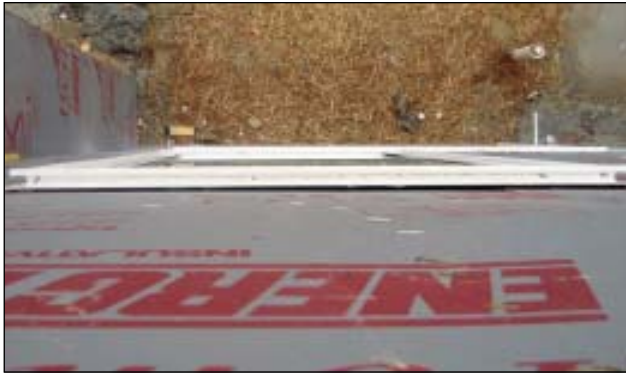
▼ **How a window looks to a water drop.** This is what water running down a wall “sees” as it approaches the head of the window, underscoring how very important it is to properly flash at the window head. Sealant alone won’t keep the water out. If the sealant ever separates and fails, you would have a perfect entry point for water to invade the structure.

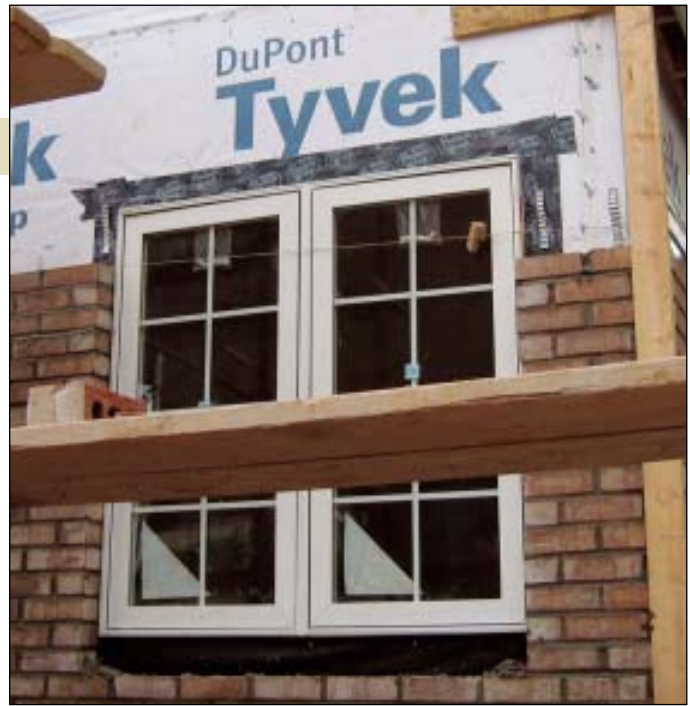
▲ **Improper head flashing.** The head flashing on this window is reverse-lapped with the housewrap. Before applying the head flashing, a flap needs to be cut in the housewrap so the head flashing can adhere directly to the wall sheathing and cover the nail fin. Once the flap is folded back down over the head flashing, water draining down the wall above the window will drain outside, not behind the head flashing.

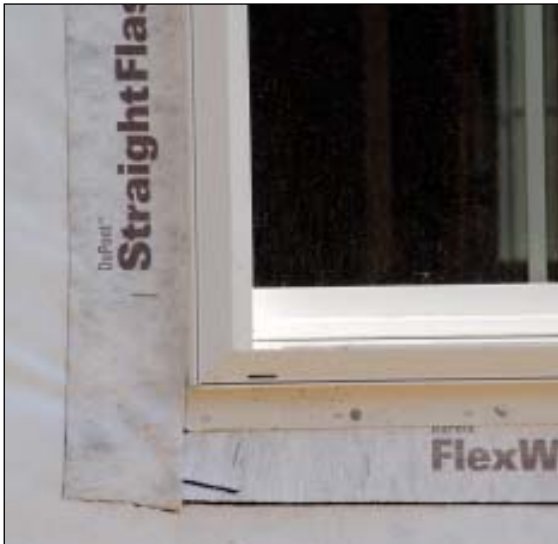
◀ **Proper window flashing.** The sequence of flashing a window is critical. Begin with a sill flashing that covers the rough sill and has a bottom flap that laps over the top of the housewrap as shown. This will ensure that any water that leaks through the window drains out. The jamb flashing should go on after the window has been installed, and should lap over the window flange to prevent wind-driven water from getting past the window into the rough opening.

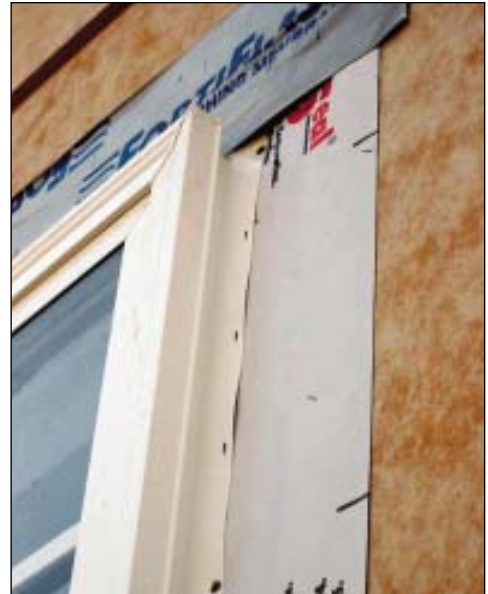
▲ **Why “splines” don’t work.** Applying jamb flashing before the window is installed meets the requirements of “Method B” of the ASTM window and door installation standard, but in my opinion it’s not the best way to flash a window. You can still end up with small gaps between the nail fin and the flashing as in this instance, which allow water to penetrate.

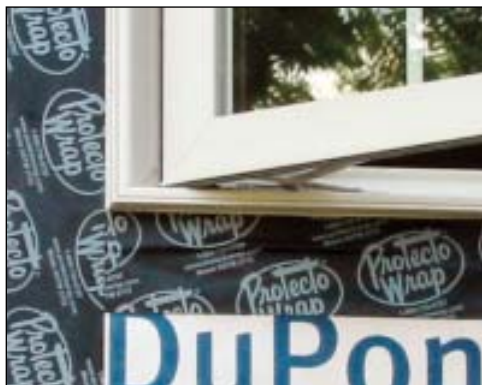
### ► Improper sill flashing.

Notice that the black sill flashing is stuck to the housewrap and then stuck over the *top* of the nail fin below the window. This is a mistake. The sill flashing always goes on *before* the window is installed.

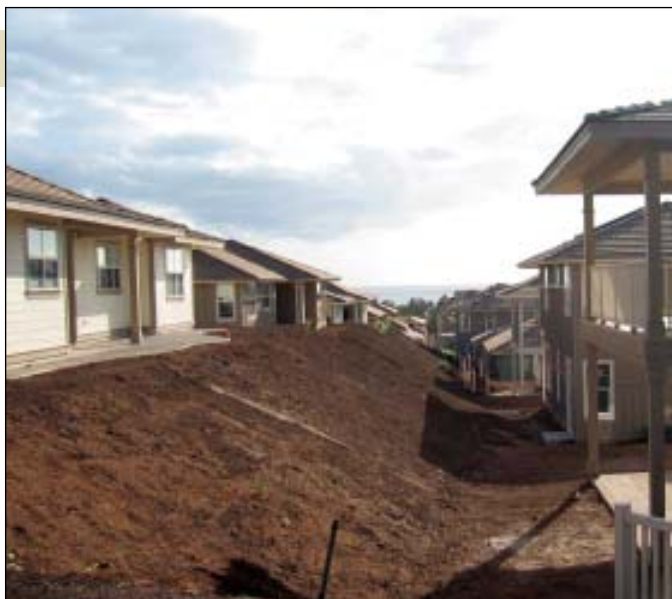
► **Dreadful drainage.** In this coastal subdivision, water running off one series of houses drains right into another. There is not enough natural drainage away from the lower structures to prevent subslab moisture.

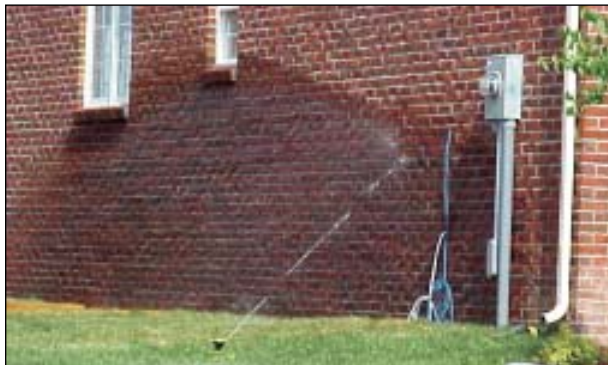
▼ **The homeowner factor.** Imagine the force of this sprinkler and the amount of water that is pouring into this wall. This is a perfect example of why redundancy is so important. The only way to avoid problems caused by the homeowner irrigating this wall is to make sure a WRB behind the brick is impeccably detailed, the drainage cavity and weep holes remain open, well-draining backfill is put in, and good perimeter drainage is installed.

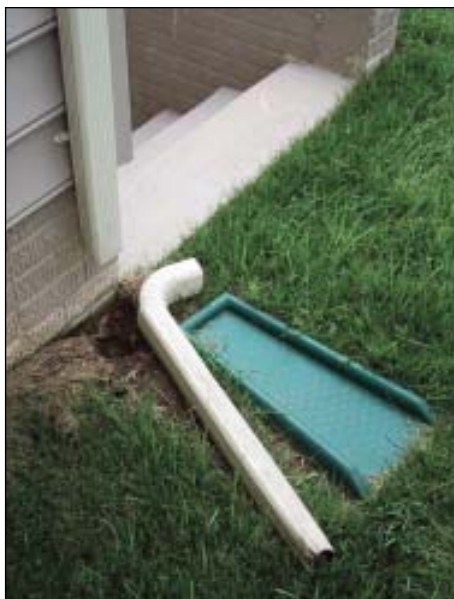
### ◀ Maintaining drainage.

When I inspect a home for moisture problems, I look for signs of lack of maintenance. For example, here the downspout is disconnected from the leader, so all the water that runs off the roof is being funneled near the foundation. This can create a tremendous moisture load on the home.
