Underpinning a Foundation

Before adding new living space above an existing garage, make sure the footings can handle the load

by Rob Corbo

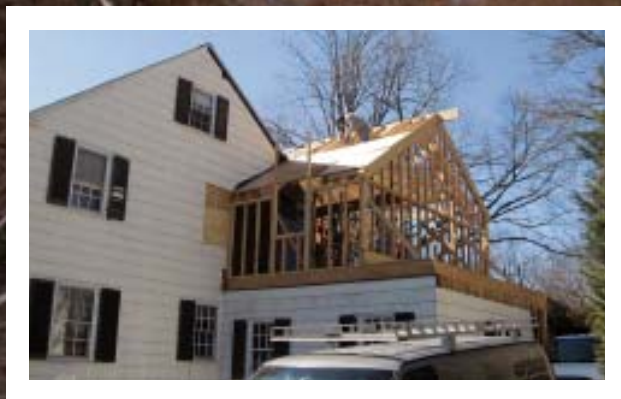
Figure 1. A test pit revealed that this shallow foundation footing, though adequate for a garage, could not support the loads created by the addition of second-floor living space without reinforcement.

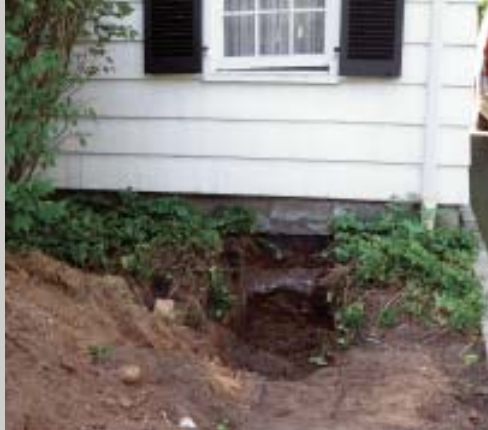
The test holes revealed that while the footing under the sidewall was adequate, the front-wall footing was only 18 inches below grade (see Figure 1). Because the plans called for the new

second-floor loads to be carried primarily by the front and back walls of the garage, it was clear to me that we would have to do something about the existing front-wall footing when we poured the footing for the new back wall.

The architect turned the problem over to an engineer, who provided us with a design for underpinning the front wall (see illustration, facing page). Then we filed for a permit update and got started with the garage demolition.

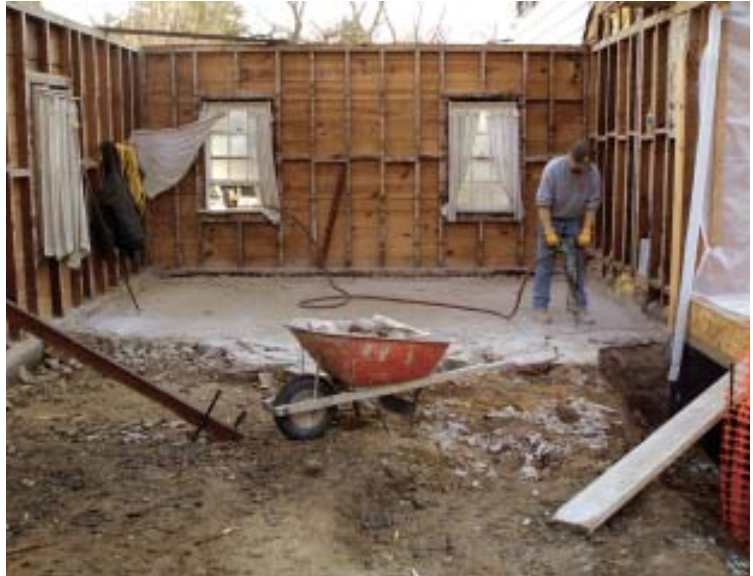
Figure 2. Before framing could begin, most of the existing garage had to be demolished, except for the sidewall — which was needed to retain the structure's 5-foot zoning variance — and the front wall, which needed to be reinforced with a deeper footing.

we rented a compressor-driven jackhammer to quickly finish the job (Figure 2, page 3).

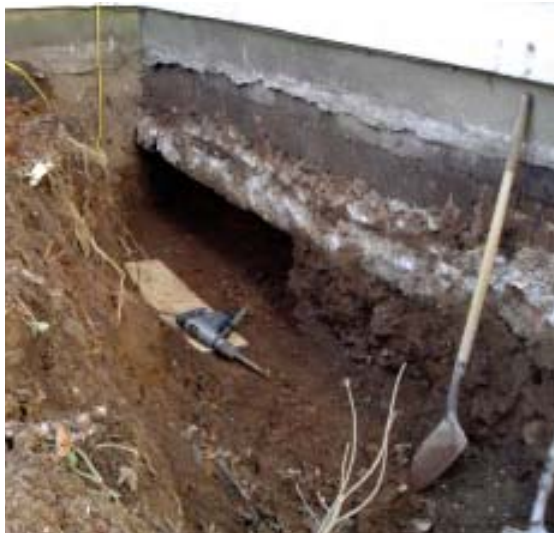
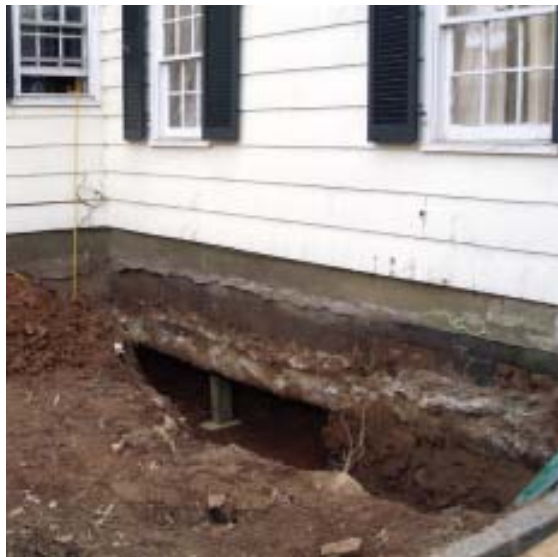
Figure 3. After digging a trench alongside the existing front-wall footing with an excavator, the author's crew used hand tools and a rotary hammer fitted with a chisel to remove the compacted soil under the footing (left). To prevent damage to the foundation, half the wall at a time was excavated and temporarily shored up (above).

With our rented backhoe, we dug a trench next to the garage foundation for access, then used hand tools to excavate under the footing itself.

To loosen the soil under the footing, we used a rotary hammer equipped with a chisel, then removed the dirt with a pick and shovel (Figure 3, page 3).

Because soil would form the back wall of the underpinning, we were careful to square up the excavation under the existing footing as much as we could.

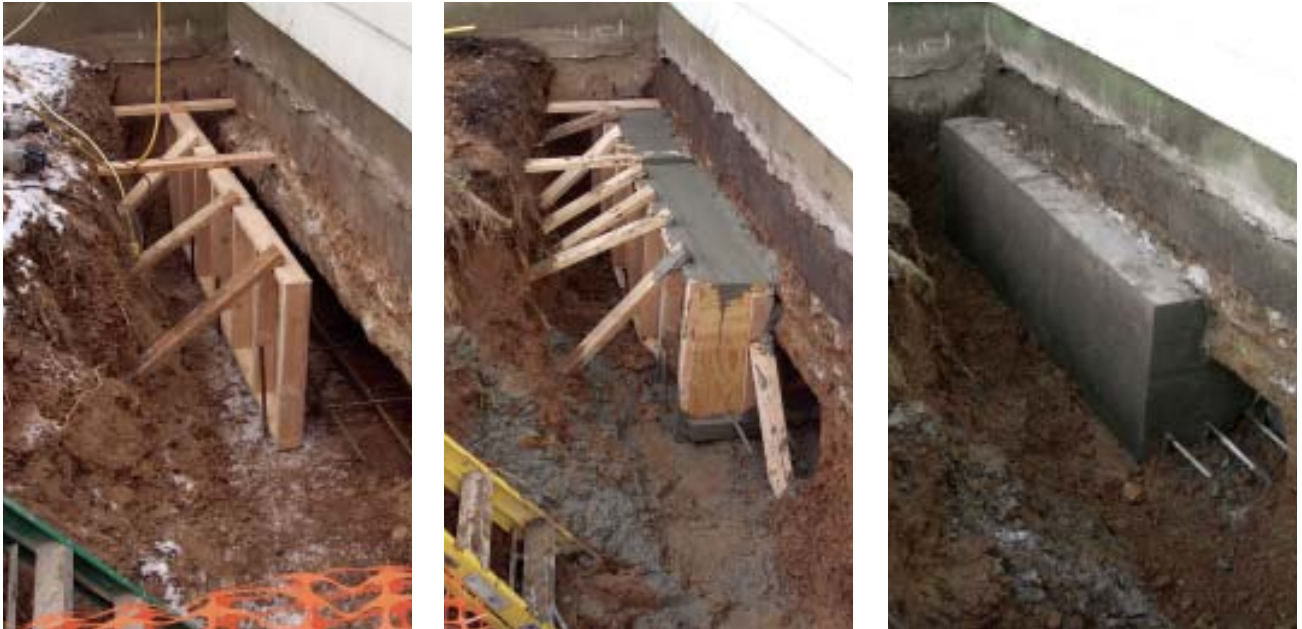
Figure 4. Built with 2x4s and $\frac{3}{4}$ -inch plywood, the underpinning form was braced with stakes and form pins (left). The side of the excavation underneath the existing footing provided the back wall for the poured concrete (center). Extending the rebar past the first form (right) helped tie the two halves of the new 24-inch-wide-by 36-inch-deep footing together when the second form was poured.

footing to be a minimum of 36 inches below grade and 24 inches wide, with #4 rebar running continuously throughout, set on chairs. We built the form with 2x4s and $\frac{3}{4}$ -inch plywood, securing the bottom with 30-inch form pins and bracing the top with 2x4 stakes.

Since we planned to do the underpinning in two pours, we extended the rebar 12 inches beyond our first form so that we could tie in later with the second pour (Figure 4).

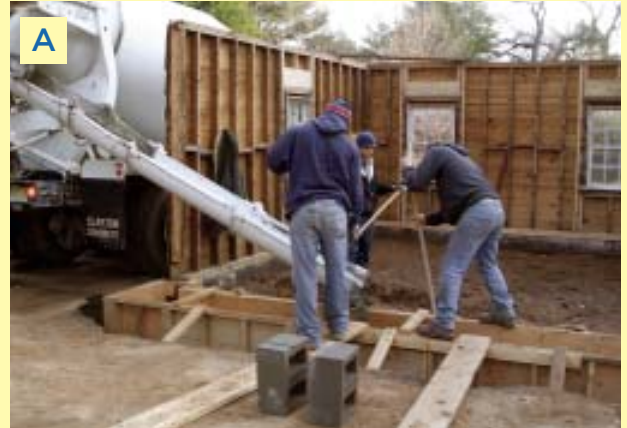
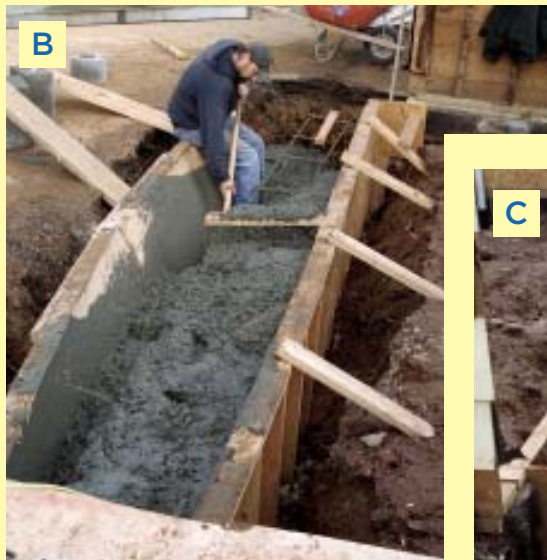
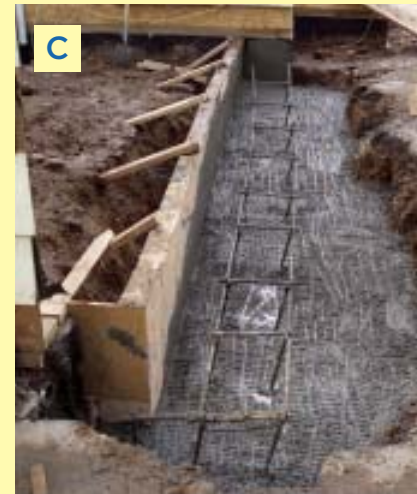
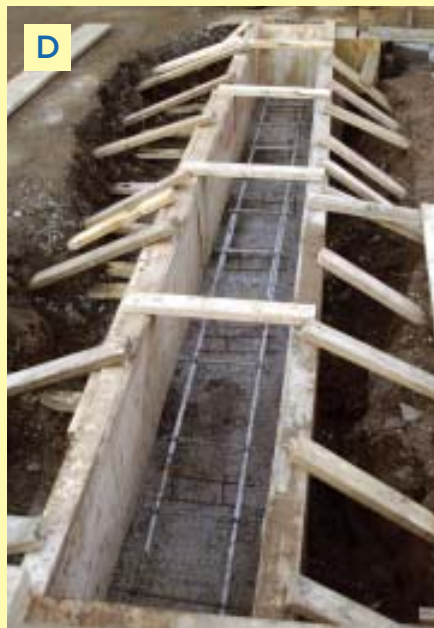
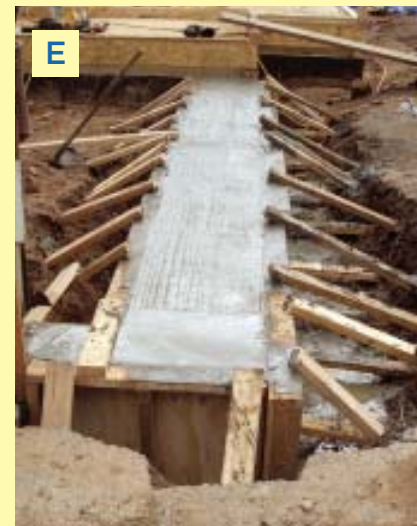
Managing a Blown-Out Form

To extend the garage, plans called for a new foundation underneath the relocated back wall (which would contain the new garage door). Rather than pour a footing below grade and then build up the foundation out of block, we formed a 24-inch-wide monolithic block from footing depth to grade, which we felt would make a more attractive transition apron between the asphalt driveway and the garage slab.

As we were pouring the last of the 4-plus yards of concrete needed to fill the form (A), though, the form wall on the driveway side began to bulge, then collapsed (B). Since the inner wall remained intact, project manager Danny DoCouto decided to pull the collapsed wall out entirely and spread the concrete into the outer portions of the trench, allowing it to establish a solid, level surface 24 inches below grade that we could build off later (C).

To get the form out of the trench — with concrete on one side and form pins on the other — we had to shovel concrete away from the wall, then lift the form by leveraging it with concrete blocks, 2x8s, and our digging bar. Even after the form was removed, we had to work our shovels into the rebar grid to expose more rebar and level out the concrete, a process that took more than an hour.

The following day, Danny cut and removed the old rebar so we could rebuild the form. Since the new outside form wall was now sitting on concrete, we wedged it into place with 2x4 stakes along the bottom plate. And this time, we used plenty of stakes to brace it along the top plate (D).

After laying in new rebar on chairs and straightening out the bowed inner form, we were ready to pour once again (E).

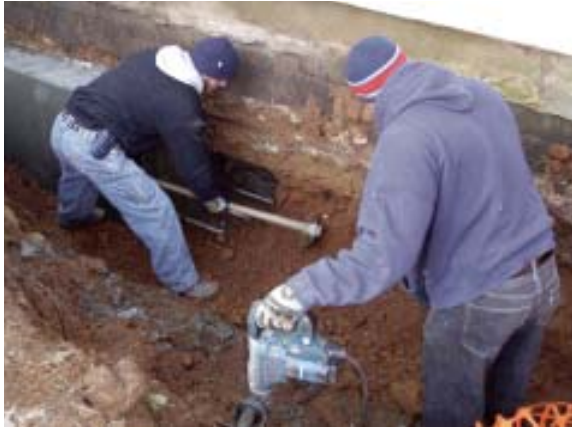
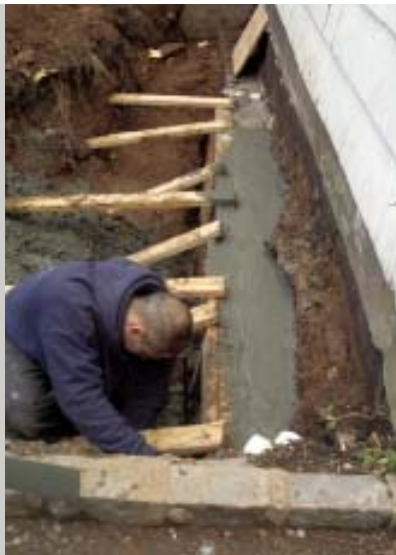
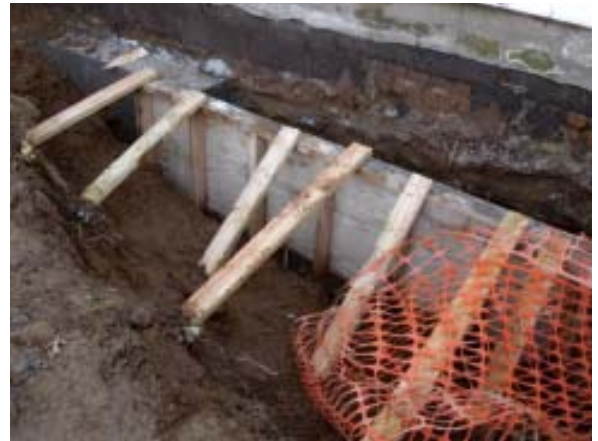
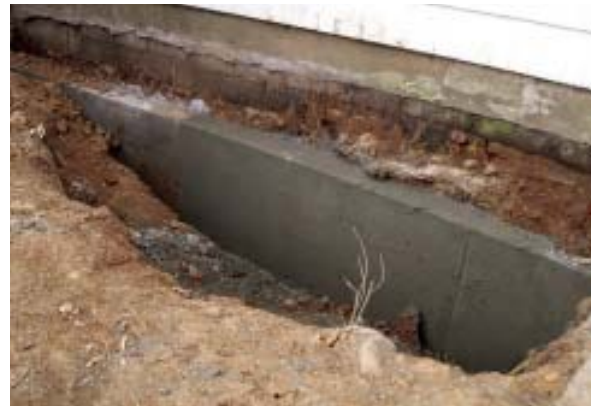
Figure 5. After stripping the form from the first half of the front-wall underpinning, the author's crew finished excavating underneath the remaining wall (above). Form pins helped hold the bottom of the form in place (above right), while 2-by-braces secured the top plate (right). The completed underpinning (far right).

The next day, we prepared for the second underpinning pour by stripping off the first form, then excavating under the remaining footing as we had before (Figure 5).

After building the form and installing rebar, we secured it with plenty of form pins and stakes, making sure that the second underpinning pour would be as uneventful as the first.
