# Air-Sealing Attics In Existing Homes

For best results, locate the heat loss with  
a blower door and an infrared camera

by Bruce Torrey

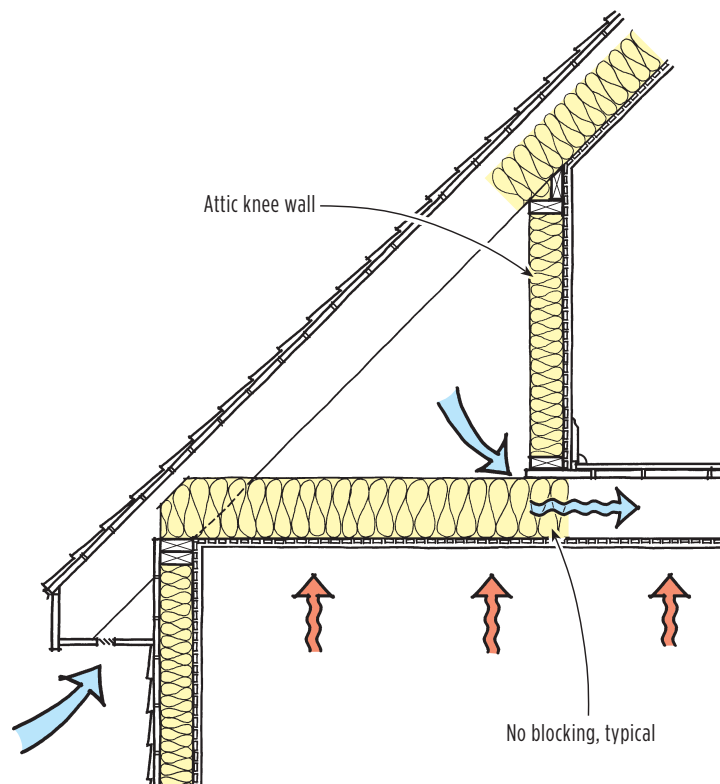
## Typical Thermal Bypass

**Figure 1.** Even though they're often insulated, attic knee walls are a common thermal problem area. Because there is typically no blocking below the knee-wall bottom plate, cold air from the attic or outside air moving through the insulation at the eaves chills interior ceiling cavities, drawing heat away from the living space.

Homes with knee walls or side attics have the further complication of horizontal heat loss and infiltration between heated floor cavities and the eaves (see **Figure 1, page 2**). In many cases attic ventilation only makes this worse, by connecting the interior to the outside and allowing wind to move far into the heated space.

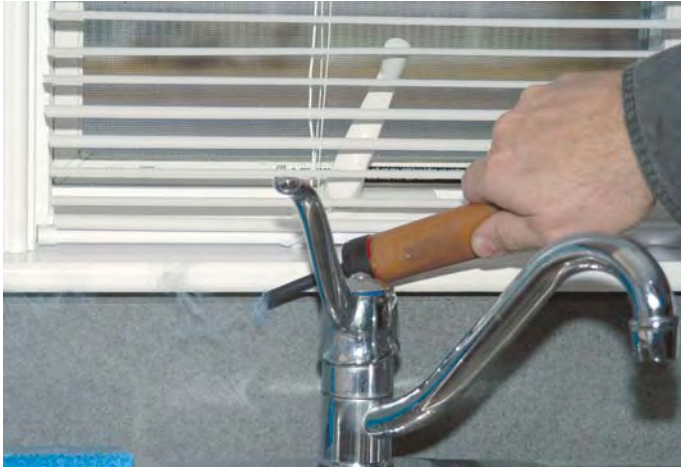
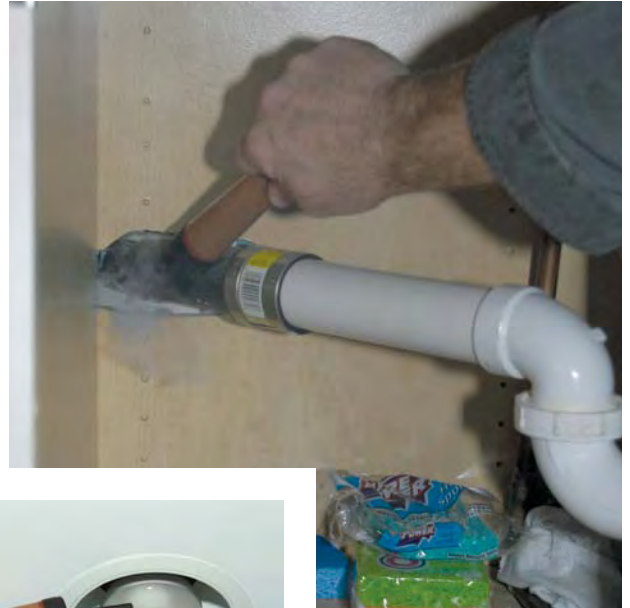
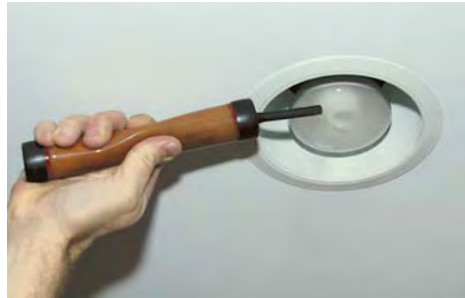
**Figure 2.** With the blower door running, the author uses a smoke pencil to detect leaks in the house's air boundary. The leaks shown here — at a window sill (above), at a plumbing penetration in a base cabinet (above right), and at one of several can lights (right) — were the result of a kitchen remodel that left the home feeling draftier than before.

With the blower-door fan running, I make a visual inspection of the home, looking for any obvious leakage spots (**Figure 2**). A smoke pencil — a handheld device that emits a stream of

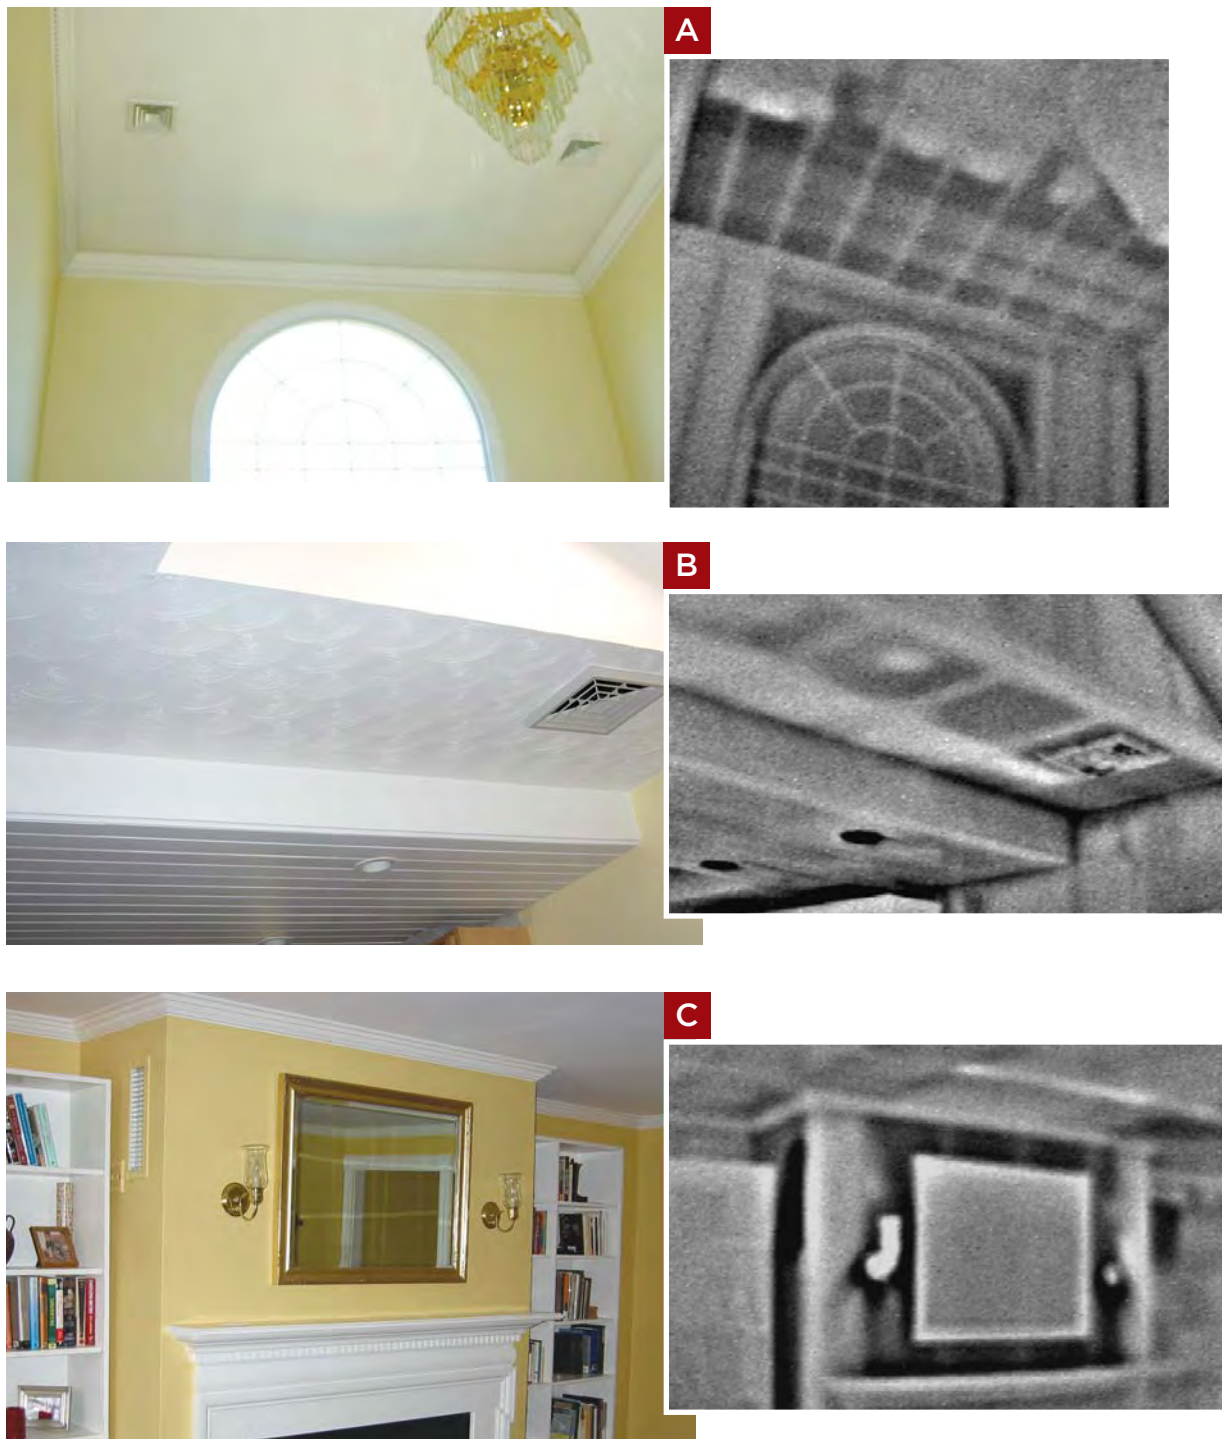
**Figure 3.** The darker spots in these thermographic images indicate the presence of cold in framing cavities behind the drywall surface — areas where cold air has infiltrated or heat has been lost through conduction. At top (A), the framing around a Palladian window lacks insulation, while the ceiling area above suffers from wind-washing at the eaves. An interior soffit (B) is cold because the batt insulation does not make good contact with the drywall; also, the gap around the ceiling register is drafty. The uninsulated wall around an interior fireplace (C) is chilled from cold attic air dropping down through the vertical chimney chase between the framing and the masonry.

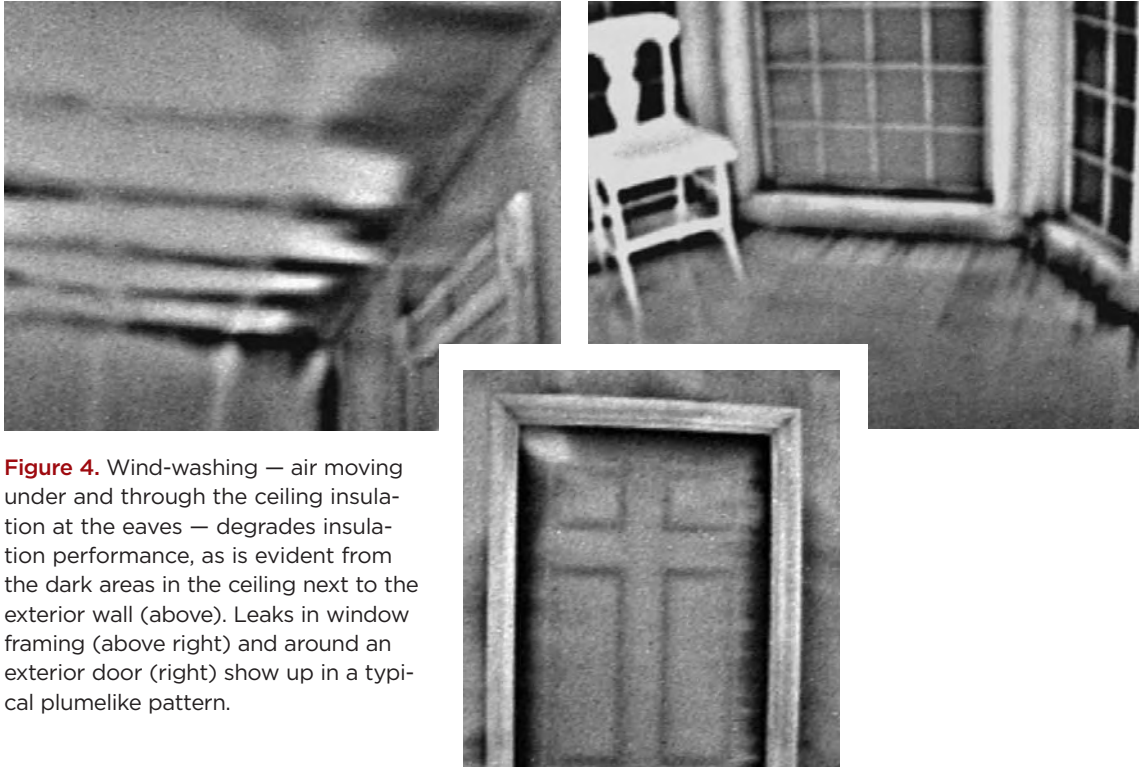
**Figure 4.** Wind-washing — air moving under and through the ceiling insulation at the eaves — degrades insulation performance, as is evident from the dark areas in the ceiling next to the exterior wall (above). Leaks in window framing (above right) and around an exterior door (right) show up in a typical plumelike pattern.

Because the blower door is drawing in cold air from the exterior or attic, the scan can identify and measure areas of air infiltration, recognizable by a plumelike thermal pattern (**Figure 4**).

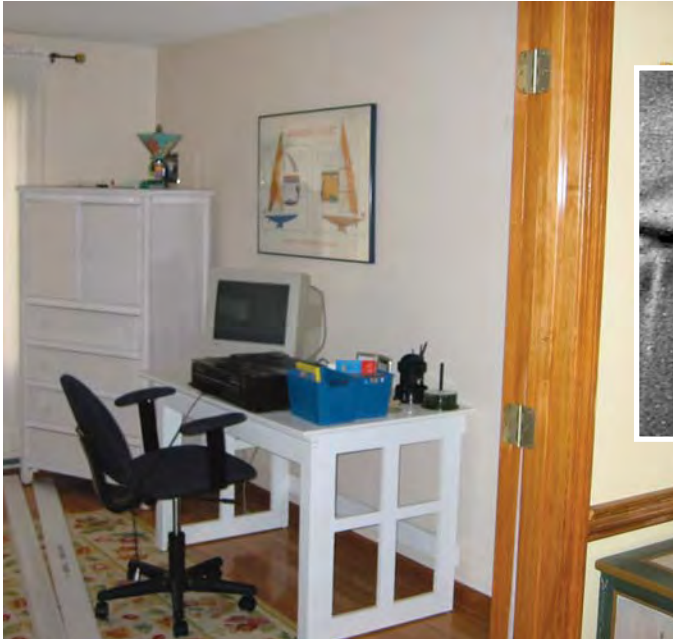
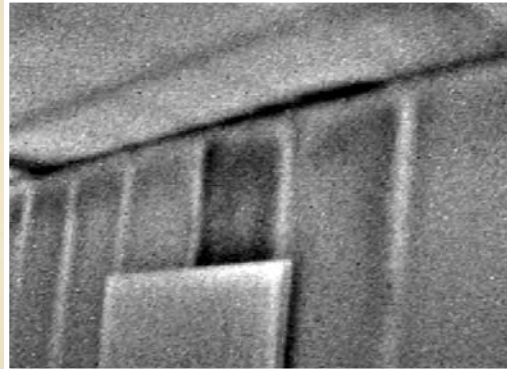
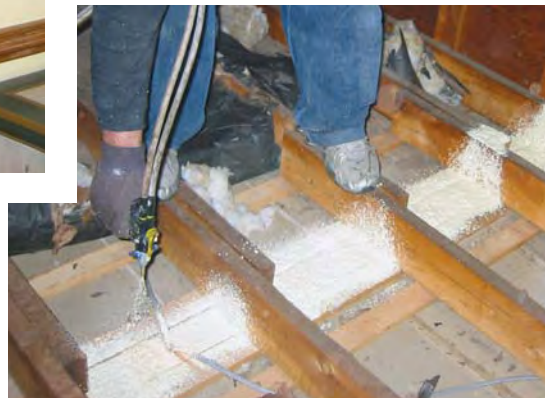
**Figure 5.** The infrared scan revealed an unexpected cold area in this interior partition wall, which was traced to air leaking into the attic along the top plate, shown here being sealed (right).

are common on ceilings near the eaves, due to the effects of wind-washing (outside air moving into the eaves and through the fibrous insulation), but they can also show up in interior locations where you might not expect to find them (**Figure 5, page 6**).

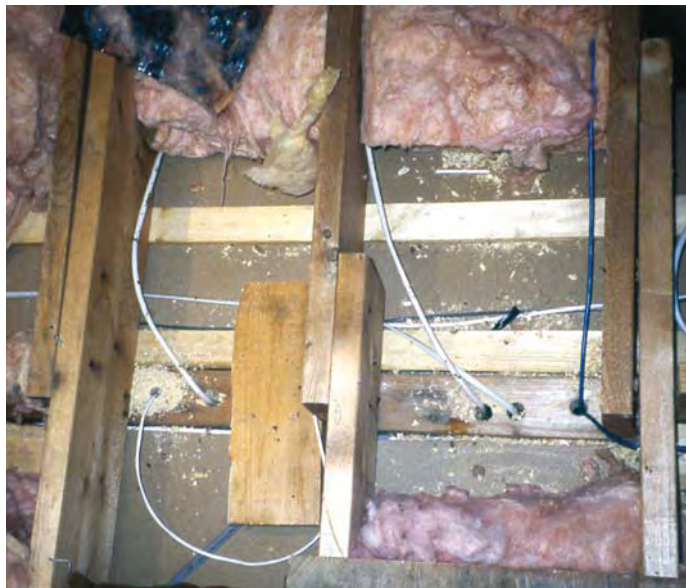
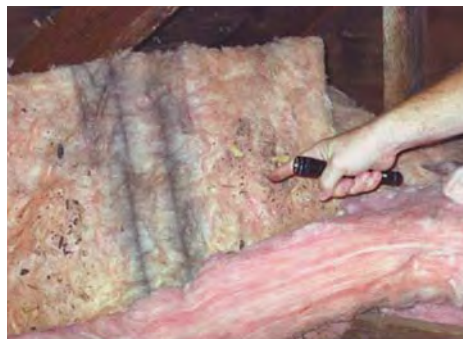
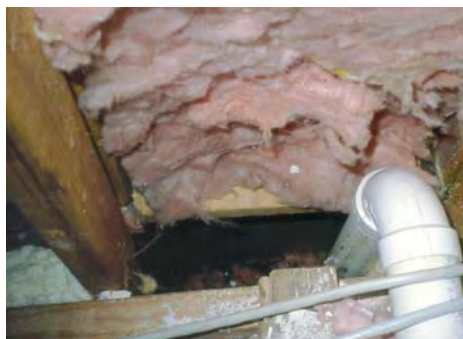
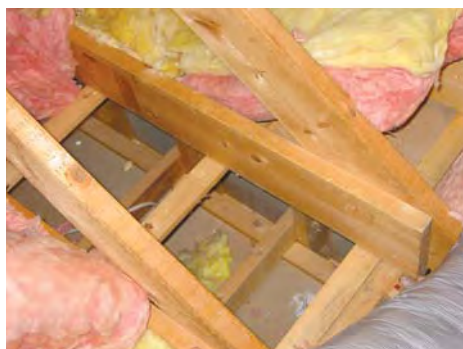
**Figure 6.** Moving attic insulation uncovers a common cause of leaks: wire holes through partition-wall top plates (above). The double line of soot stains indicates upward air leaks between the drywall and a partition plate (top right). Fiberglass stuffed into a plumbing wall (center right) was no match for the air rising from below; note the spray foam at left in the photo — the solution. A double layer of fiberglass did not prevent air movement through an interior soffit into the attic (bottom right).

the attic they are full of penetrations for electrical, mechanical, and plumbing runs (**Figure 6, page 7**). Even the long intersections between the edges of the top plates and the cut ends of the ceiling board provide air paths into the attic.

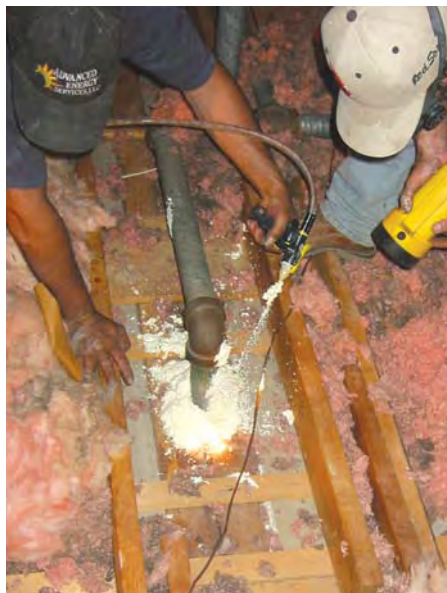
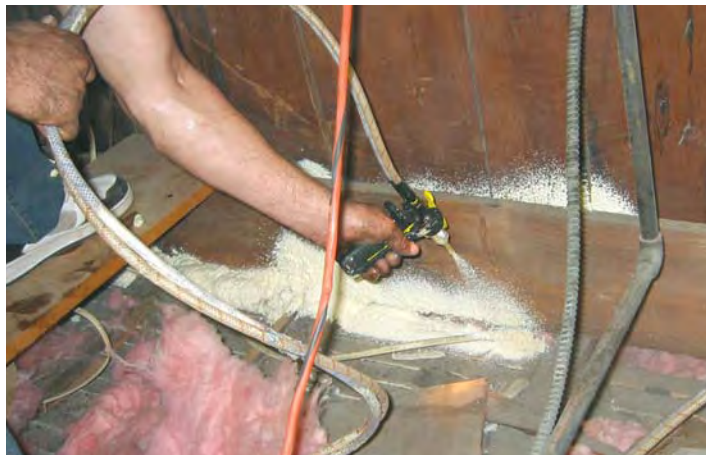
**Figure 7.** Because it sticks even to dirty surfaces, two-part urethane foam works well for sealing around attic penetrations (left). A worker seals beneath an attic ledger (above), after first chinking the gap underneath with fiberglass.

**Two-part foam.** For sealing the leaks, most weatherization contractors use two-part polyurethane foam, which comes in cardboard containers in various sizes with an attached 30-foot hose and spray nozzle. The foam sticks well to dirty surfaces, and the high-pressure applicator makes it easy to spray in hard-to-reach places (**Figure 7, page 7**).

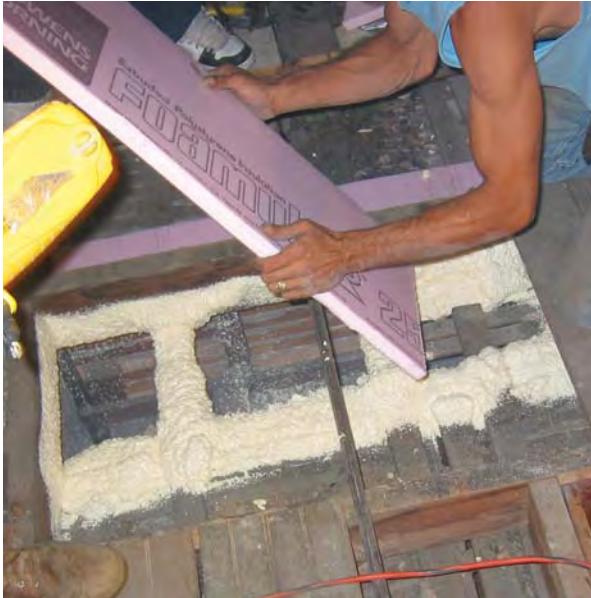
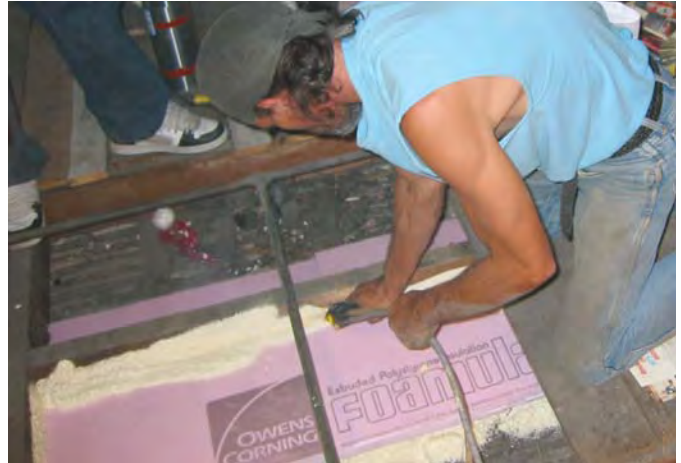
**Figure 8.** Rigid foam board is ideal for sealing large openings like this oversized framing chase. After cutting the board to fit, the worker beds it in wet spray foam (left), then seals the edges (above).

directly. With larger bypasses — wet walls, unblocked balloon-framed cavities, the space under an attic knee wall — the opening can first be loosely stuffed with fiberglass, then sprayed. For extremely large openings like drop soffits and large chases, it's best to fit a piece of plywood or rigid insulation board over the hole, then seal it in place with foam and screws (**Figure 8, page 8**).
