Gable-End Retrofits

A builder's guide to hurricane-resistant reinforcements for gable ends

by Richard Reynolds

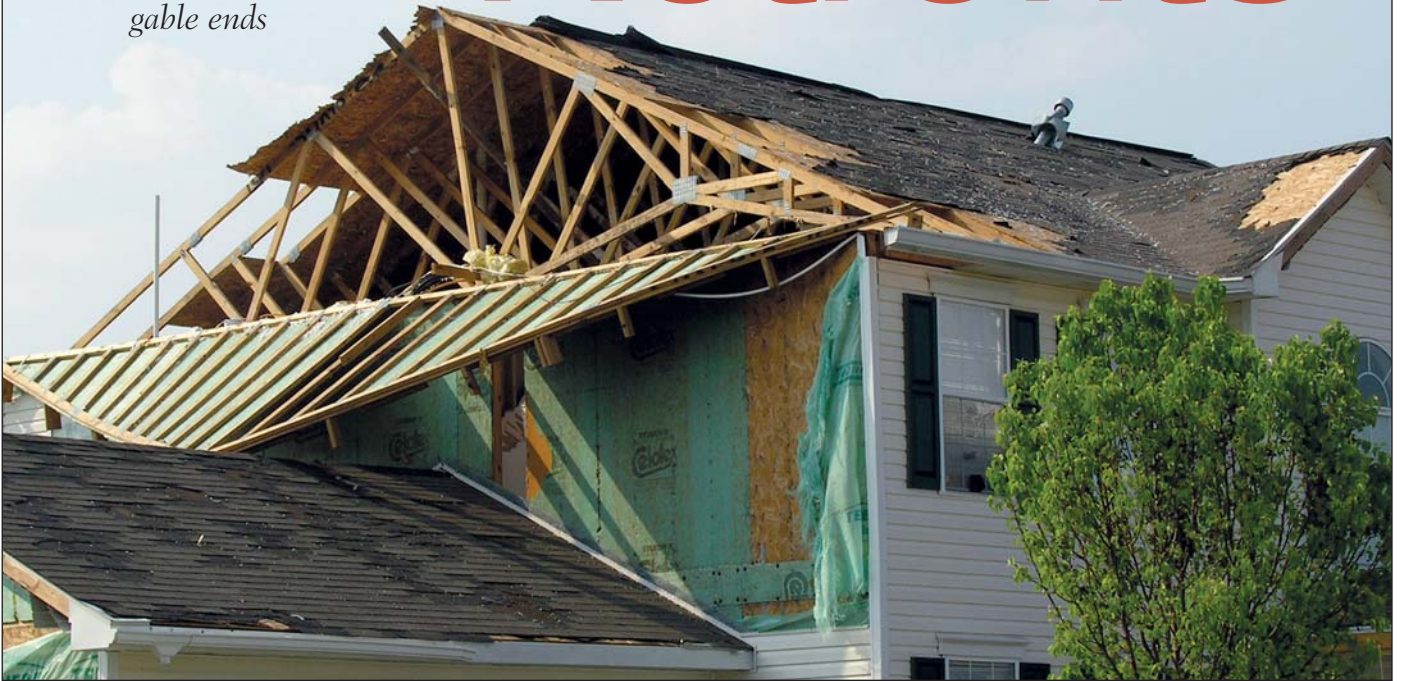
Negative pressure from hurricane-force winds pulled the top of the gable end outward after it ripped off the sheathing at the edge of the roof. The retrofit measures briefly described in this article can dramatically reduce the risk of such an occurrence.

Observations made in the aftermath of Category 3 and stronger hurricanes have clearly illustrated the vulnerability of gable ends. Failure comes in three varieties: The most common gable-end failure is one where the wall loses support along its top edge — typically because the sheathing gets blown off. The second most common failure is at the connection between the triangular gable-end wall and the rectangular wall below it. In this scenario, the wall gets pulled out by the negative pressure of the wind. The third potential failure is collapse of the actual framing members that make up the gable-end wall struc-

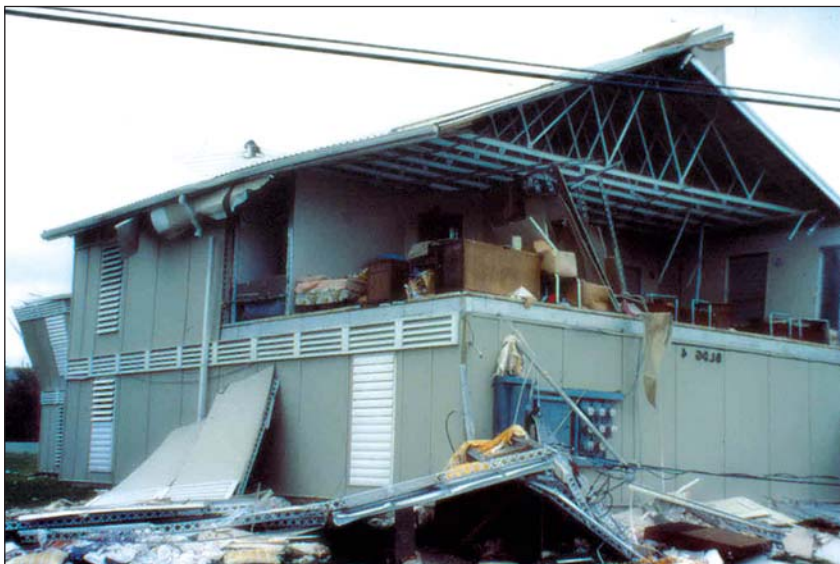
Once the gable end goes, it can unzip a house, not only devastating the structure but also ruining the entire contents of a home, which become saturated with water.

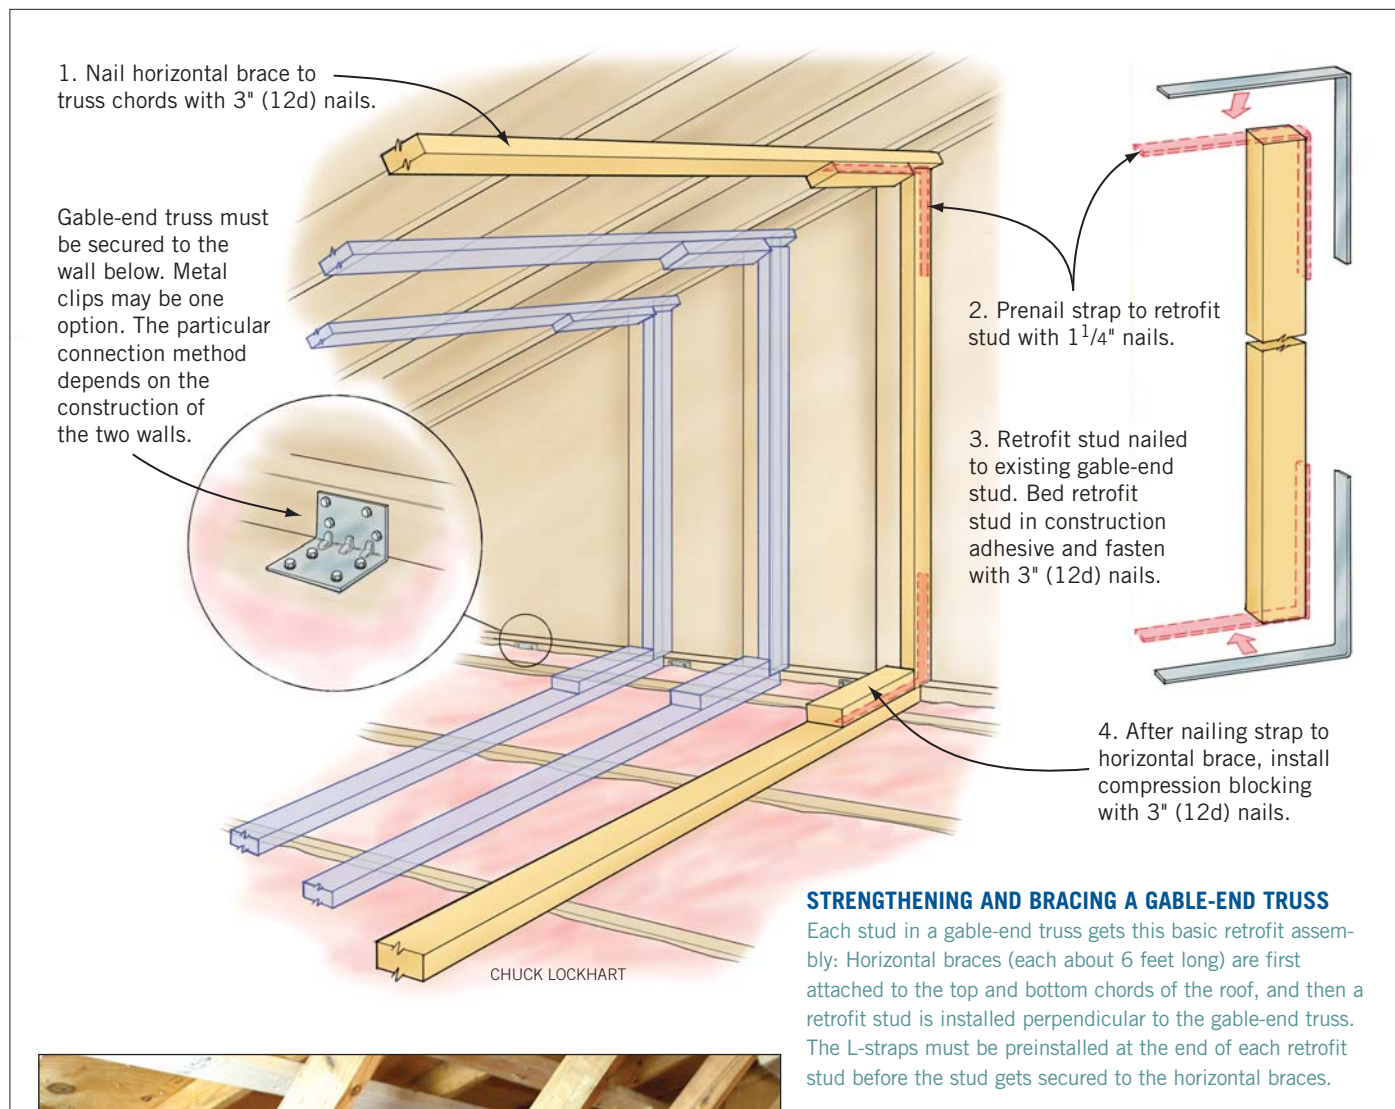
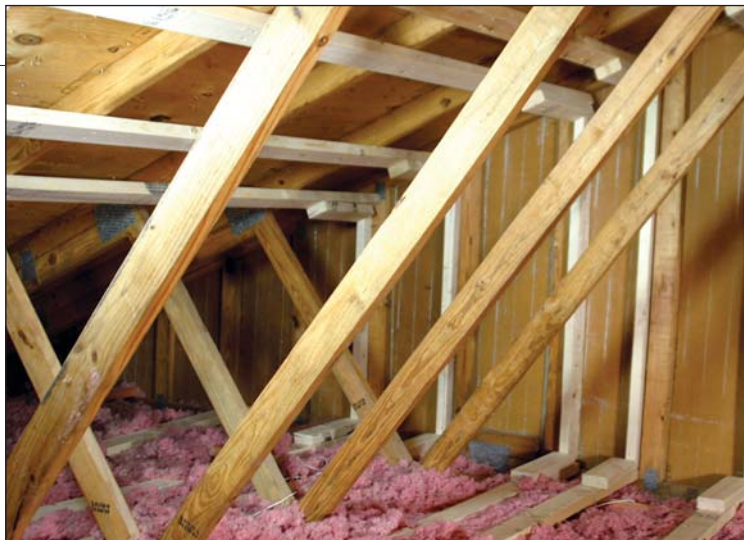
Tasks 1–3: Strengthening and bracing the gable end. There are a couple different methods that have been worked out for securing retrofit studs. The drawing (above) illustrates the basic procedures involved for the “L-strap method,” and the photo (left) shows the finished product.

The first step is to install 2x4 braces, called horizontal braces, which butt up against existing gable-end studs. These must extend at least 6 feet into the attic and be placed at each gable-end stud (typically every 24 inches). Horizontal braces distribute the wind loads on the gable-end wall to the ceiling and the roof diaphragms. Distributing the load over a large area like this avoids local failures of roof decking and of ceiling drywall or plaster.

The next step is to install an additional stud, called a retrofit stud, beside each existing gable-end stud that is more than 3 feet long. This supplemental stud, oriented perpendicular to the gable-end wall,

provides the beam necessary to resist bending stressing.

The retrofit studs must be connected to the ceiling and roof diaphragms via the horizontal braces. The transfer of force is accomplished by the use of straps, and perhaps with compression blocks, depending on the retrofit method selected. See table (below) for specific sizing and spacing of all the elements needed for the retrofit assembly, including strap sizes.

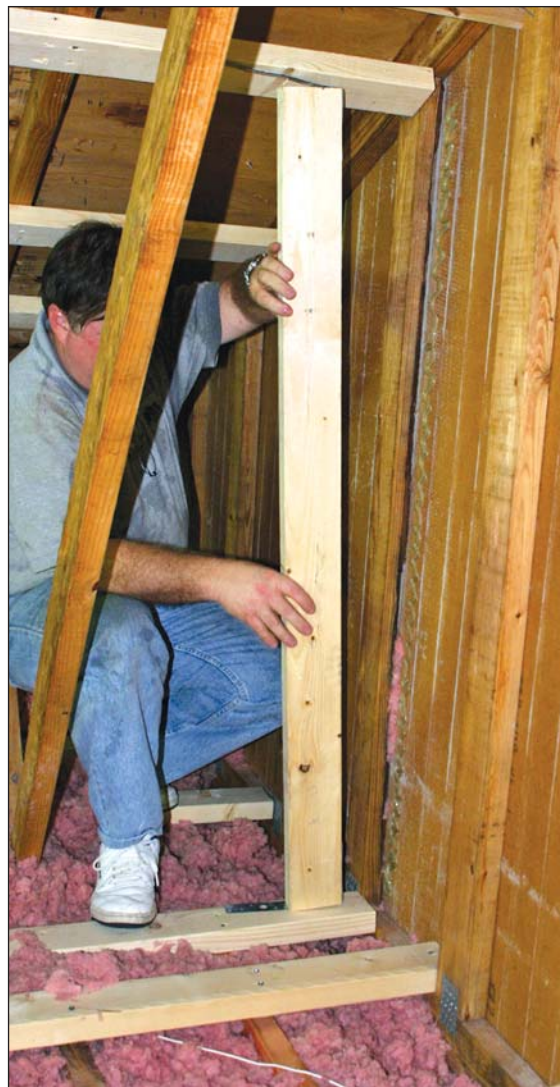
Assembling the pieces: After the horizontal braces get installed, metal straps must be preinstalled on the retrofit studs. These retrofit studs can then be installed by bedding them in a generous bead of an AFG-01-rated structural wood adhesive along the edge of each gable-end stud.
