# Rebuilding a Chimney Top by Mike DeBlasio

Stainless anchors and pressure-injected grout form a strong bond with the original masonry

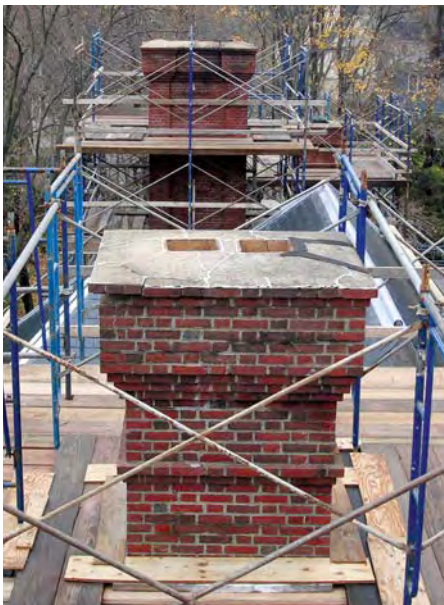
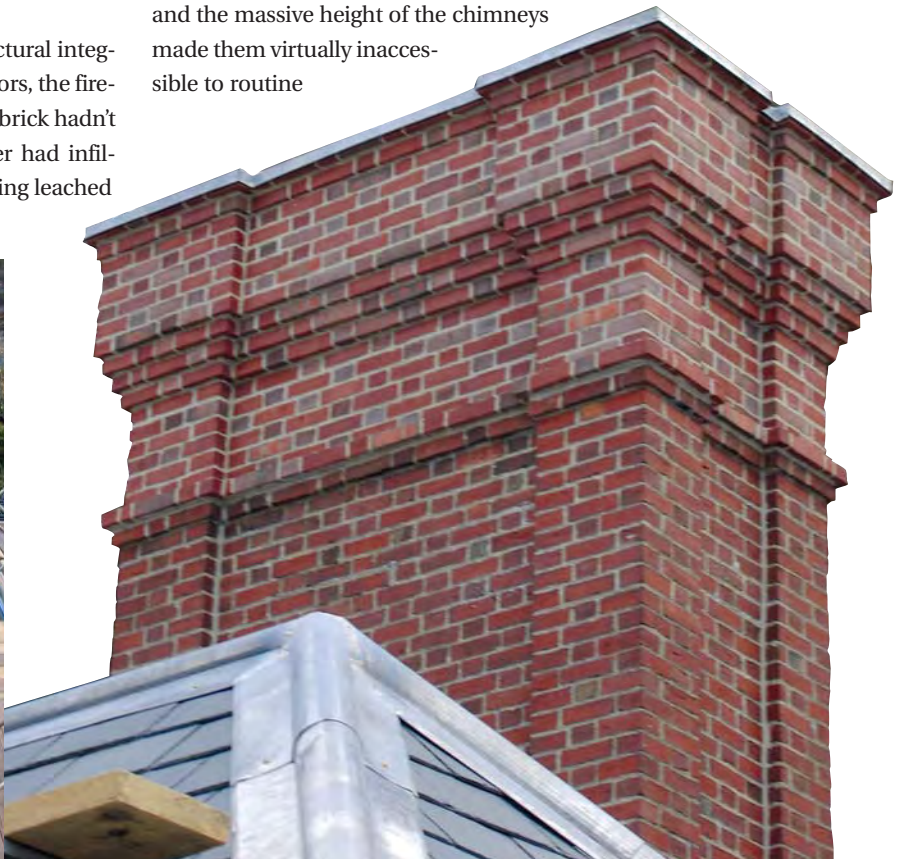
**Figure 1.** Vertical cracks indicate a chimney in trouble. A combination of water infiltration and unrelieved thermal expansion of the flues caused the failure (far left). The view down the flue shows cracking and water seeping in (left).

We found serious problems with all the chimneys, all due to faulty construction (see **Figure 1**). The corbeled tops required complete rebuilding. Vertical cracks had opened between the corner “pilasters” and recessed faces on the biggest chimneys; similar vertical cracks ran the full height of the two smaller chimneys. Set back 1½ inches, the recessed faces had not been properly bonded in interlocking sequence with the corners. Instead, the builders made continuous vertical joints, creating serious weaknesses. Furthermore, the space that should have existed between the clay flue liners and the brick was solidly filled, eliminating the conventional allowance for flue expansion.

We ran a small video inspection camera down the flues and found them crazed with stress cracks. The mortar had eroded out of the abutting joints, a fire hazard for sure. We even found flue tiles with corners broken due to rough handling during construction, the gaps crudely patched with mortar. Those tiles should never have been used. Making matters worse, the flues were all undersized: Some were as much as 30 percent smaller than necessary for proper drafting.

In short, the chimney tops had to be rebuilt and the flue tile replaced; the vertical cracks had to be repaired and reinforced; and the fireboxes needed rebuilding. Quite a list of urgently needed repairs — and none of them simple.

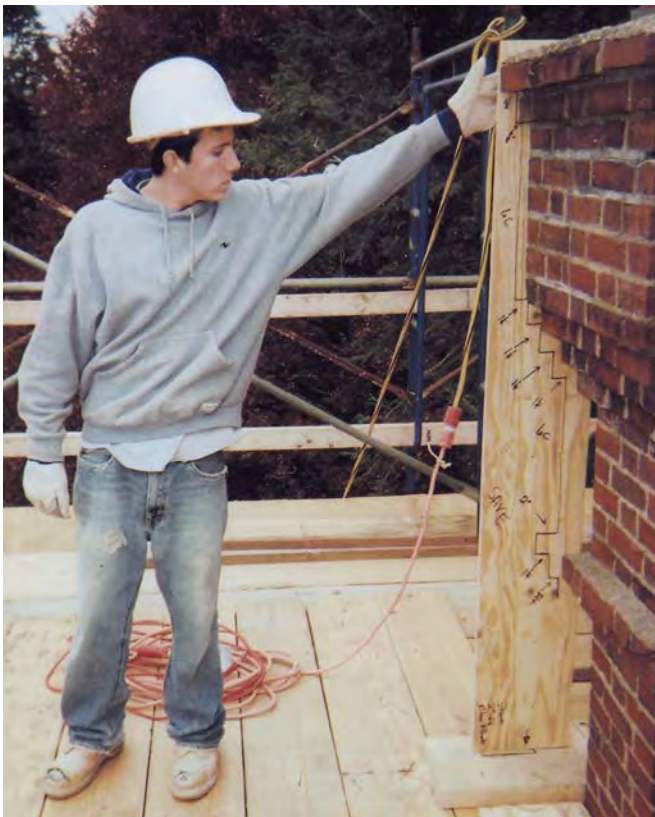
**Figure 2.** Plywood templates and photography will provide a visual record of the original corbeling when the chimneys are rebuilt.

exhaust fan at the top of the chimney. Next we tackled the chimneys — but not before tracing the corbels' profiles onto pieces of plywood and taking photos, so that later we could rebuild them according to their original design (Figure 2, page 2). Then we tore down the top 4-plus feet of each stack, using small rotary hammers to remove the brick below the corbeling.

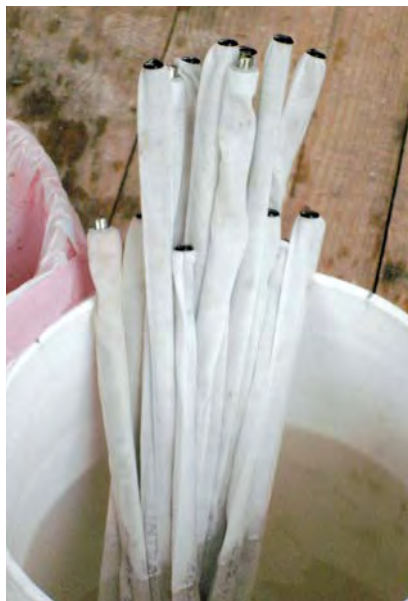
**Figure 3.** Reinforcing anchors presoak before installation in the masonry. The anchors — hollow, perforated stainless steel tubes in a fabric sock — come in a variety of sizes; the ones shown are 1/2 inch in diameter and 22 inches long.

We relied on a proprietary system called the Cintec Anchor (Cintec, 800/363-6066, [www.cintec.com](http://www.cintec.com)). The anchor is a perforated stainless-steel tube encased in a fabric sock (Figure 3); it comes in various lengths and diameters depending on the application. When inserted into a cored hole in the masonry and pressure-injected with a fluid grout, it creates an extremely strong mechanical bond across the bricks. The sock prevents the grout from entering any deep fissures that intersect the coring. The anchors we used were 1/2 inch in diameter and 22 inches long, and cost \$7 apiece.

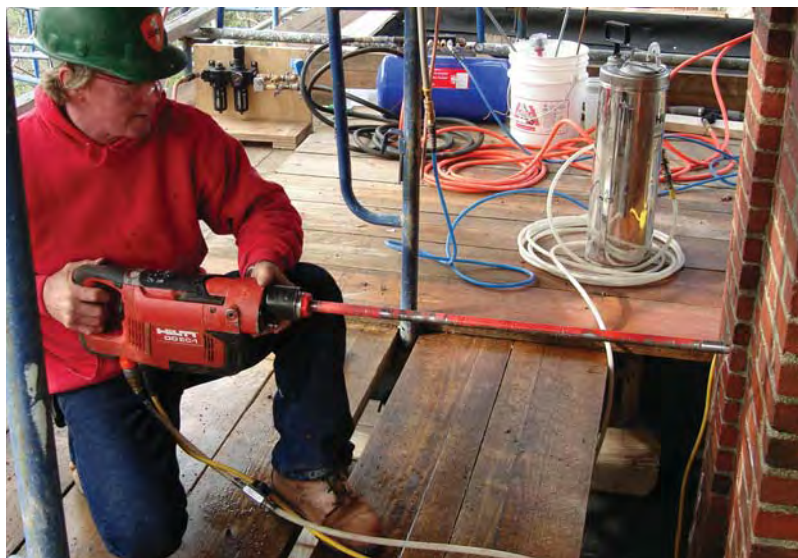
**Figure 4.** A short 3/4-inch diamond coring bit, guided by a site-made jig, makes the initial hole for the anchors (top). A long-shank coring bit (above) completes the 26-inch-deep holes, providing sufficient depth for the anchors and a finishing masonry core plug.

To guide the 3/4-inch-diameter coring bit at the chimney corners, I devised a jig of threaded steel pipe fittings and lumber (Figure 4). After bottoming out with a short bit, we removed the jig and let the hole itself guide a longer bit, coring to a finished depth of

26 inches. We cored holes across the pilaster corners at 3 feet on-center vertically, offsetting them 8 inches from adjacent sides. In preparation for the anchors, we blew each hole clean with pressurized air.

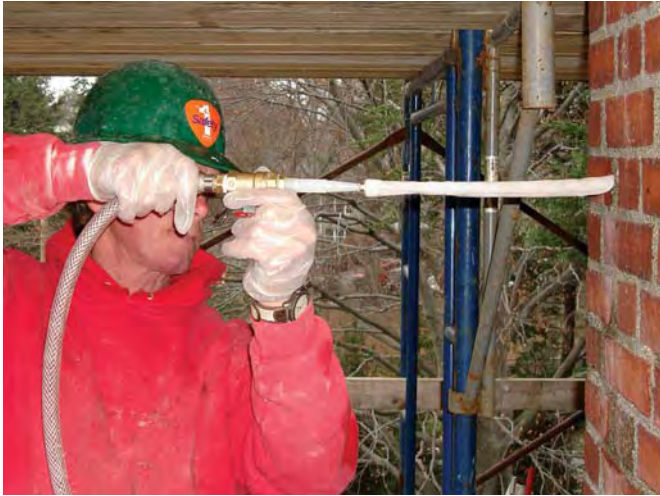
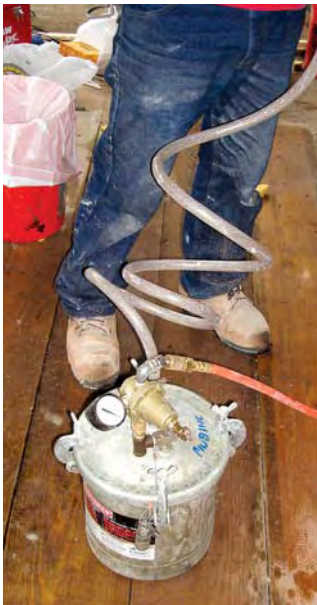
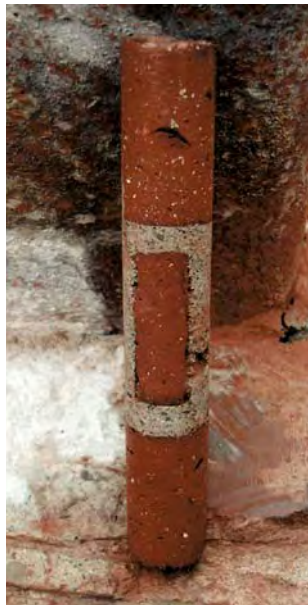
**Figure 5.** The anchor, fitted with its proprietary mastic injection nozzle, is gently inserted into the cored hole. Grout is pressure-injected until the “grout milk” stops flowing from the site (top). The grout is delivered from a conventional pressure pot at a relatively low psi (above left). The author saved coring plugs to protect and disguise the anchor holes after grouting (above right).

Cintec grout comes in 56-pound bags and is added to about 1 $\frac{1}{4}$  gallons of clean cold water. After it's mixed thoroughly with an electric paddle, you let it stand for about five minutes, while it thickens a bit. Then you mix in just enough water to bring it to a smooth, creamy texture, ready for the pressure pot and injection. The pressure pot is identical to that used for airless spraying, except that the outlet must be modified to accept a  $\frac{1}{2}$ -inch hose adapter and up to 12 feet of reinforced hose equipped with a quarter-turn ball valve. A special mastic nozzle is provided, which you trim to fit the anchor's injection tube.

With the grout in the pot and the pot pressurized to about 30 psi, we checked the flow for continuity and sufficient pressure. To install an anchor, you fit the nozzle on the anchor, insert it in the bore hole — taking care not to tear the sock — and pump in the grout until the “grout milk” stops flowing out of the hole. Rotating the anchor during filling ensures that it's centered in the bore. We recessed the anchors about 4 inches from the surface and plugged the bore holes with a length of the cored material (**Figure 5**).

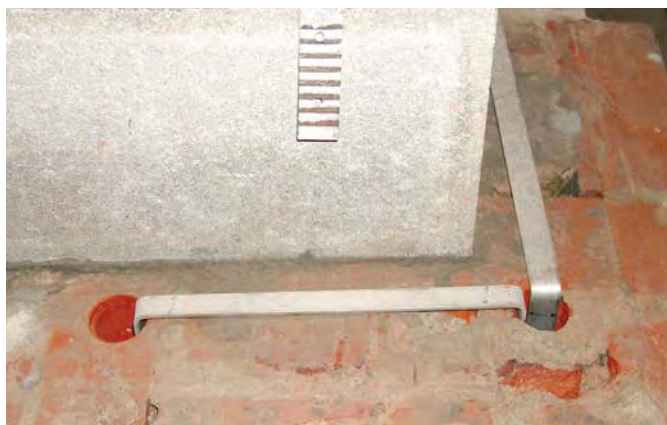
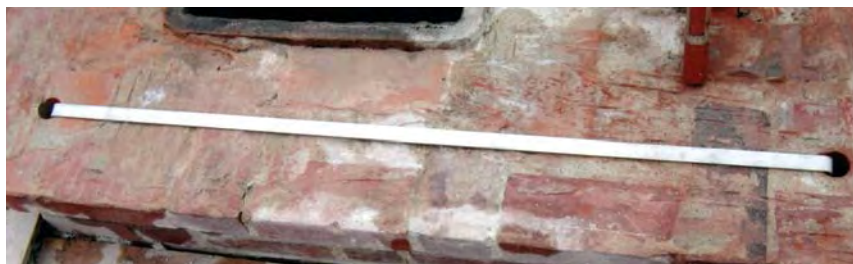
**Figure 6.** At the top of the completed tear-down level, the author cores down vertically to install stainless-steel reinforcing straps. A wet vacuum prevents the slurry from staining the roof slates below (top left). The straps are site-bent, with 4-inch drop legs, to suit each location (top right). The strap holes are grouted in, while the straps themselves are embedded in the following course of mortar and brick (above).

At the top level — the point to which we'd demolished the chimney — there was no practical way to introduce anchors close to the surface. Instead, we cored down vertically, about 6 inches, at every corner (**Figure 6, page 5**) and grouted in custom-bent stainless-steel straps to create a strong mechanical connection between the corners and the inset face brick.

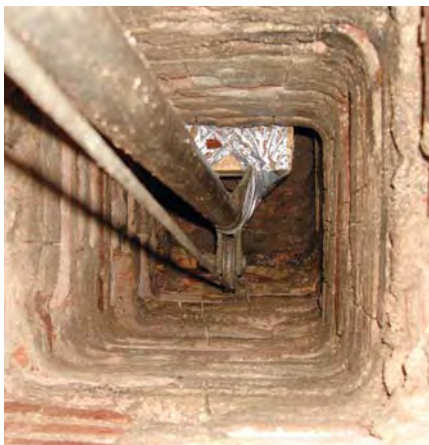
**Figure 8.** The Ahrens chimney relining process involves drawing a bell-shaped flue-forming device up through a masonry mix that’s added by the bucketful from above. An offset wheel, visible at the end of the 2-inch-pipe, keeps the bell centered in the chase.

Once the old tile is out of the way, relining begins. First, a self-centering, cylindrical “bell” is drawn up the chimney’s interior through a proprietary masonry mix

introduced from above (Figure 8). The bell forces the mix against the surrounding brick, forming a round (or oval) flue while filling and sealing all voids and fissures along the way. The mix’s recognized insulating value is equal to 5 inches of brick per 1½ inches of mix. Insulation minimizes creosote condensation and flue expansion and contraction, and allows zero-clearance contact between the chimney and combustible framing. (In older construction, the framing is often found to be hard up against the bricks.)
