# Restoring an Old Barn

by Fred Ambrose and Ezra Ambrose

Carefully shoring the entire structure allowed it to be repaired one section at a time

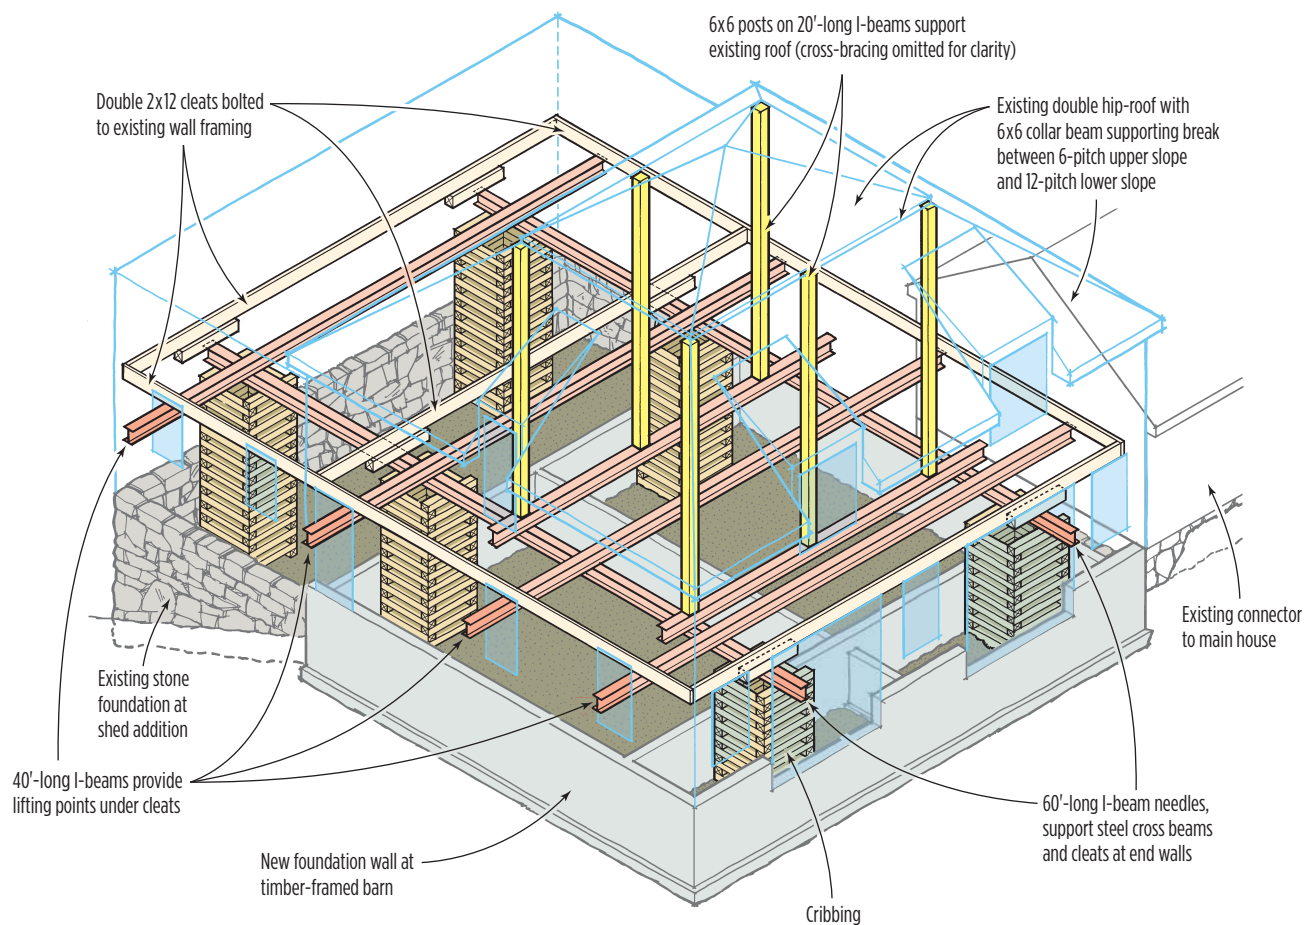
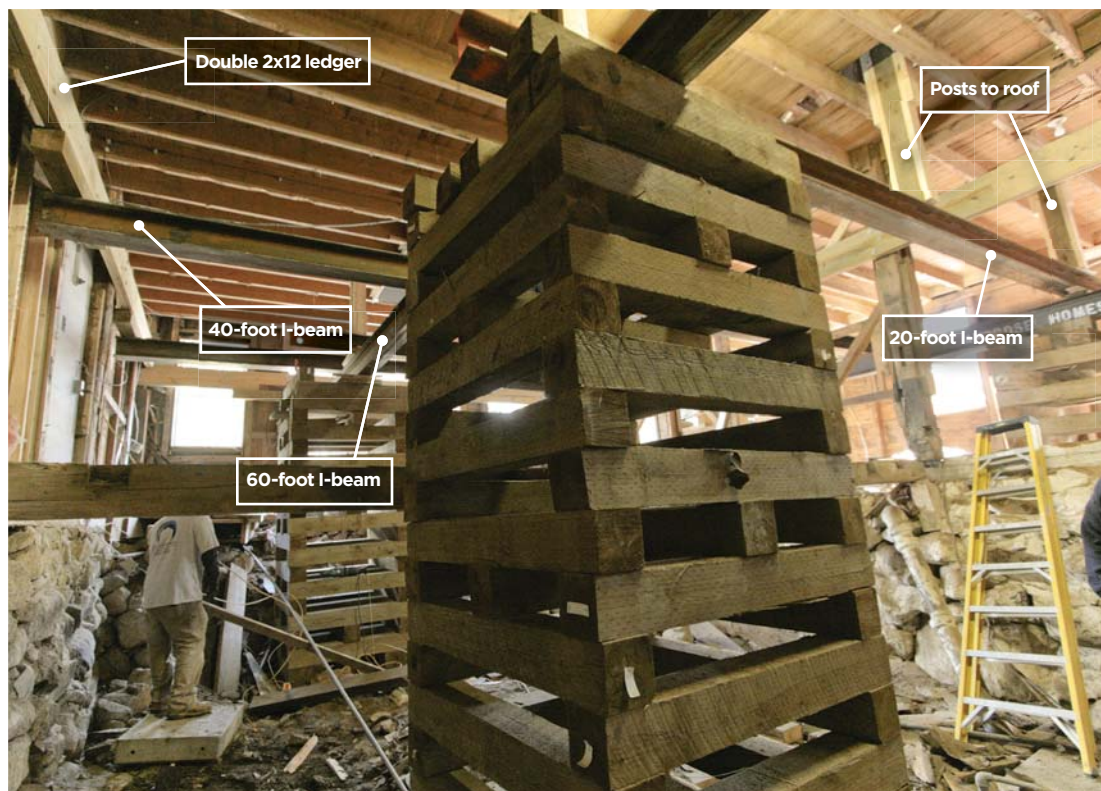
**Figure 1.** A grid of steel I-beams held up the barn's walls and roof while the foundation was removed and replaced.

long steel I-beams. Although we shored the roof and walls independently of each other, we did so off the same six stacks of cribbing (see **Figure 1**, page 2). We cut through the first floor and set the cribbing on grade in two parallel rows. The rule of thumb when you set cribbing is to lay the bottom course at least 6 inches deeper than any anticipated excavation. It's common sense; you never want to risk undermining the crib. We were excavating for a minimum 3-foot crawlspace and

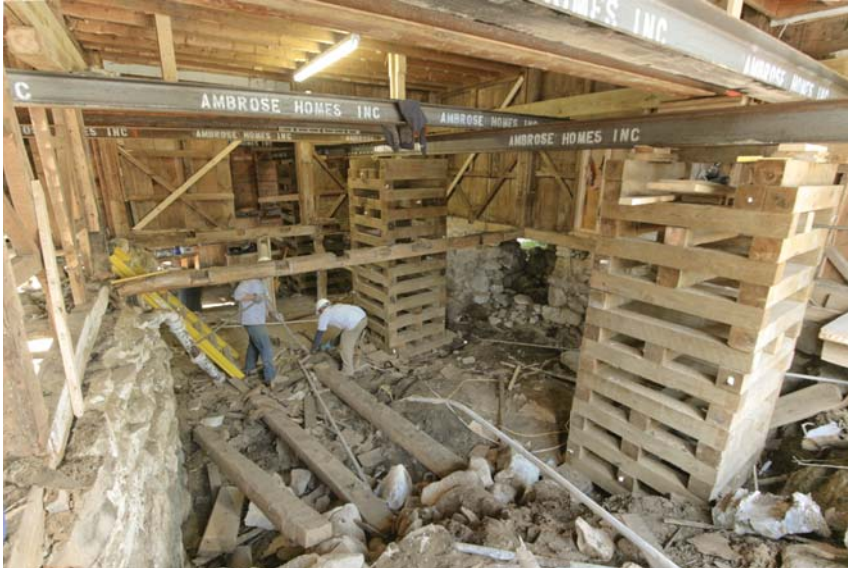
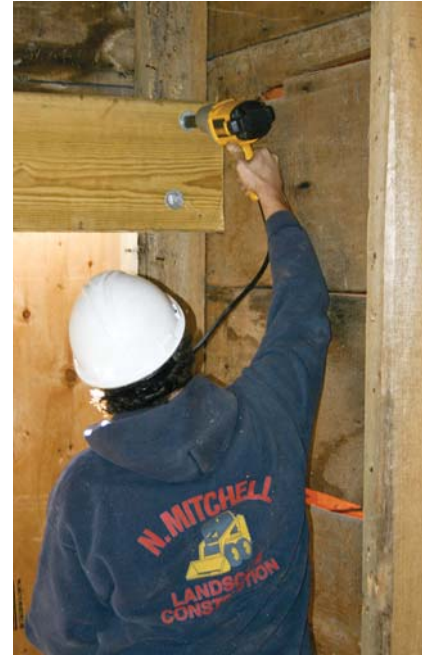
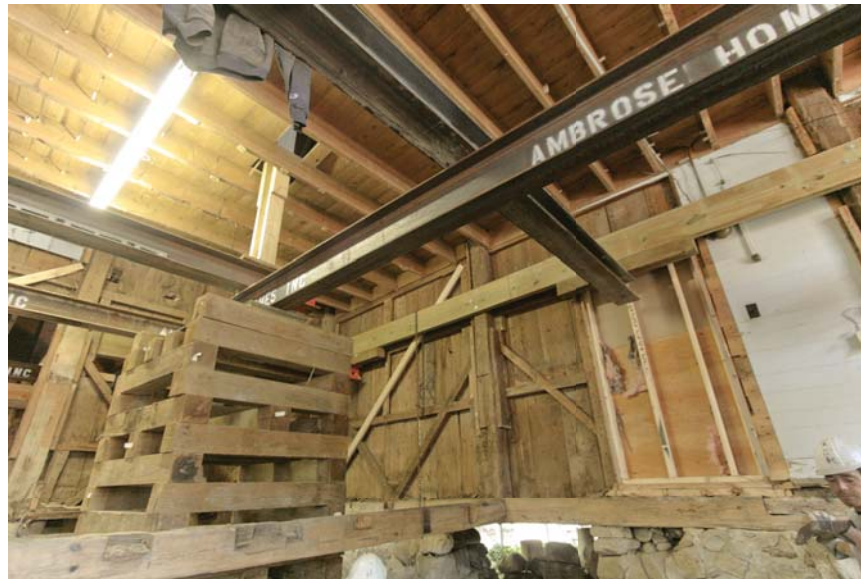
**Figure 2.** The eight I-beams provided multiple lifting and jacking points. Besides supporting the perpendicular beams, the two 60-foot-long needles picked up the doubled 2x12 ledgers lag-screwed to the wall framing at each end of the barn (above right). Four 40-foot crossmembers caught the ledger along the side walls (right).

The cribbing supported two primary 60-foot-long steel I-beam "needles" running front to back through the structure. These beams picked up doubled 2x12 cleats that we lag-screwed to the front and back walls, and also supported four 40-foot perpendicular I-beams that in turn picked up 2x12 cleats along the side walls (**Figure 2**, page 3).

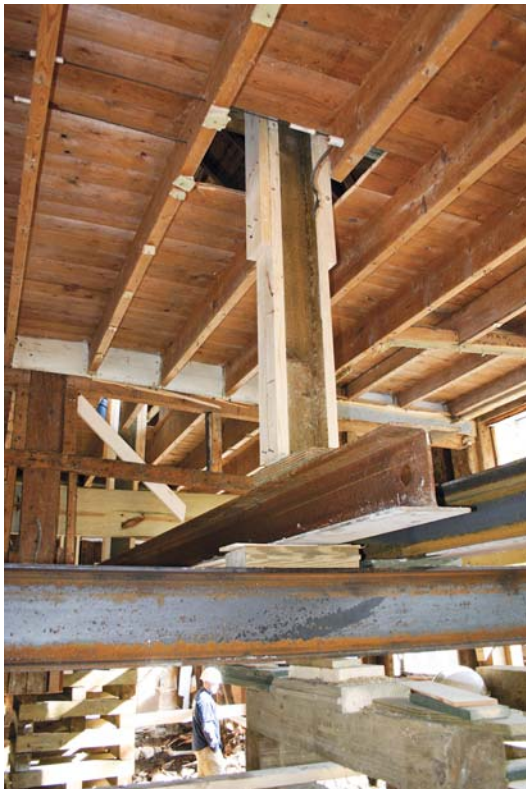
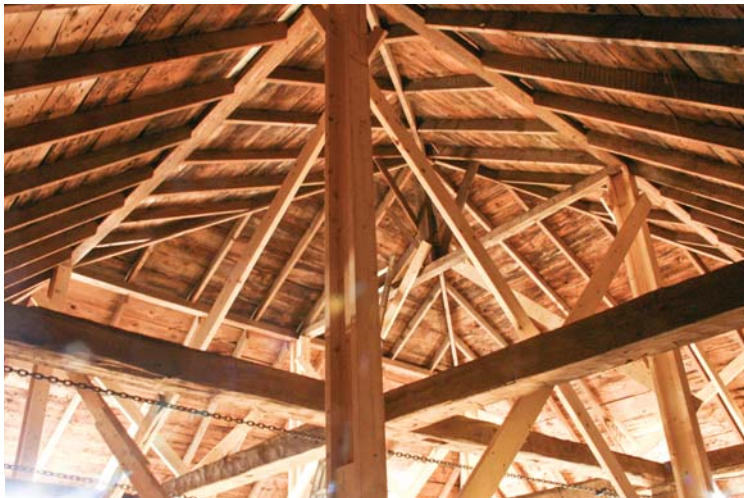
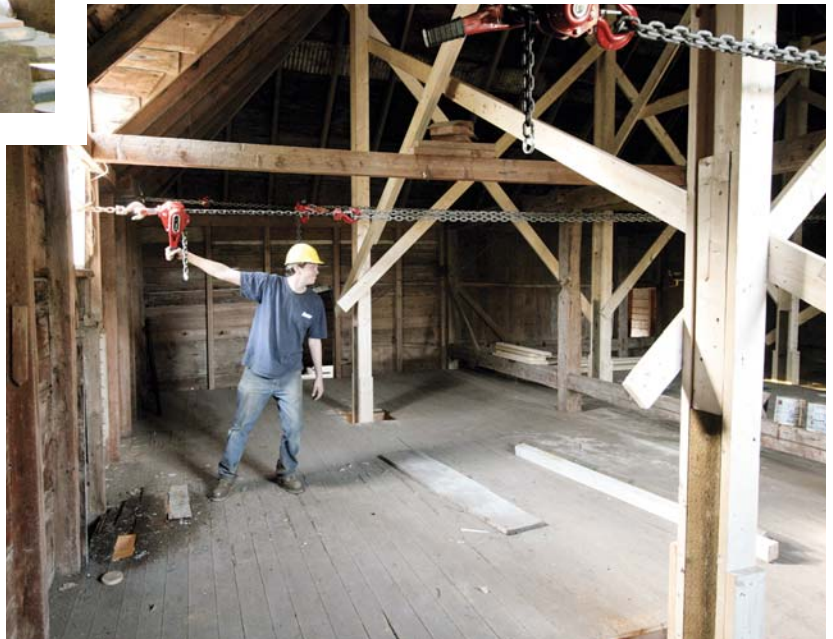
**Figure 3.** Built-up posts ran from a pair of 20-foot I-beams through the second-floor framing (above) to the roof purlins (above right). This arrangement allowed the roof framing to be jacked independently of the walls. Three-ton chain hoists stretched between the top plates helped pull the walls back toward plumb as the sagging roof was lifted (right).

To support the roof and provide jacking points, we laid two 20-foot-long I-beams

across the needles, directly below the 6x6 purlins that support the break between the lower and upper roof planes. We then built six site-laminated 6x6 posts, running them from the 20-foot I-beams up through the second floor to the purlins. Below the roof, we installed plenty of 2x6 cross-bracing to help the posts act as a unit and prevent bowing (**Figure 3**).

Jacking the roof could not alone pull the bowing 8x8 plates and leaning walls back in. For this, we cut holes in several locations above and below opposite plates, wrapped chains around the plates, and tensioned them with HIT 3-ton lever hoist come-alongs (purchased through [Arizonatools.com](http://Arizonatools.com) for about \$400 apiece). To help distribute the force and prevent the chains from biting in, we placed 4-foot lengths of 6x6 on the outside, under the chain, and armored the corners with

As we jacked the roof, we retensioned the chains and the plates moved inward, bringing the walls closer to plumb. We made 1/2-inch corrections each day, taking about a week in all to finish. When the plate sighted reasonably straight and the walls were within a few degrees of plumb overall, we called it good. (Later, when the new walls were in place, we created plumb interior surfaces by stretching

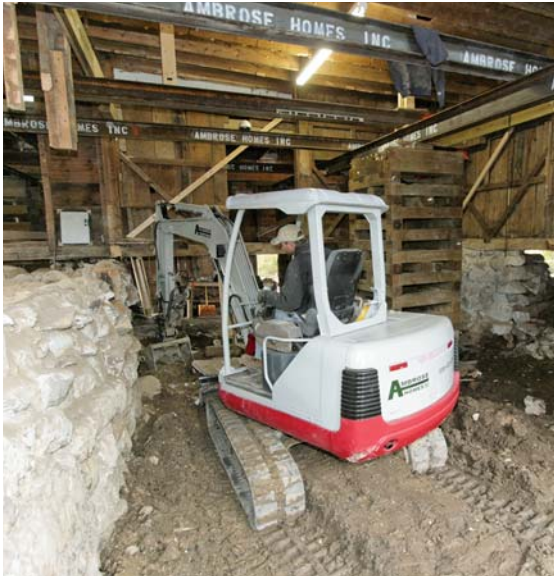
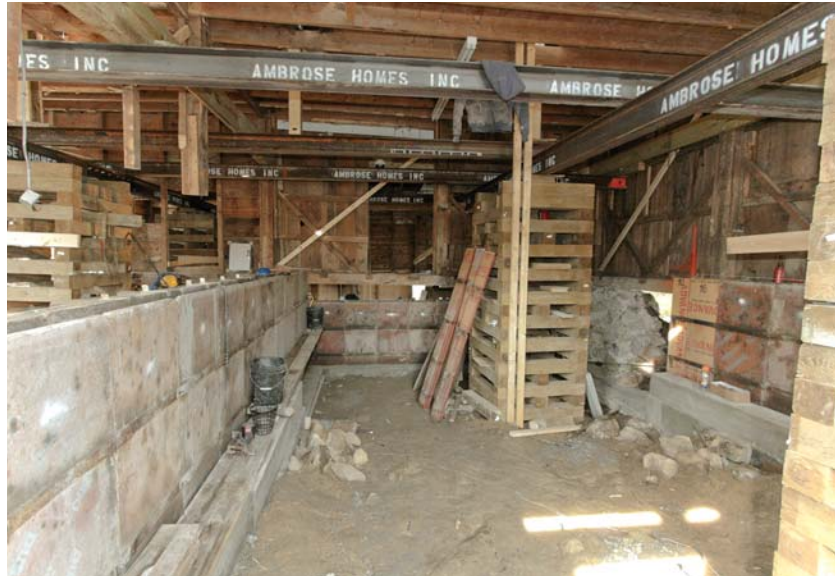
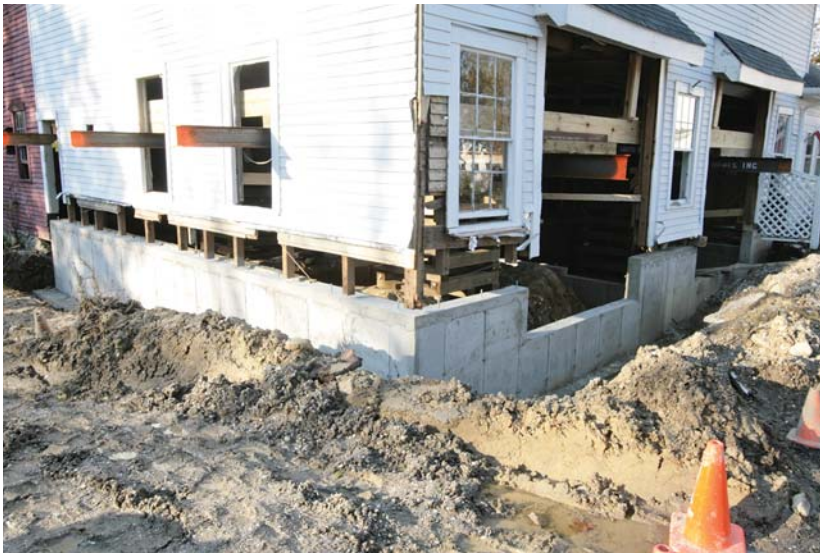
**Figure 4.** A mini-excavator helped clear the way for the new crawlspace foundation (above left). Reinforced stepped footings and stem walls replaced the original foundation a section at a time (above). Temporarily supporting the original balloon-framed walls on the new foundation ensured stability until the wall framing could be replaced (left).

Because of the barn's historic designation, the exposed stone foundation at the back had to remain intact, even though it was structurally useless. However, most of the shallow foundation along the front and sides had long since vanished into the site's clay soil, so here we were allowed to pour new grade-beam footings and crawl-space foundation walls (Figure 4, page

5). Since the barn was built on a mostly unexcavated slope and we needed to create a 3-foot-deep crawlspace, we first gutted the first-floor framing, then excavated from the interior, working around the cribbing with our mini-excavator and skid steer loader. Where the machines couldn't go, we shoveled by hand.

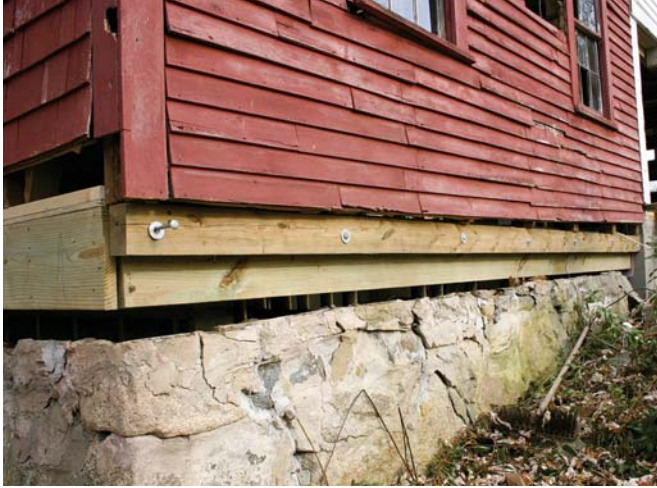
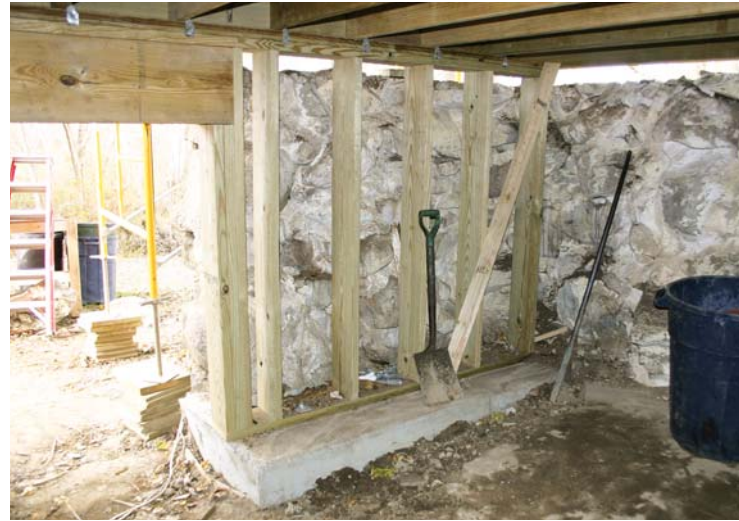
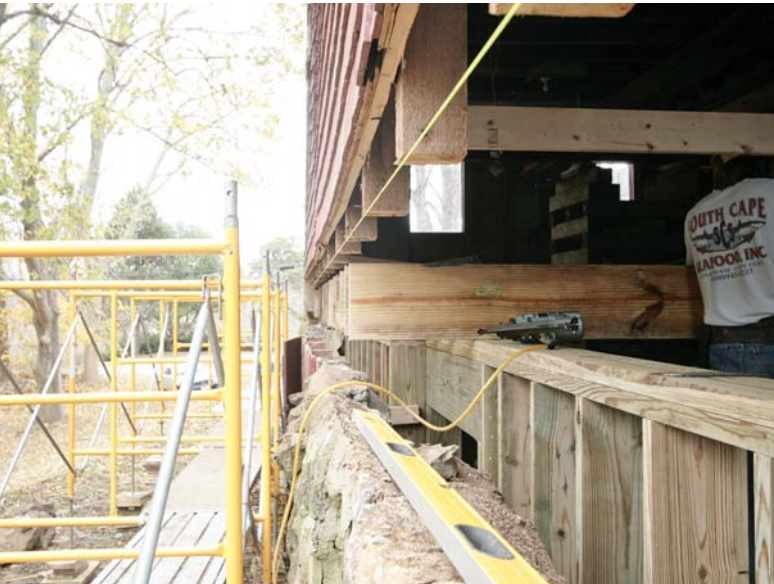
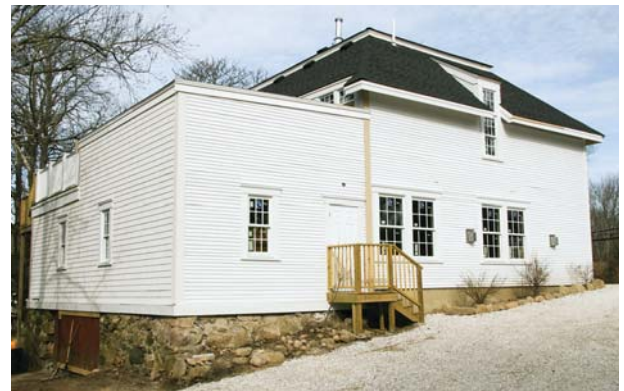
**Figure 5.** According to the permit, the historic stone foundation at the rear of the barn had to be preserved. Rather than rebuild it, the crew opted to cantilever the new floor framing (top left) over a pressure-treated pony wall set on a reinforced footing poured just inside the stonework (top right). A string line provided orientation for the joist ends, set back 3 inches for a double rim joist (left). With mortar closing the gap, the addition appears to bear on its original foundation (above).

To preserve the rustic foundation at the rear of the barn, we poured a 12-inch-thick steel-reinforced footing directly inside the stonework and framed a pressure-treated pony wall on top (Figure 5). After

cutting away the old studs for clearance, we extended new floor joists past the pony wall over the top of the stone, for a total overhang of around 18 inches.

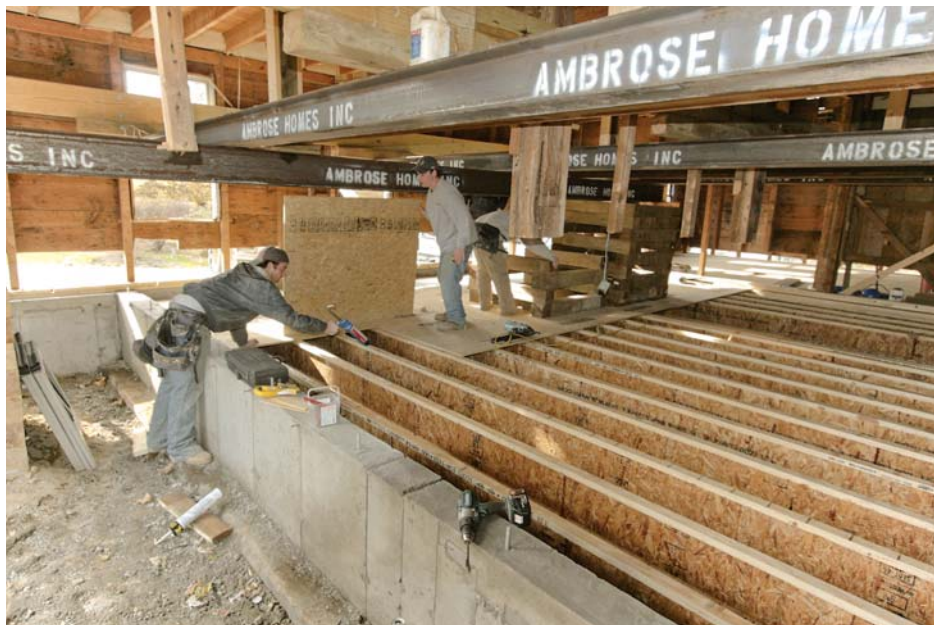
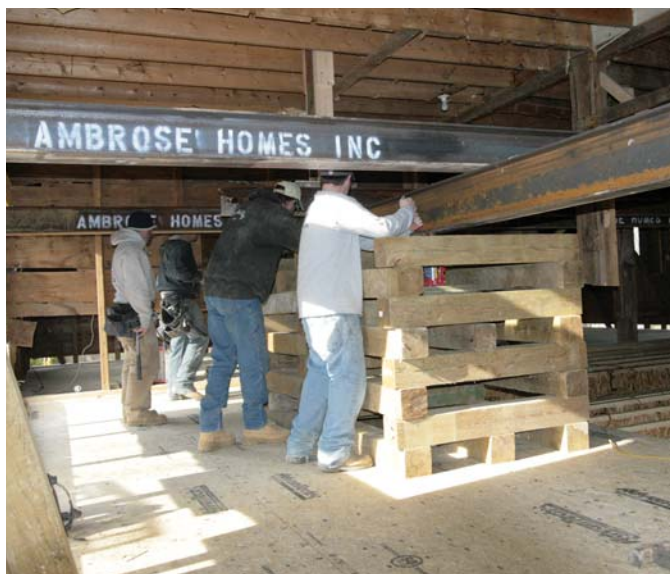
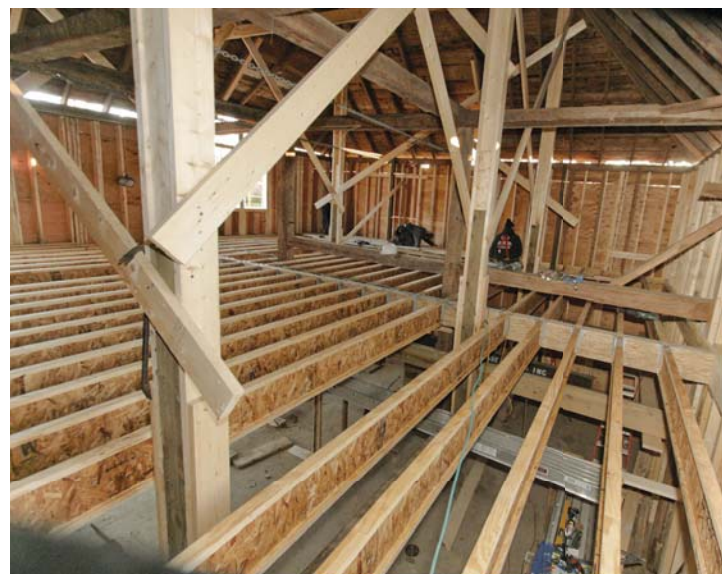
**Figure 6.** The new first-floor framing had to be installed around the cribbing (left). To fill in the gaps, the crew repositioned the cribbing above and below a completed floor section, then transferred the beam loads to the new stack (below left). With the first floor and wall framing replaced, only the roof supports remained to shore the structure while the second-floor joists were installed (below).

Since the cribbing was critical to the building's support throughout the repair phase, we had to frame the floors around each stack. We did this by framing and sheathing the deck to either side, then shoring with cribbing beneath the new joists and shimming it snug. Then we

continued cribbing up to the underside of the I-beam and shifted the load over onto the relocated stack (Figure 6).

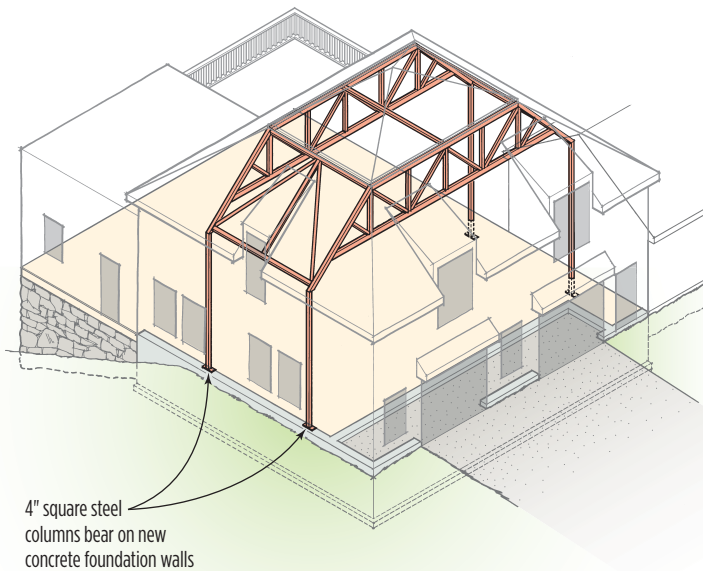
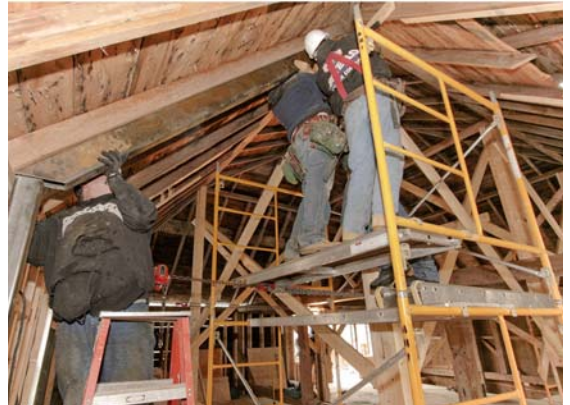
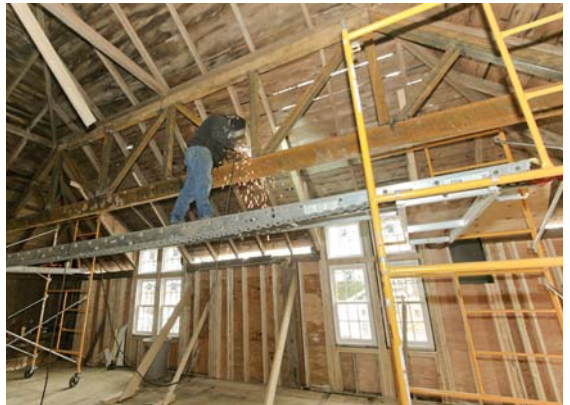
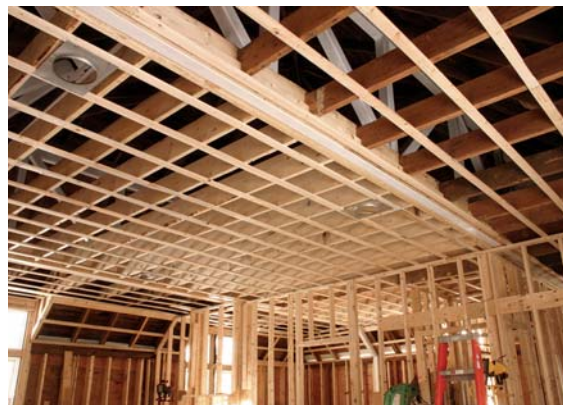
**Figure 7.** After being jacked to its original elevation, the original roof framing was supported by an engineered tubular steel truss (top and above), which was cut on site and assembled in place (top right), then welded together (center right). The truss (painted white) eliminated the need for collar ties and provided a flat ceiling plane (right).

To support and unify the roof framing, our engineer designed a rugged tube-steel truss that bears on four 4-inch-square steel columns extending up from the concrete foundation. The truss was custom-cut on site and fitted in place under the irregular roof framing (Figure 7, page 8). We made plywood patterns to enable the welder to cut the steel accurately. The steel fits snug under the 6x6 collar beams,

shouldering the entire load of the roof system and eliminating any need for collar ties. Diagonal bracing within the truss provides the roof with the necessary resistance to wind loads, a real concern in this 110-mph coastal wind zone.

We set the bottom chords of the truss dead-level to a laser line, creating a

nice flat ceiling plane. Short lengths of threaded rod tack-welded to the bottom chords hold 2x10 cleats, which we used for face-hanging the 2x10 ceiling joists. A scuttle through the ceiling provides access to the new attic.
