A New Interior in an Antique Building

New I-joist floors solved serious structural problems
in this traditional timber-frame home

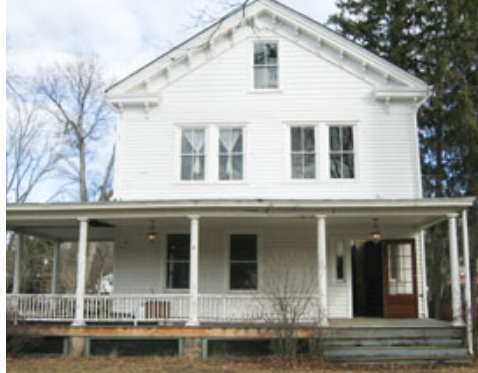
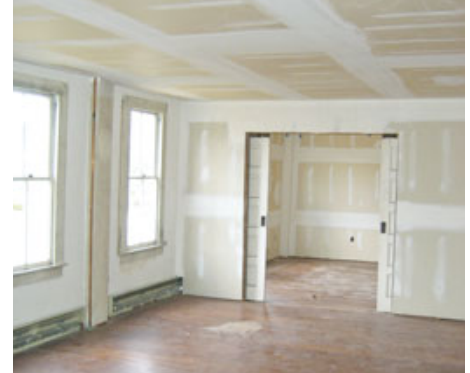
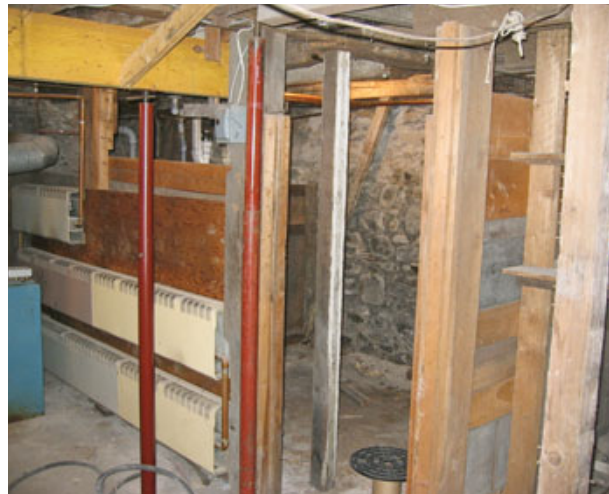
Figure 1. While the exterior of the 150-year-old timber-frame building was in reasonable condition (above left), the interior was well-worn and already in the midst of renovation when the project began (above and left).

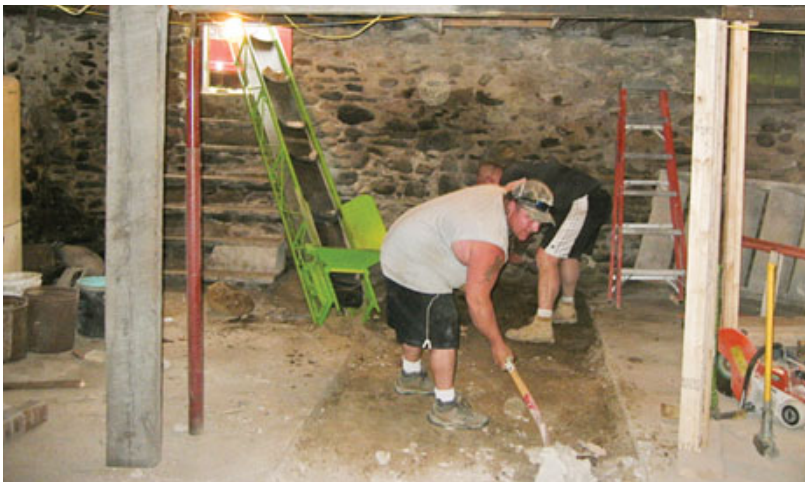
Figure 2. One of the first orders of business was to provide a center bearing wall in the basement. After cutting through the thin slab, the author's crew dug a trench the length of the basement for a new reinforced concrete footing (above). To accommodate the bearing walls for a stairway, the 12-inch-deep by 24-inch-wide footing widens to 5 feet at one end of the basement (right).

In the basement, the center bearing would include both 4-inch Lally columns and a framed bearing wall. Rather than create individual piers for the columns, we poured a 24-inch-wide by 12-inch-deep reinforced trench footing down the center of the basement (**Figure 2, page 2**). There was no easy access to the basement, so we dug the trench by hand. Luckily, the old basement floor was no

more than a thin coating of cement over the dirt, so we could easily cut it up with a demo saw and a diamond blade. Other than hitting some large rocks, digging the footing was easier than expected. We moved the soil directly into a dumpster outside with a rented conveyer belt, and then, after placing the rebar, we placed the concrete using a chute through the basement windows.

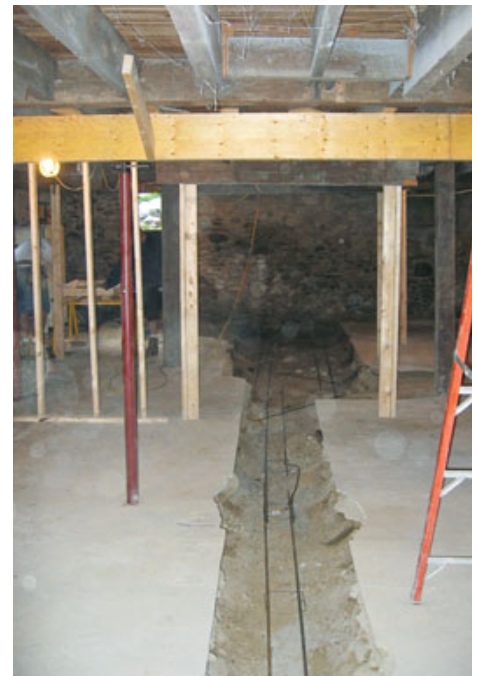
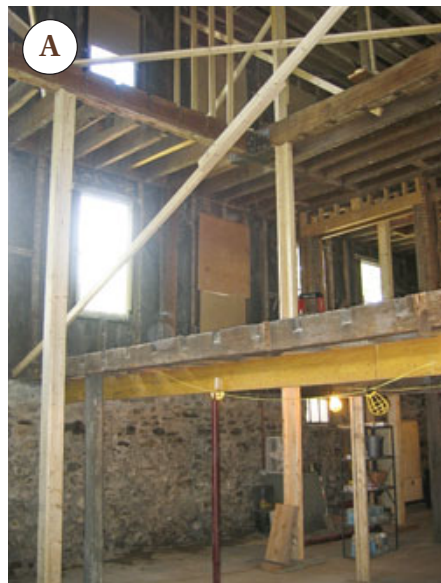
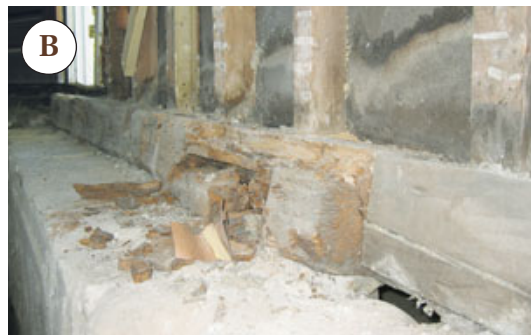
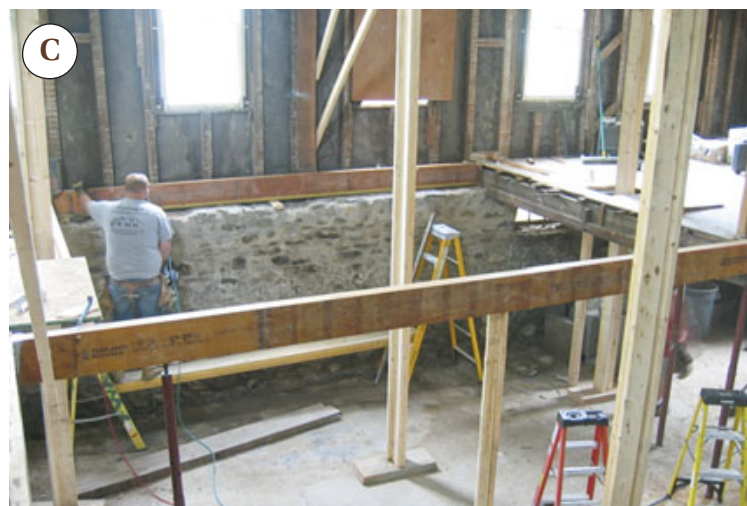
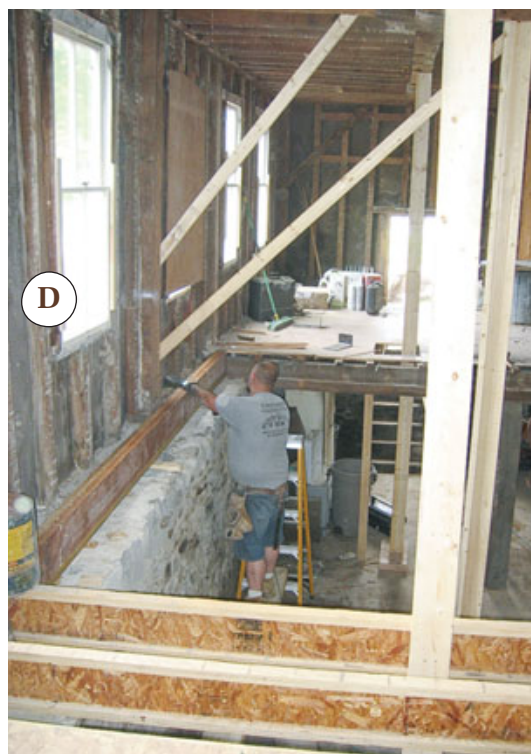
Figure 3. The floor framing was removed in sections and interior bracing installed to stabilize the walls; tall posts supported the floor system above (A). Because the original oak sill was rotting (B), the crew placed a new 2x4 pressure-treated sill on the inner portion of the wide foundation, then set a double-LVL rim joist on top to catch the ends of the new I-joists (C). This approach allowed reframing of the floors to proceed in sections (D).

Demolition. First, we demolished all of the nonbearing walls. Next we removed as much of the flooring and subflooring as we safely could, to get as much weight as possible off the framing and expose any potentially dangerous conditions. We started on the first floor and worked our way up (**Figure 3**). We removed the

floor framing in thirds, starting at the front of the building and working toward the back.

To support the second-floor framing while we tackled the bearing walls, we posted down to the basement floor through holes cut in the flooring. My little 16-inch Husqvarna chain saw got a workout — we went through a half-dozen chains, but it was a lot faster than using a reciprocating saw.

As we removed each floor section, we replaced it with new framing before moving on to the next. Thanks to the trench footing and center bearing walls, the longest joist span was only 14 feet 2 inches, so we used 9¹/₂-inch 230 series I-joists from Weyerhaeuser for the first-floor framing. On the second and third floors, we used 11⁷/₈-inch-deep I-joists so that we could cover existing 10- and 11-inch-deep beams without interrupting the ceiling plane.

LVL rim joists. Our initial plan was to hang the I-joists from LVL rim joists bolted to the 8x8 oak sill beams around the perimeter. But on discovering that many of the sills were rotting and would have to be replaced, we decided instead to hang the joists from a doubled LVL beam attached to a 2x4 PT plate sitting on top of the foundation wall inside the rotten sills. This way we could continue replacing the floor framing and replace the existing sill later, working from outside. We leveled the LVL band-joint assemblies with a laser, temporarily shimmed them in, then packed nonshrink grout in the voids.

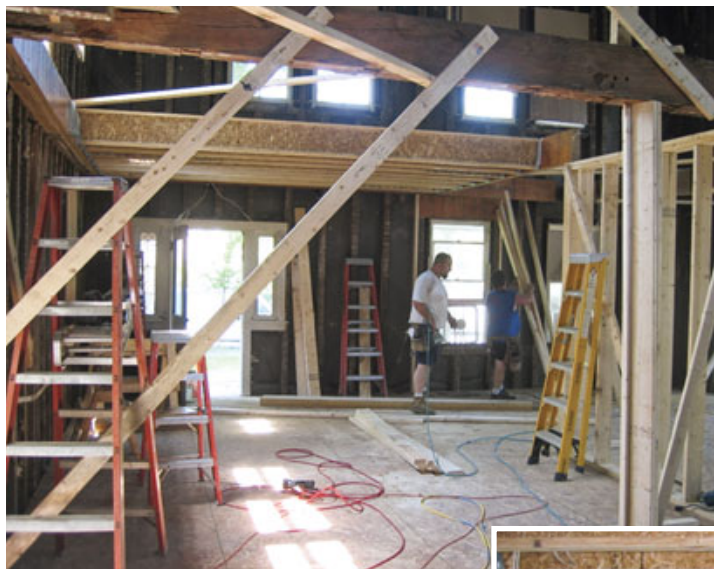
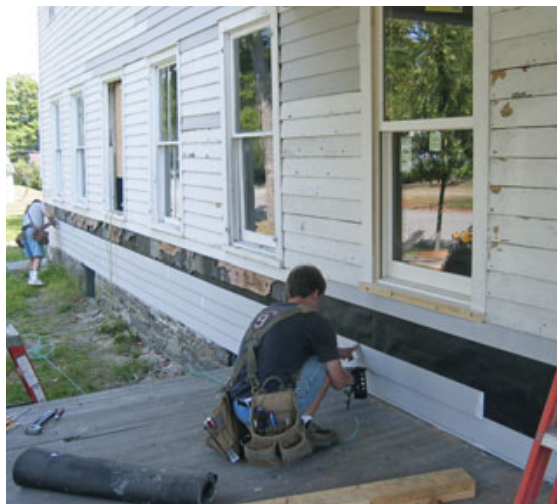
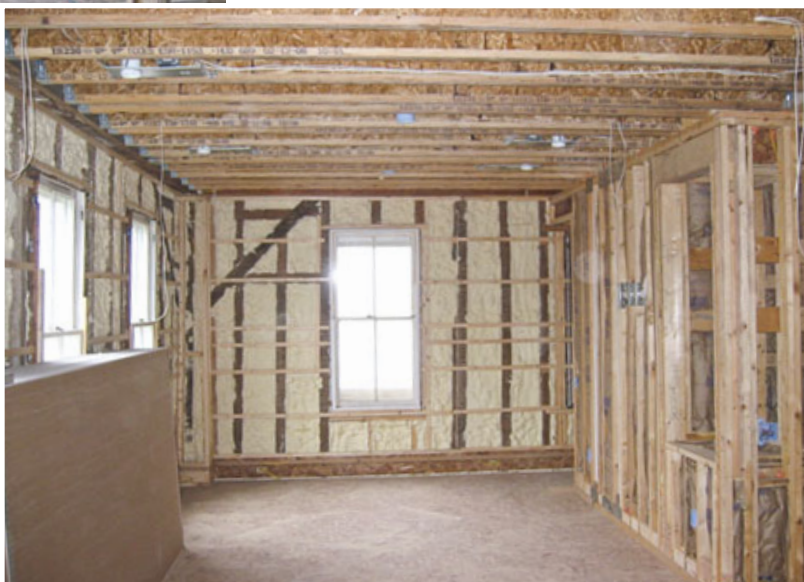
Figure 5. Diagonal braces prevented the exterior walls from spreading as the floors were reframed, a section at a time (above). Meanwhile, carpenters removed the bottom clapboard courses and replaced the rotted sills (above right). After the exterior walls were insulated with closed-cell foam, the author strapped them with 1X2s, shimming or notching as needed to remove the worst irregularities (right).

After completing the new interior framing, we tackled the existing sill replacement from the outside (**Figure 5**). The building had no sheathing, so to expose the sills, we only had to strip the bottom five courses of clapboards and cut the heavy building paper. We removed the oak sill in 12-foot sections, replacing it with a built-up sill made from five layers of pressure-treated 2x8s.

top of the old sill, so we had to cut the toenails off before installing the new sill. We toenailed the bottom of the studs into the sill, and where the sections of our new sill joined we lapped the top layer over the section before it. After packing voids between the new sill and the top of the foundation wall with nonshrink grout, we stapled up 30-pound roofing paper and

re-sided. Finally, we drove GRK screws through the LVLs into the new sill beam from the inside to join the floor framing to the new PT sill.

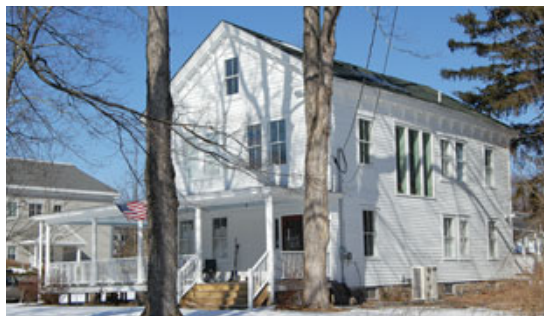
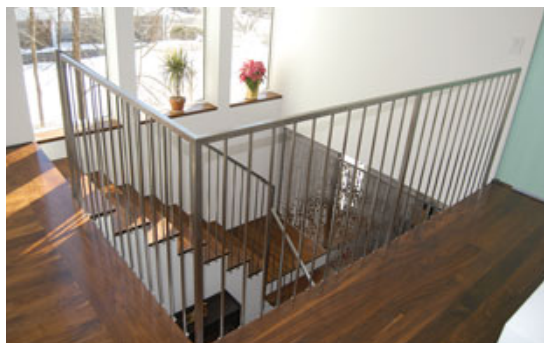
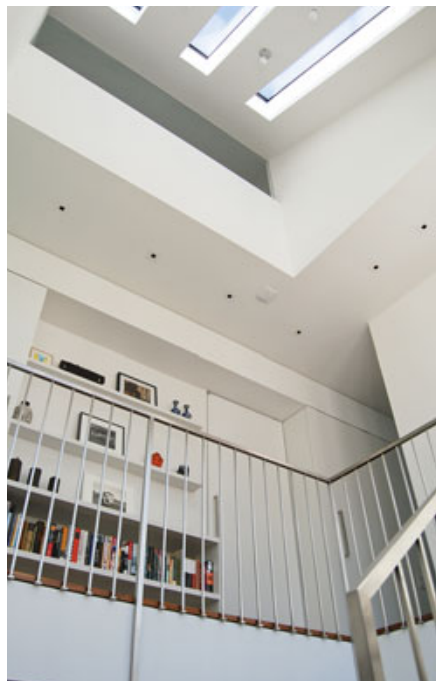
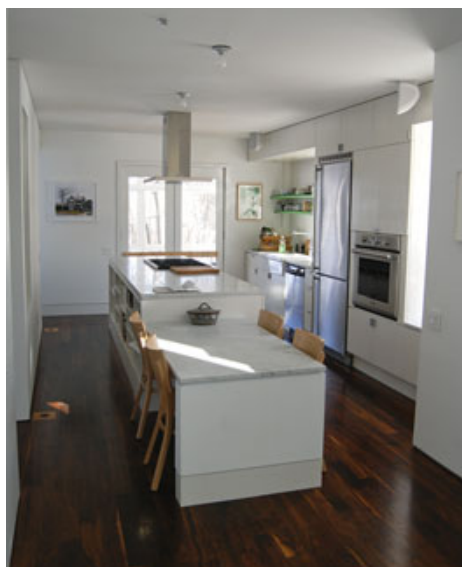
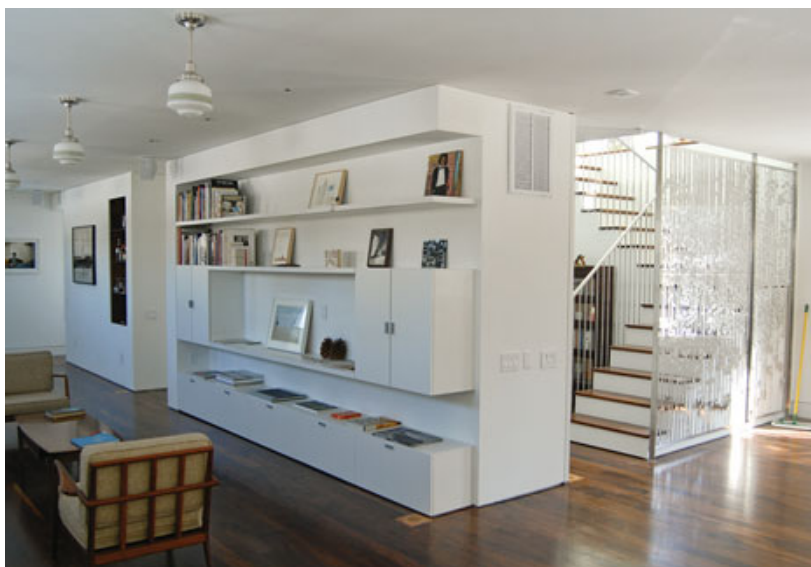
Figure 6. A bay of tall windows on one side is the only clue from outside that the vintage home has a stylish contemporary interior.

needed. While packaged in a traditional-looking exterior, the resulting interior space has an open and modern look that would have been hard to achieve if we had tried to make do with the original floor framing (Figure 6).
