Laying Block Steps

Get a cast-in-place look with versatile CMUs installed over a reinforced slab

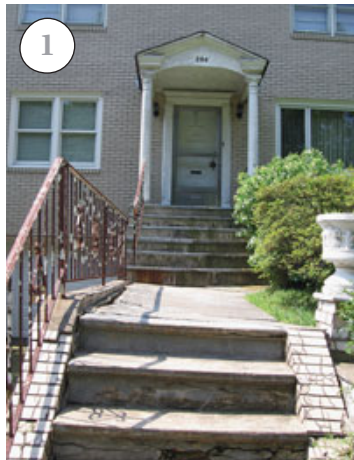
repairs to the existing façade, steps, and front walkway (1). Even though the 1950s residence had few of the characteristics of the neighborhood's grander homes built earlier in the century, it was subject to the same historic preservation rules and review by New Jersey's Landmarks and Historic Preservations Commission. For smaller repair projects like this one, the commission's local historic preservation officer can issue a Certificate of No Effect, which we had to apply for along with the building permit. After reviewing our plans and specs, the officer suggested that replacing the front entry's rotted columns with similar wood columns — instead of fiberglass ones — would allow us to avoid full commission review at the next monthly meeting. We followed

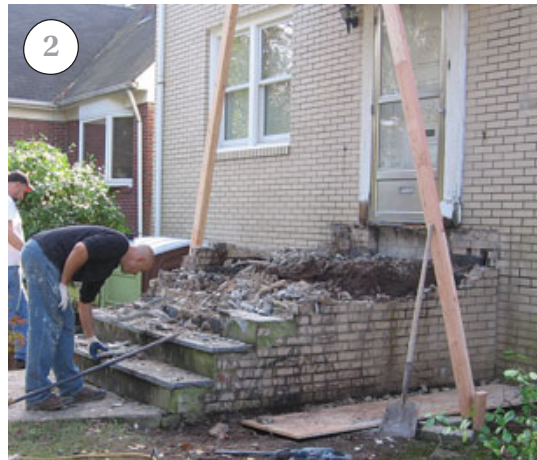
When we began pulling the steps apart, it became clear that the crumbling surfaces had contributed to the deterioration of the overall structure (2). There's a saying that they don't build things like they used to, and if these steps are any indication, it's probably a good thing: The stairs had been backfilled with broken block, wood construction debris, and dirt, all of which had settled over time as the deterioration worsened and water poured in and compressed everything even more. The porch landing, originally limestone set on a 2-inch-thick concrete pad, had 6 inches of space beneath it. We were amazed — not by the fact that there was so much damage, but that the stairs had lasted close to 60 years.

The original bluestone treads and landing pavers were worn, spalled, and cracked, and weren't worth salvaging. Everything — including the railing — got tossed in the dumpster.

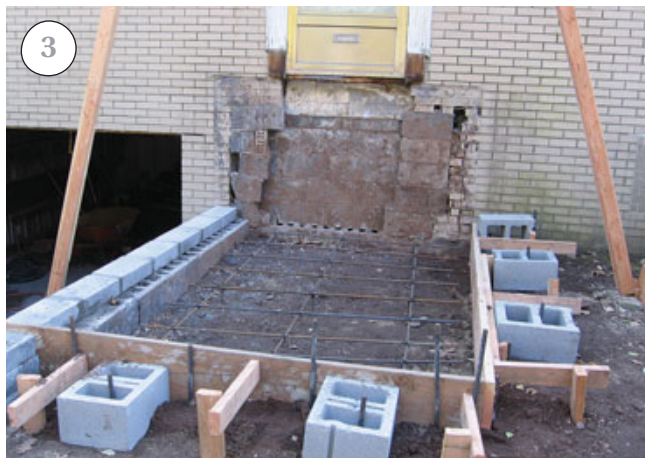
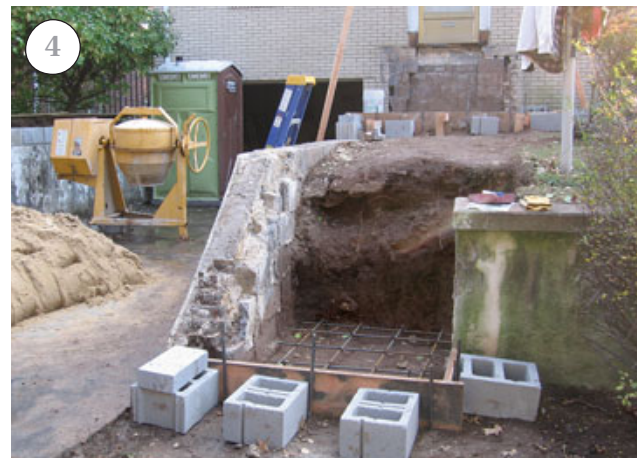
Once we had propped up the porch roof and cleared away the debris, we built forms for the two slabs that would support the upper and lower sets of stairs (3, 4). Against our advice, the owner wanted to keep the existing retaining wall, so we didn't have the option of forming a perimeter footing for the stairs. Instead, we would form and pour reinforced 12-inch-thick concrete slabs on grade that would be thick enough to provide a solid base and serve as the first step for each set of stairs.

We placed the formwork so that the top of the upper slab would be 43 inches below the door threshold, our benchmark elevation. This would allow room for five 8-inch-high steps (the slab itself is the sixth step), plus a 2-inch-thick limestone landing platform and a 1-inch-thick bluestone threshold under the door. We formed the lower slab so that the top would be 91 inches below the benchmark, leaving room for another set of stairs with five risers.

We wanted to reinforce the retaining wall and lock it to the upper slab, so we capped it with solid 8-inch pancake block. This

left 4 inches of the 12-inch-wide block exposed, which would allow concrete from the slab pour to flow into the block cavities. We reinforced each slab with 1/2-inch rebar tied in a grid 12 inches on-center and supported by chairs.

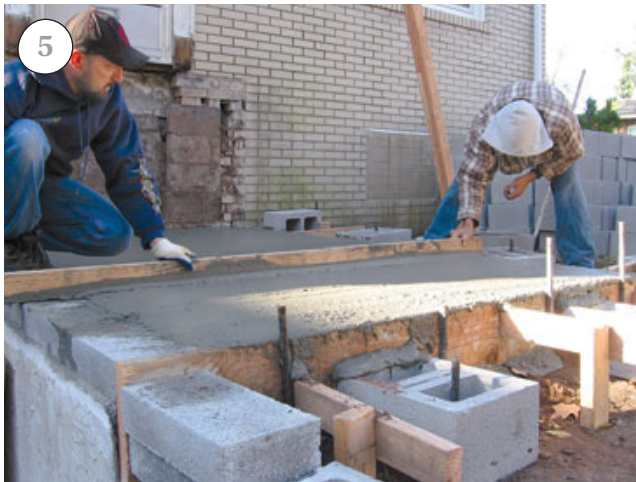
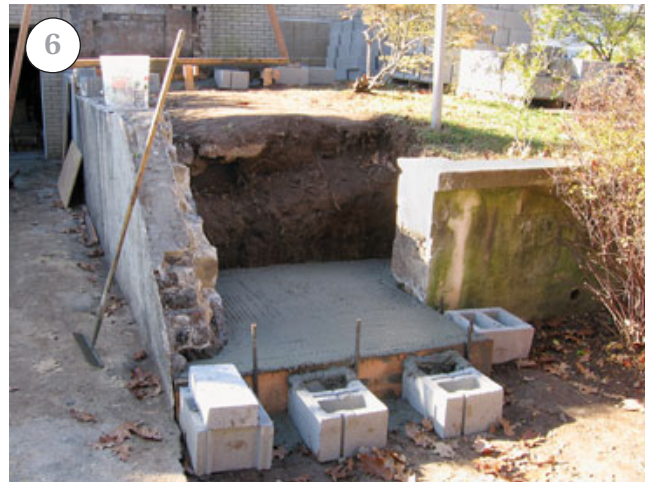
It took almost 4 yards of concrete to pour the upper and lower stair slabs and to repair part of the retaining wall on the opposite side of the driveway. We left the slabs a little rough to help key the mortar and blockwork (5, 6).

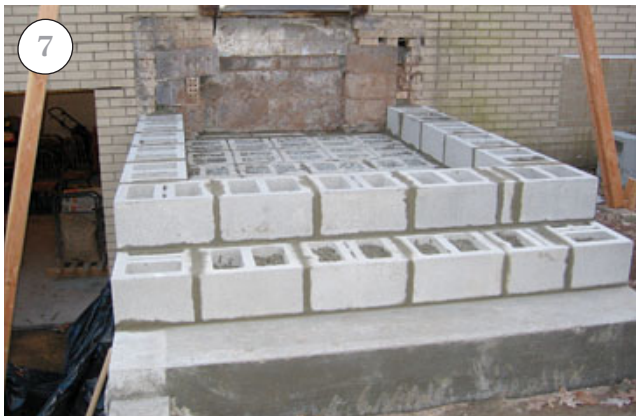
Each step is basically a platform built with 8-inch by 12-inch by 16-inch concrete masonry units (CMUs), stepped back far enough from the platform below it to allow room for a 12-inch-wide by 2-inch-thick limestone tread (7). Each 8-inch riser equals the thickness of a block, or 7½ inches, plus a ½-inch mortar joint. As we set the blocks for each platform, we mortared the joints around the perimeter, then infilled with more blocks set in mortar. There's no vertical reinforcement, but we filled the perimeter cores with mortar and the interior cores with ¾-inch stone (8).

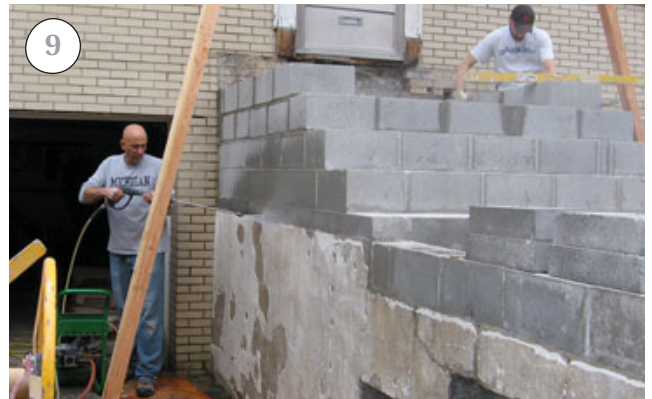
Once the blockwork was completed, we scraped, power-washed, and patched the existing retaining walls and began parging everything before setting the limestone treads (9). We used a 2½-to-1 sand-mortar mix, building up to a ½-inch total thickness with two coats of mortar.

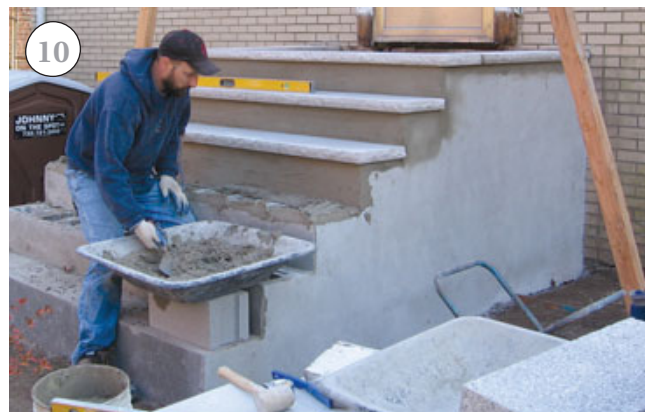
We replaced the original bluestone treads with 2-inch-thick by 12-inch-wide limestone treads, which cost less per lineal foot in our area (\$13 vs. \$9, including the rock-face treatment) and seem to adhere better to mortar (10).

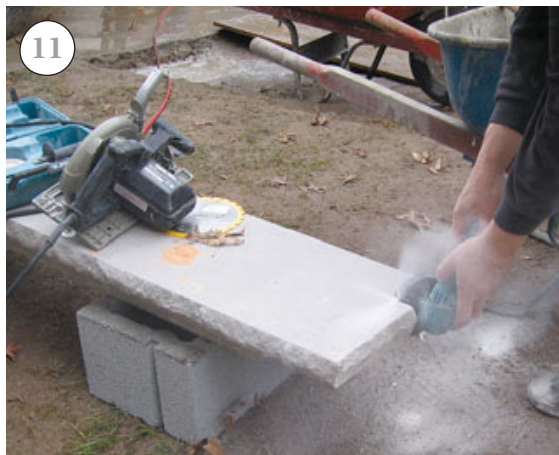
for waste. We used a circular saw and an angle grinder, both equipped with diamond blades, to cut the stone (11). When we set the treads, we pitched them so that water would drain away from the steps.

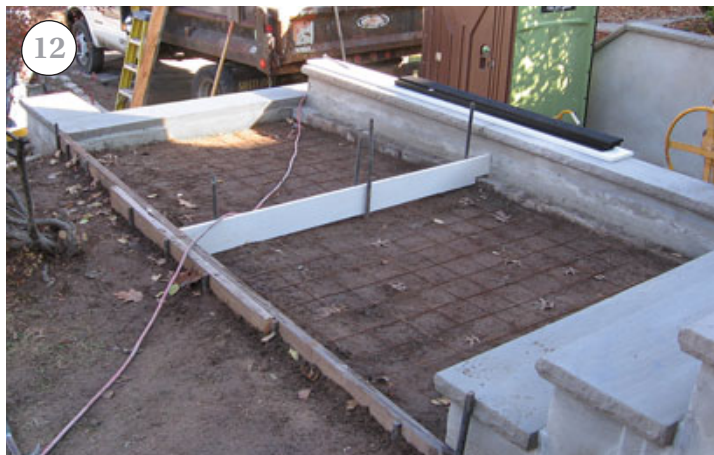
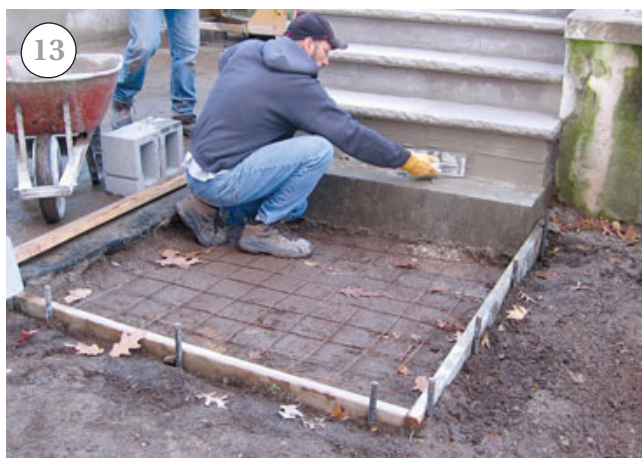
While we were finishing up the treads, we formed the upper and lower walkways that connect the two sets of steps (12, 13). Each walkway measures about 4 to 5 inches thick and is reinforced with welded wire mesh fabric. To prevent ponding and to direct water into the yard and away from the driveway, we pitched the formwork slightly — about $\frac{1}{4}$ inch per foot — away from both the house and the retaining wall.

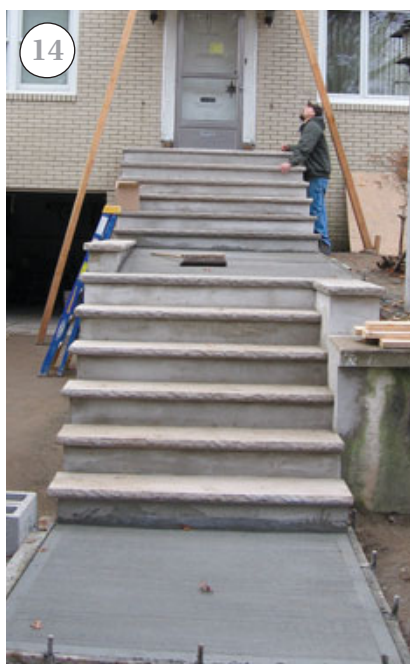
For crack management, we installed an expansion joint when we poured the longer upper slab. After floating the wet concrete with a wood float, we waited until all the bleed water had evaporated before giving the walkways a broom finish for traction (14).

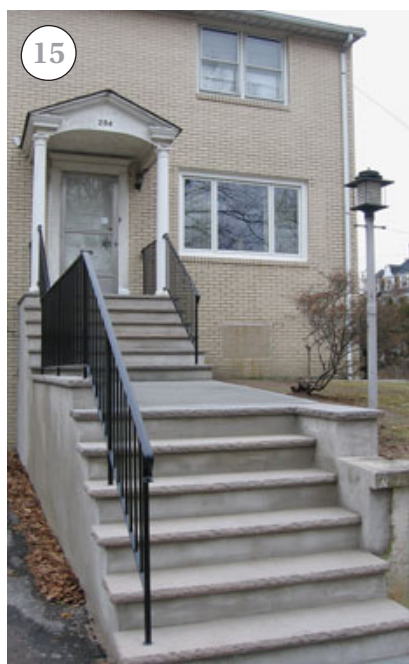
We couldn't reuse the existing rail, so we installed a new aluminum rail system. It cost about \$51 per lineal foot, or \$2,650 installed. We also replaced the porch columns, but because we finished the project in cold weather we haven't been back to finish the painting yet (15). Even though the total project budget was less than \$25,000 (which included repairs to another retaining wall), my small crew kept busy during a slow time, and we learned a little about working in a historic neighborhood.
