## Removing a Structural Chimney

by Clay Dusel

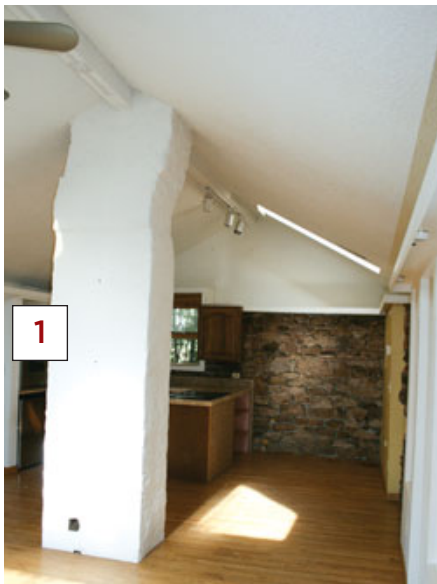
**T**wo summers ago I received a call from some homeowners who wanted to remodel their kitchen and, as part of the project, remove a brick chimney that ran up through the center of the house (1). The chimney had been abandoned decades before when someone removed the original 1890s wood stove and installed a modern furnace in another location.

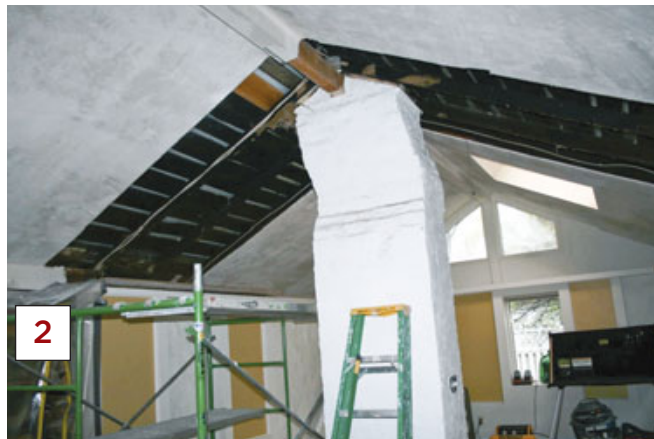
original roof and ceiling with a cathedralized gable that contained a pair of structural ridge beams. The ends of ridge beams were actually supported by the abandoned chimney (2).

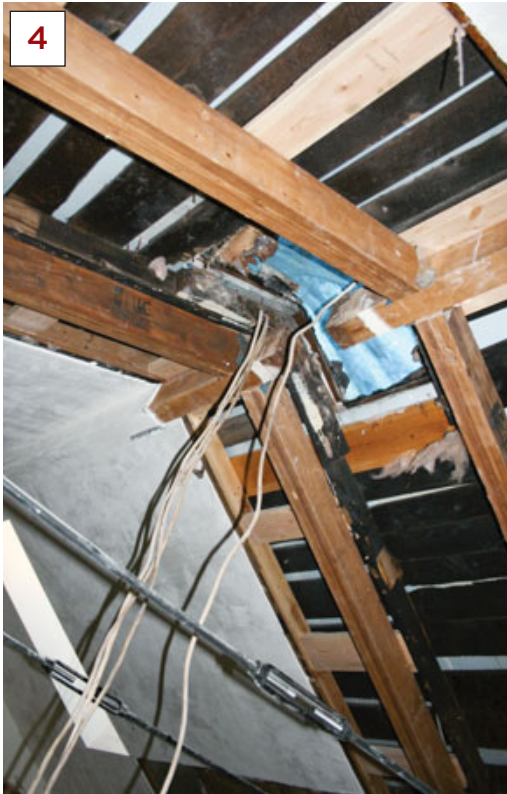
The upper ends of the chords butt to the sides of the existing ridge beams and are held in place with upside-down joist hangers (4); the lower ends land on the existing stone exterior walls and are connected end-to-end by the rods (5). The  $\frac{5}{8}$ -inch rods connect in the center with turnbuckles (6) and pass through holes in the LVLs, where they terminate with washer plates and double nuts. After all the pieces were in place we used the turnbuckles to tension the rod until the top chords lifted the ridge beams slightly off the brick. At this point, the chimney no longer carried a load, so we tore it down, filled in the missing section of ridge beam, and then patched the roof, ceiling, and floor.

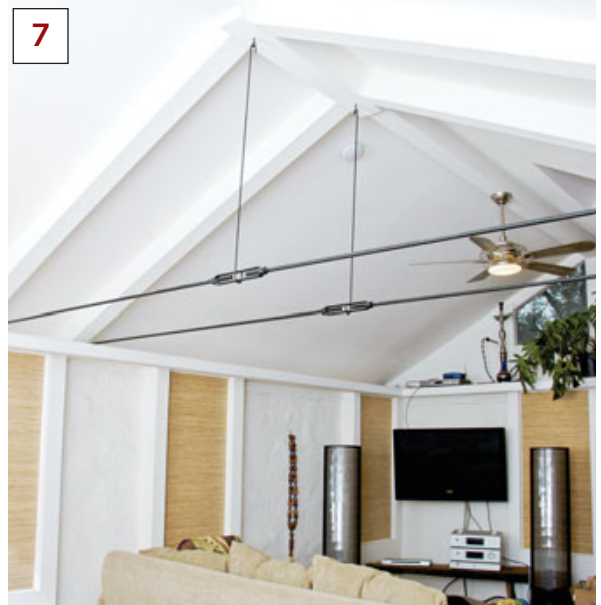
To prevent the collar ties from sagging, we used smaller rods to tie them to the ridge beam above. The support trusses (7) do more than just free up space in the center of the room — they create a visual break between the new kitchen and the existing great room.
