# Sealing a Crawlspace Liner

A plastic membrane with leaky seams is useless in an area with a high water table

by Patty McDaniel with Scott Gaston

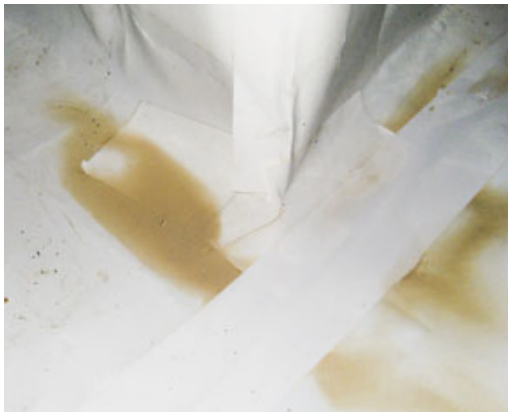
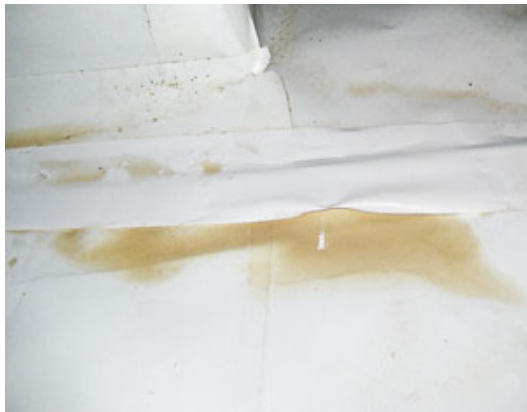
I don't actually venture into the crawlspace too often. But a couple of years ago, while installing a new dryer vent pipe, I discovered a puddle on top of the liner. Closer inspection revealed that water was entering at the taped seams, then flowing and pooling at low points (see **Figure 1, page 2**). The ground below the liner was saturated enough that the liner was actually floating in some areas. I took the thriving frog population as evidence that I had a chronic problem on my hands.

**Figure 1.** In spite of being taped, many of the joints in the CleanSpace liner were leaking liquid water, as evidenced by the dirt stains left behind.

These improvements made a big difference but didn't completely eliminate the water leaking through the crawlspace liner. When I contacted the installers, they said that the warranty covered the entrance of water vapor, not liquid water. They recommended that I add a perimeter drain on the inside of the crawlspace, directed to the existing sump pump (at an estimated cost of \$3,200), and offered to retape the liner (for \$500). If I took both steps, they would then guarantee the liner against water leaks. (In fairness, another franchisee offered to retape the seams for free).

But by this point I had lost faith in tape as a suitable method for seaming polyethylene in the presence of both water and dirt. So I contacted the building scientists at Advanced Energy in Raleigh, N.C., who have extensive experience with conditioned crawlspaces (see "Building a Sealed Crawlspace," 10/03). They suggested that I use duct mastic to seal the seams, specifically a fiber-reinforced product called RCD #6 ([rcdmastics.com](http://rcdmastics.com)). Described by the manufacturer as a "fibrous adhesive sealant," RCD #6 is a high-tech mud typically used to seal joints in ductwork, but it can also be used for joints in insulation boards and vapor retarders.

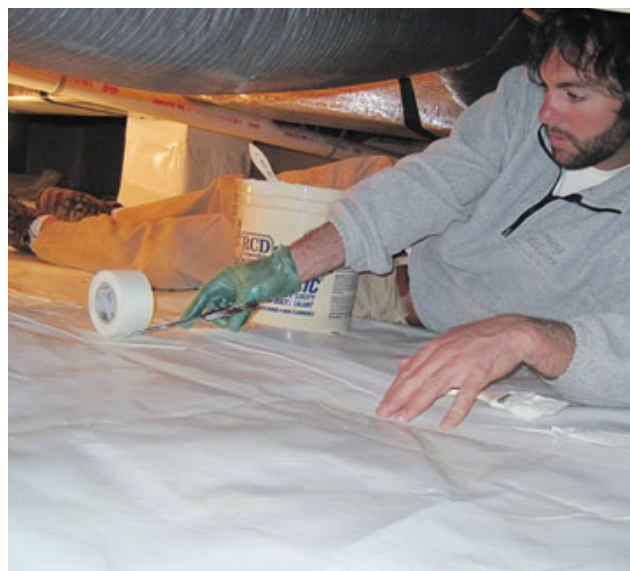
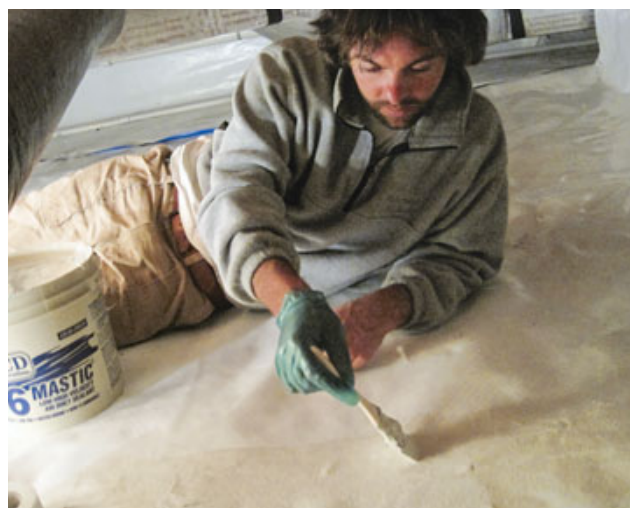
**Figure 2.** Fiberglass mesh tape (top) followed by a thick coating of duct mastic created rugged, waterproof seams. The self-sticking mesh tape held the overlapping plastic sheets in place as the mastic set up.

In some places the tape was still partially adhered, in others it came away easily. We cut away the loose tape and left it in place where it was relatively snug. Where water had entered through the seams, dirt was left behind, so it was easy for us to identify vulnerable areas. But creating a good, tight overlap over an uneven dirt floor can be a challenge — especially if you're lying on the material you're trying to align. The pieces tend to wrinkle, but the wrinkles at the laps don't politely align. We found that we could use the sticky drywall mesh tape to hold the sheets together while the mastic set up.

We applied a line of mastic about 3 inches wide and  $\frac{1}{8}$  inch thick, making sure we completely covered the mesh tape. We worked the piers together, with a person on each side, to make sure we sealed every joint.

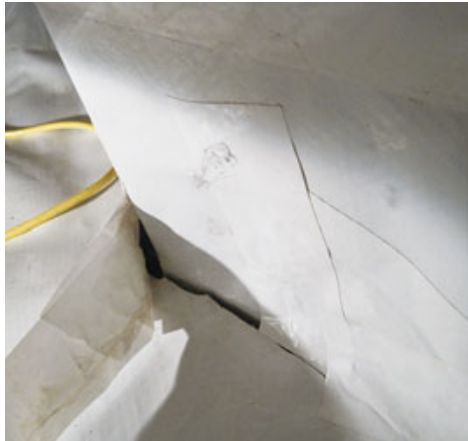
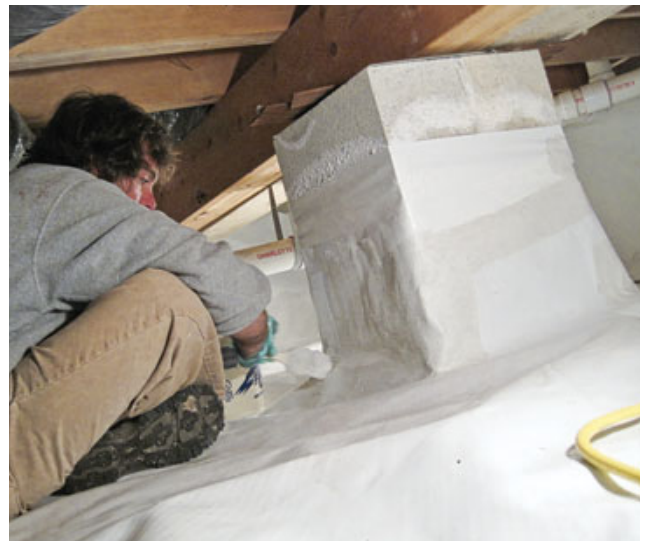
We started in one corner of the crawlspace and worked our way back toward the crawlspace entrance, sealing every seam and all the joints around every pier (**Figure 3**).

**Figure 3.** After removing any loose tape (left), the authors applied mesh tape and mastic to every lap and cut around the piers (below). To make sure they sealed every joint, they worked the piers as a team, positioning themselves on each side; this also reduced unnecessary movement on the membrane as the mastic set up.
